Inspection Report

House Inspect Australia

51 Beach Road, Wangi Wangi , NSW, 2267

Building Inspection

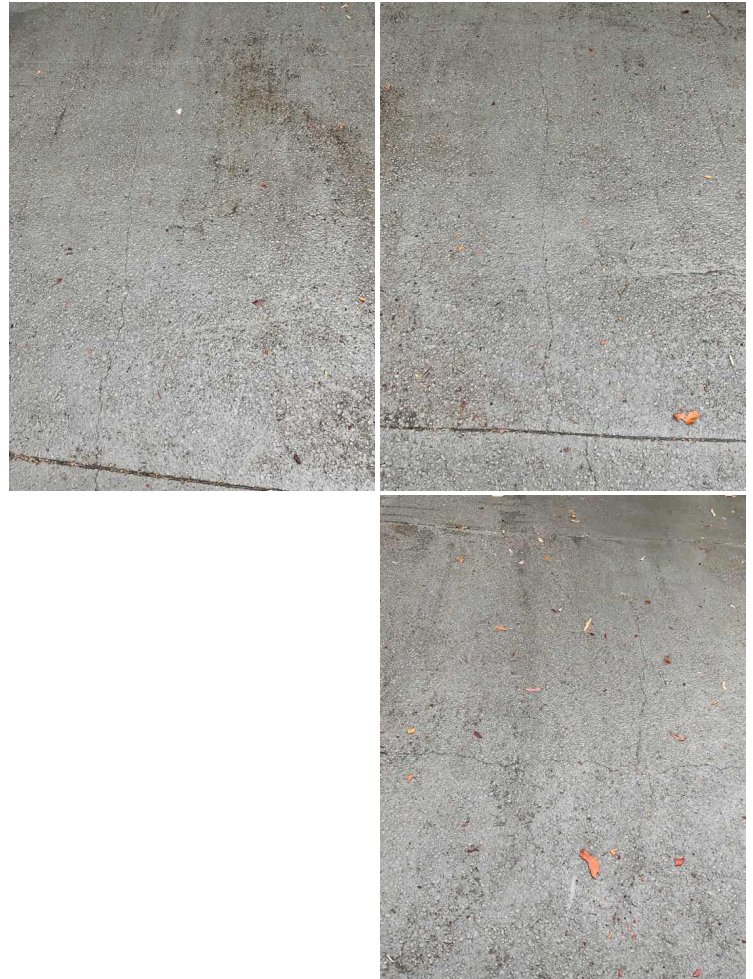
Driveway Condition

Common cracks & settlement were observed on the driveway. Maintenance is recommended. Note: Whilst these cracks appeared to be minor at the time of inspection, we strongly recommend you monitor these cracks and if worsening occurs contact a concreter for further advice.

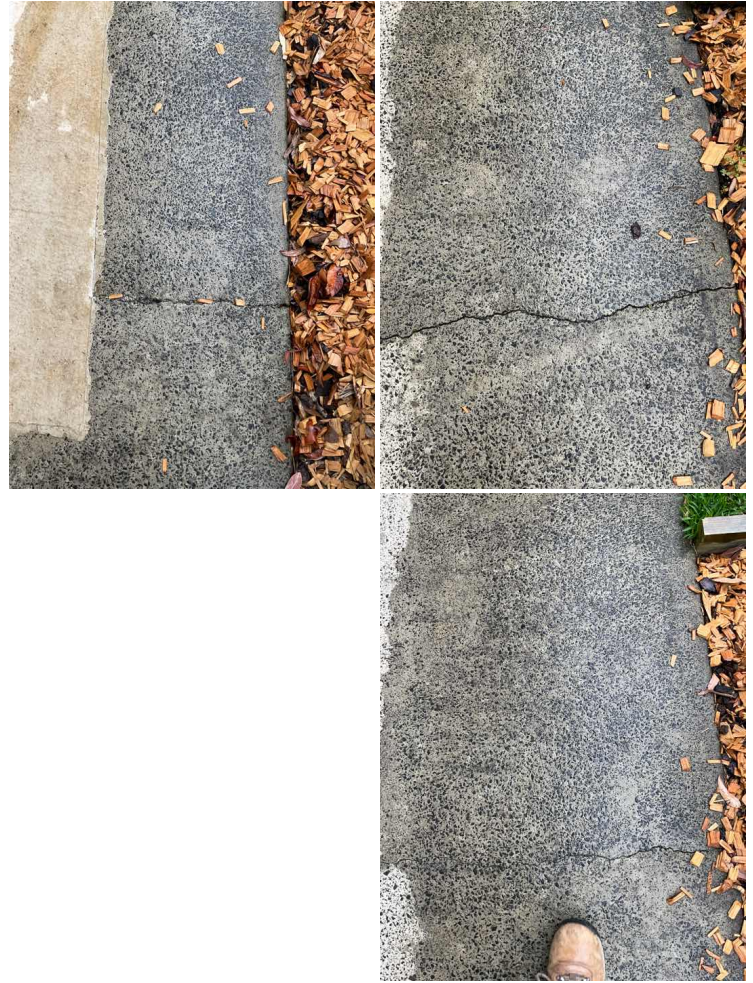
Pathways Condition

The concrete path is in poor condition replacement recommended.

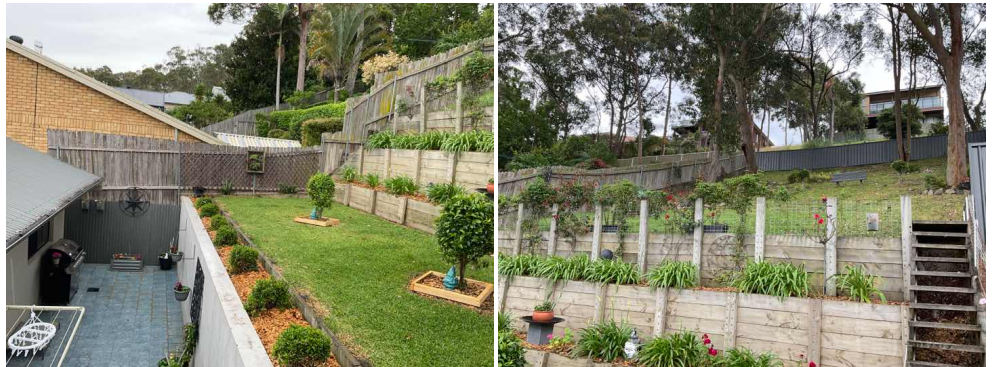
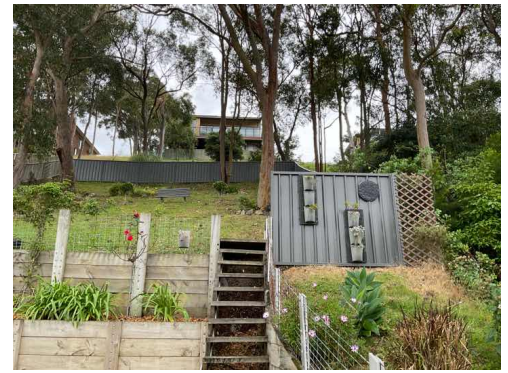
Of the visible areas, the general condition of the fences and gates is serviceable for the age of dwelling. Damage to gates noted. contact a licensed fencing contractor for repairs

Plinth board rot - Recommendations: Repairs are required by fencing contractor.

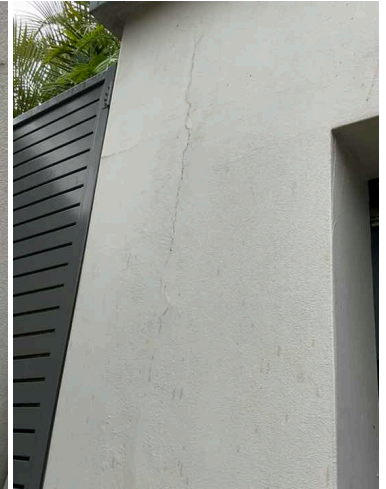
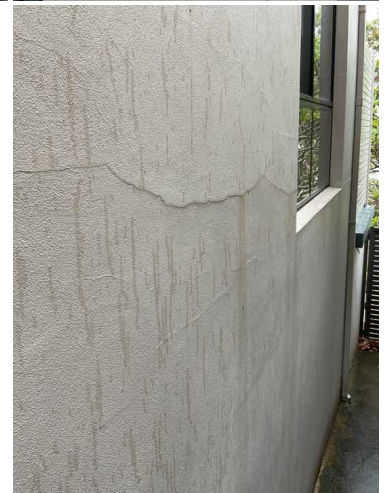
Condition

There appears to have been some settlement in the building which has caused some cracking to the walls. These cracks are categorized as 0 to 2. This can also cause some doors to bind or be out of square. In the inspectors opinion these cracks are due to settlement, usually due to ground movement and subsequent movement to building materials can be expected. Any cracks should be monitored and if cracks increase in size, further investigation should be carried out by a structural engineer.

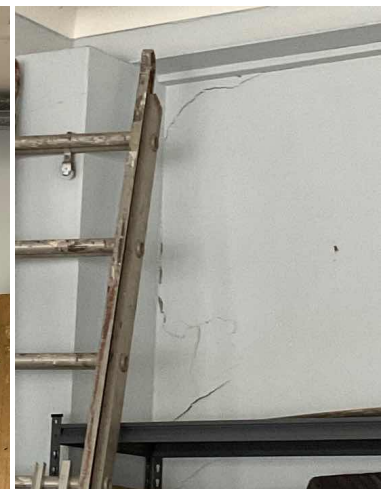
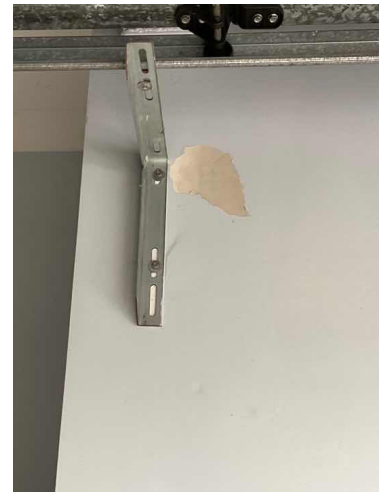
Section of Wall linings have minor damage - **Recommend maintenance repairs to increase longevity of linings**

Areas identified with minor cracking due to movement/settlement - **This can be rectified with minor maintenance. Suggest Filling and Painting.**

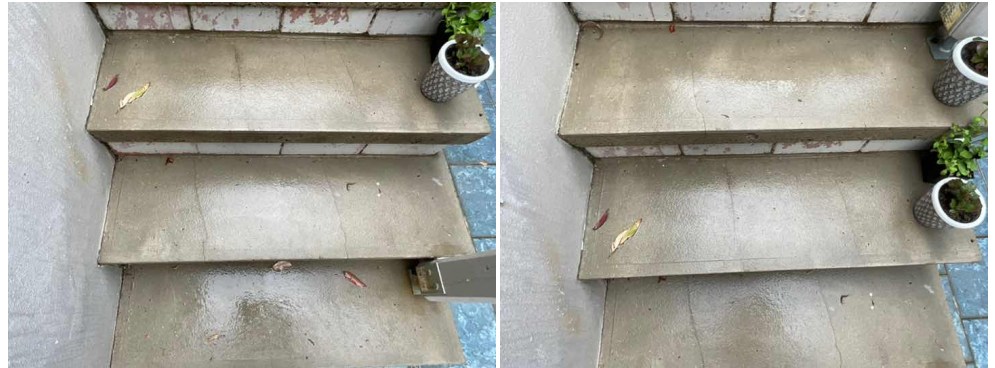
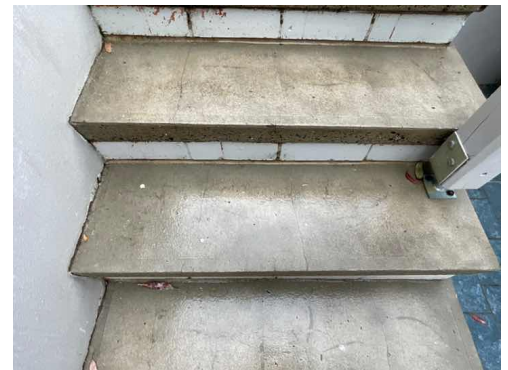
Treads

Settlement/movement cracking.
Recommendations: A qualified brick layer or concreter should be engaged for advice and recommendations.

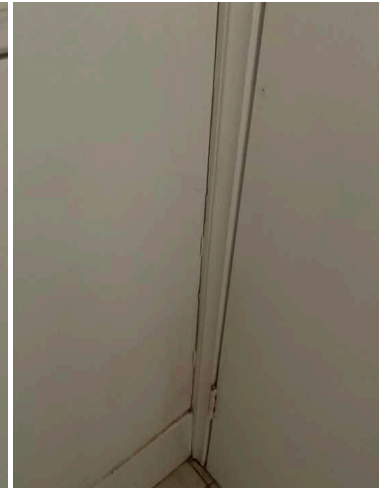
Other Doors

Minor cracking around door architraves. These are contributed to settlement and movement- **Minor maintenance recommended. Fill and Paint**

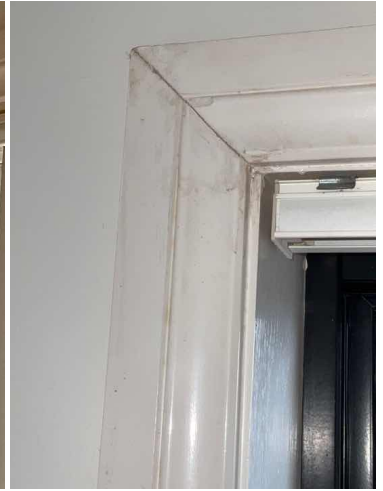
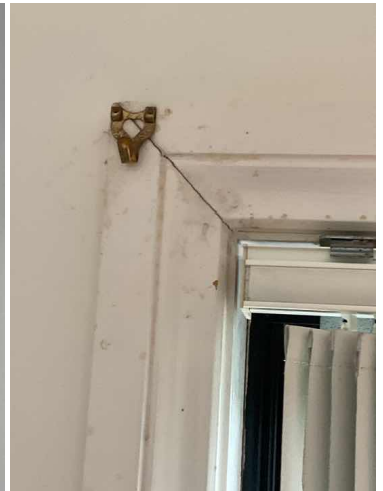
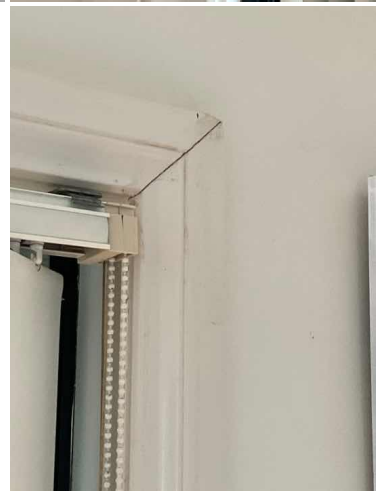
Windows

Minor cracking around window architraves. These are contributed to settlement and movement- **Minor maintenance recommended. Fill and Paint**

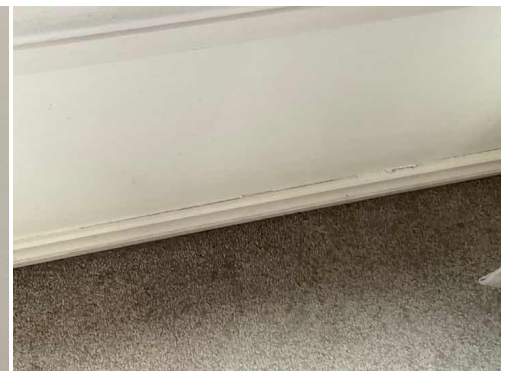
Walls

There are visible cracking where skirting abuts wall. These are considered minor settlement cracks - **It is suggest that a flexible sealant will suffice**

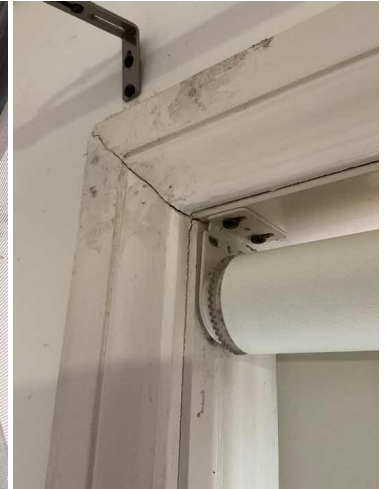
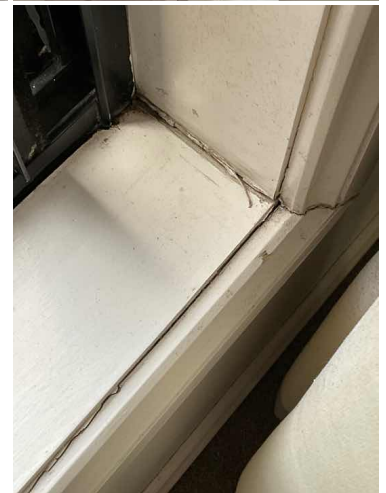
Windows

Paint/Stain to timber work has deteriorated - **Consider minor maintenance. Recommend consulting with a Painter for further advise and recommendations**

Minor cracking around window architraves. These are contributed to settlement and movement- **Minor maintenance recommended. Fill and Paint**

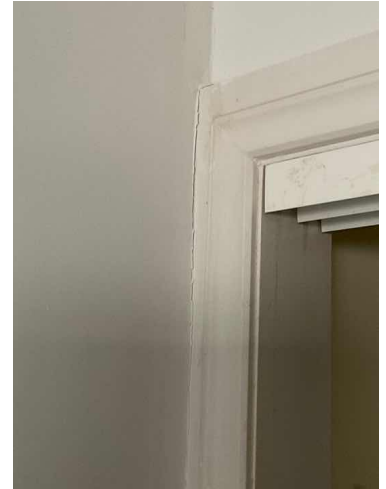
Robes

Minor cracking around robe door architraves. These are contributed to settlement and movement- **Minor maintenance recommended. Fill and Paint**

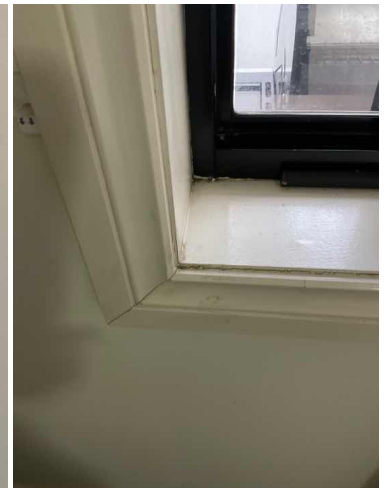
Windows

Minor cracking around window architraves. These are contributed to settlement and movement- **Minor maintenance recommended. Fill and Paint**

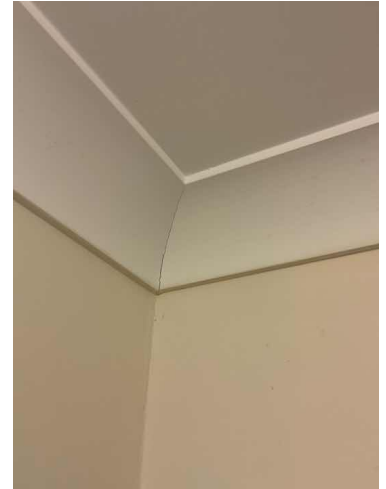
Ceiling

Cornice Cracks Noted - These are typical and generally fill and paint will suffice (**General Maintenance Conditions**) however Monitoring these cracks advised for 12 months and if become wider consult with Plasterer is recommended

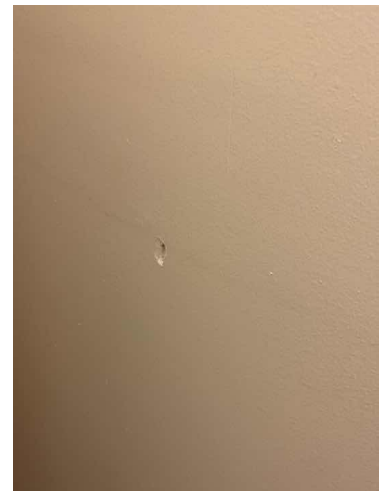
Walls

Impact damage noted. Patch and paint will generally suffice, however see a qualified plasterer for further advice

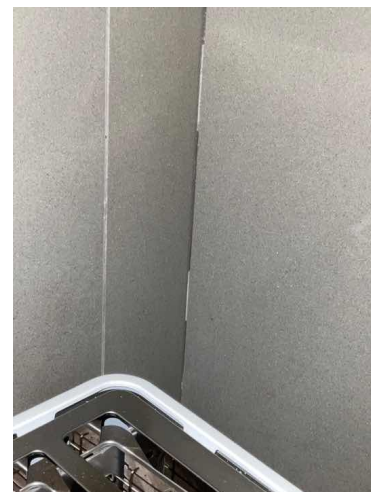
Cupboards And Bench Tops

Section of Splashback have been identified as requiring sealant - **Recommend to have this attended to, preventing likelihood of possible damage**

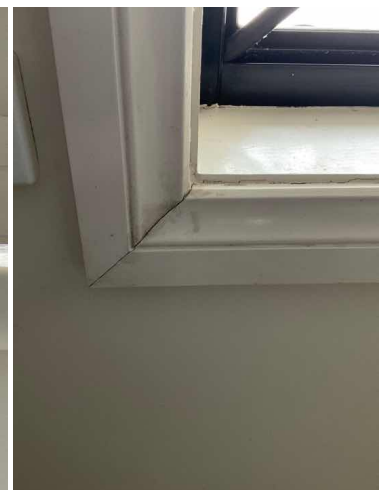
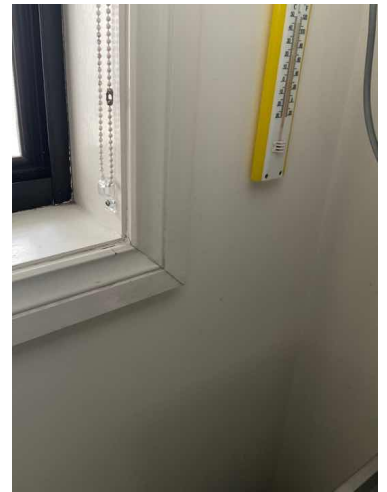
Windows

Minor cracking to architraves. These are contributed to settlement and movement- **Minor maintenance recommended. Fill and Paint**

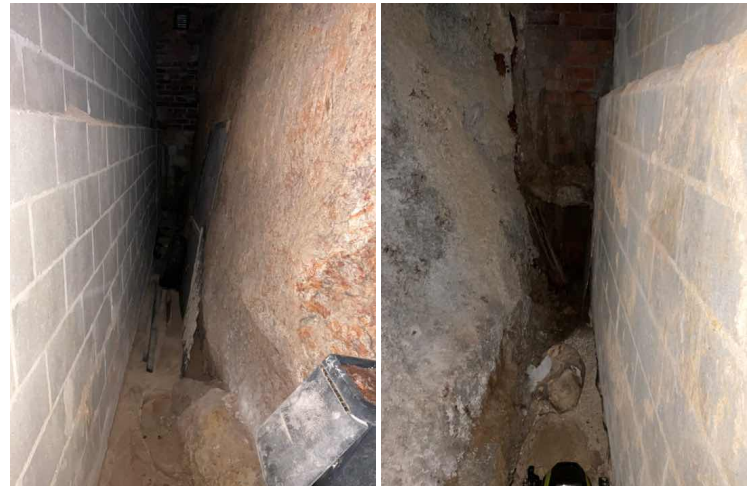
Dampness in sub floor soil. Damp sub floor soil should be avoided as it can cause fungal decay, mould and possibly footings problems. Recommendations: A qualified drainage plumber should be engaged for advice and recommendations.
