**Building, Pest &
Pool Inspections**

Ironside Inspection Services Pty Ltd

10 Lillydale St, Carseldine, QLD, 4054

Pest And Building Inspection

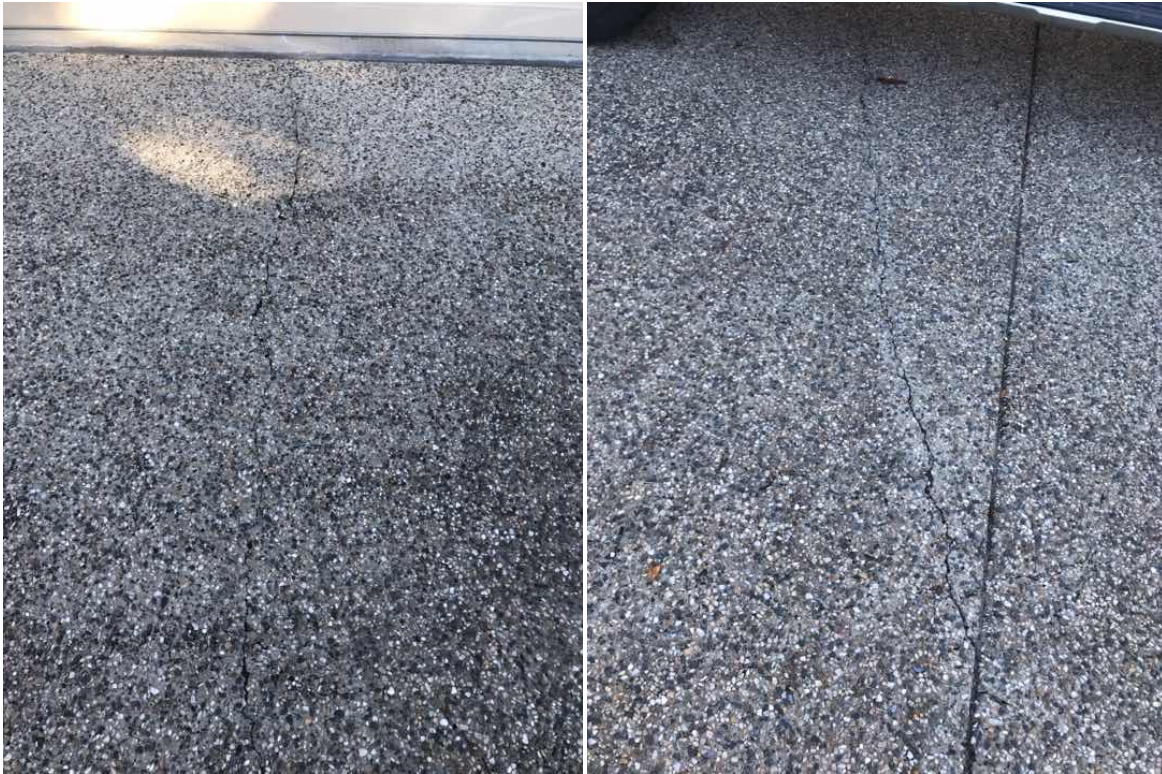
Driveway Condition

Common cracks & settlement were observed on the driveway. Maintenance is recommended. Note: Whilst these cracks appeared to be minor at the time of inspection, we strongly recommend you monitor these cracks and if worsening occurs contact a concreter for further advice.

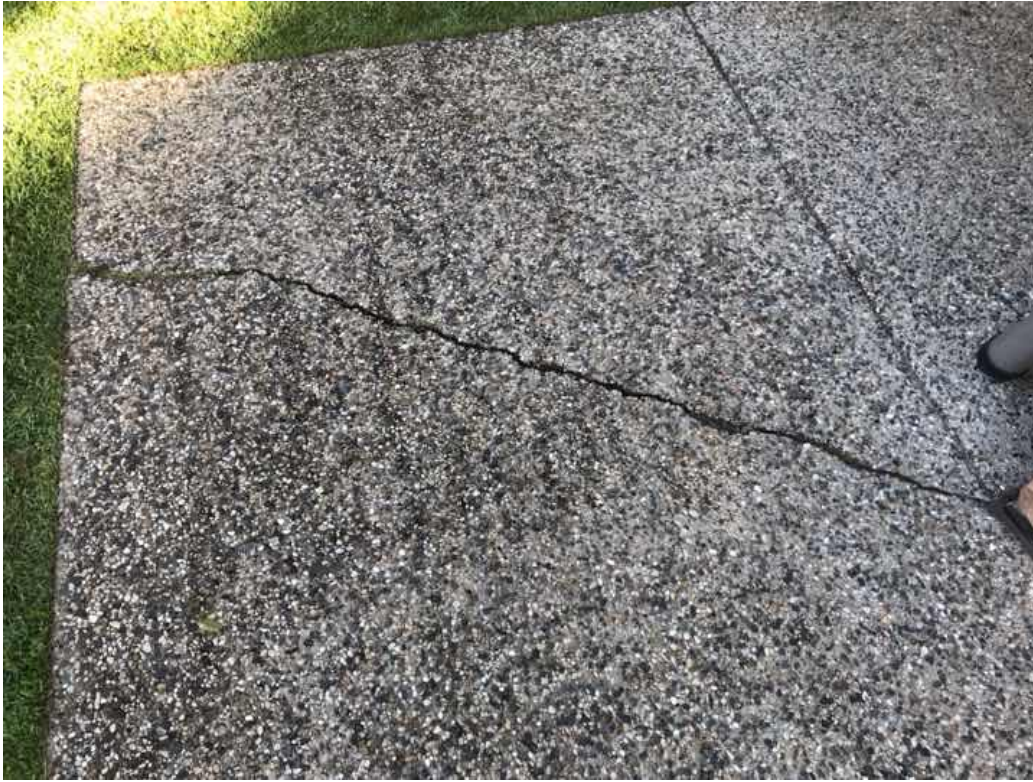
Pathways Condition

Common cracks and settlement were observed on paths. This may not have any effect on the actual structural integrity of the dwelling itself. Maintenance is recommended. Note: Whilst these cracks appeared to be minor at the time of inspection, we strongly recommend you monitor these cracks and if worsening occurs contact a concreter for further advice.

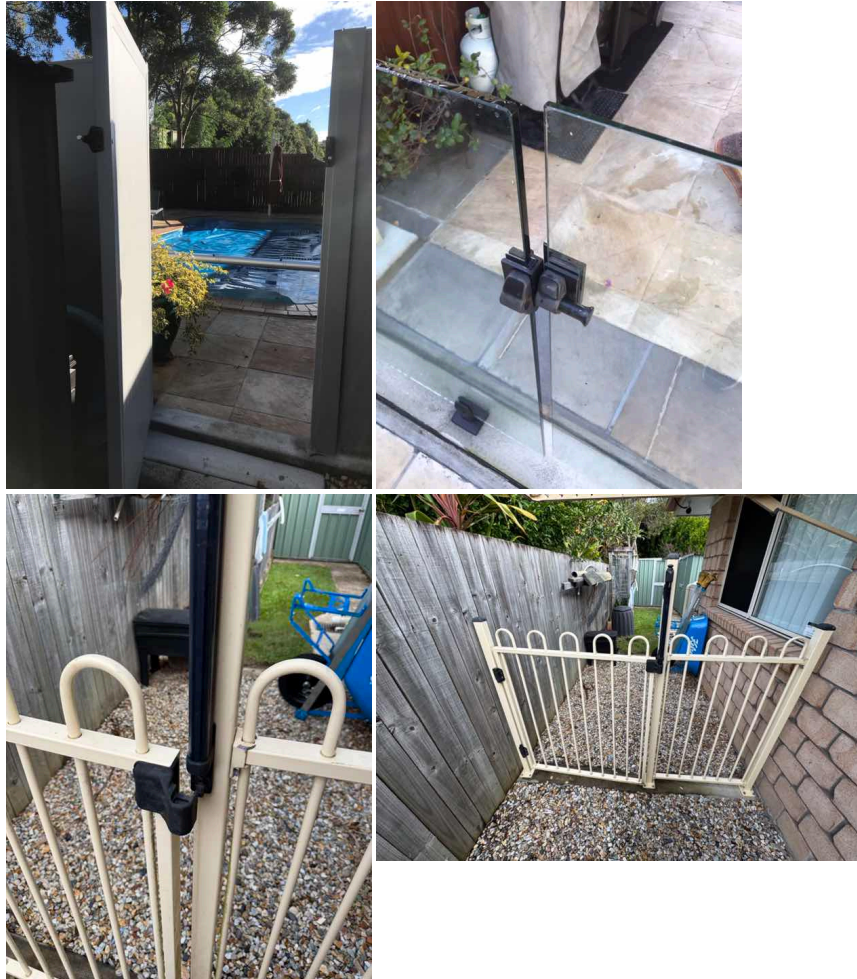
Pool Fence

A swimming pool is present but the pool fence appears inadequate. The gate is not closing and latching as it should. This should be repaired. The pool fence should be checked for compliance with safety regulations. Considered safety Hazard

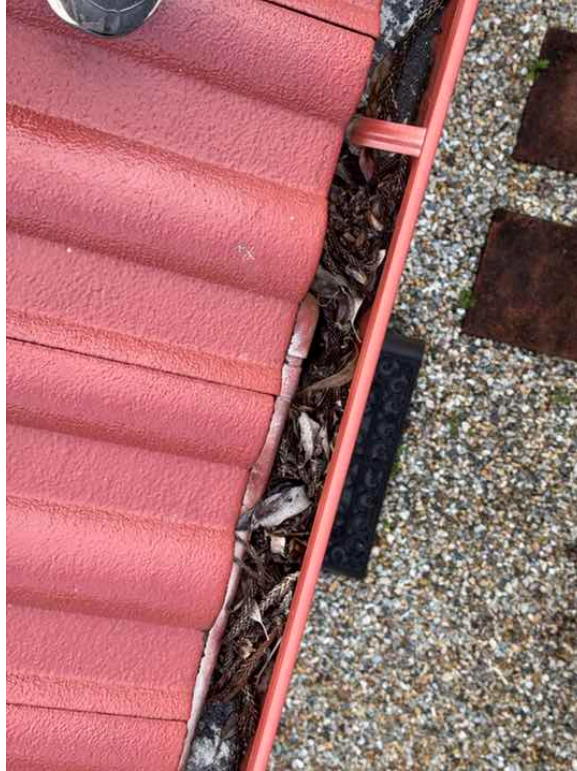
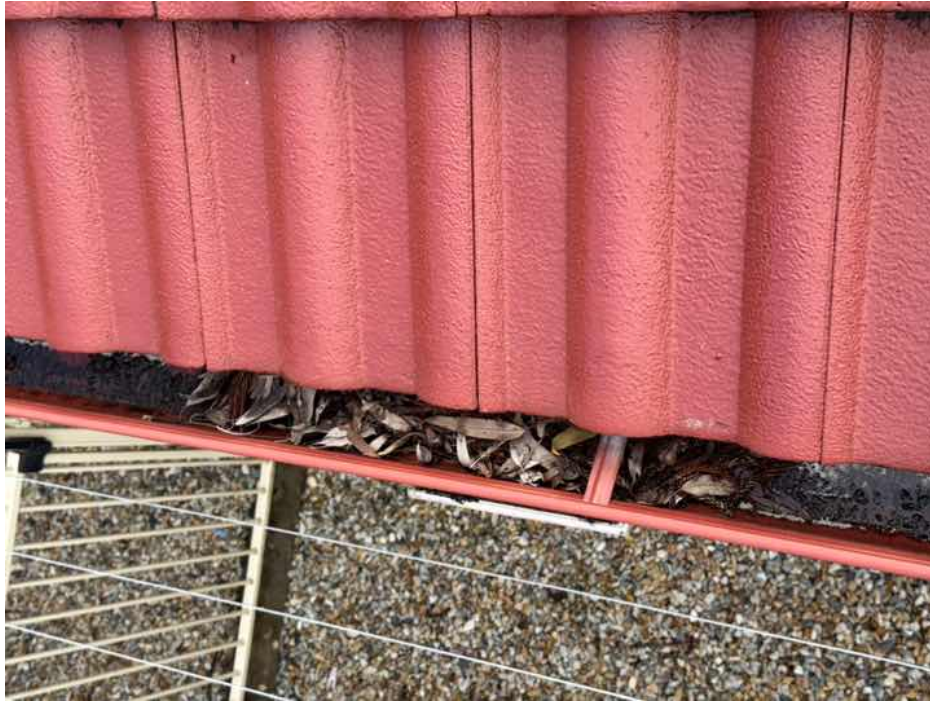
Guttering**Gutter Findings**

Debris in guttering areas- this requires cleaning out to prevent blocking of down pipes and leaking into eaves and fascia. Recommendations: Have gutters cleaned and assessed by a plumber for adequate fall. Also regularly clean to prevent ponding. Ponding water will contribute to rust.

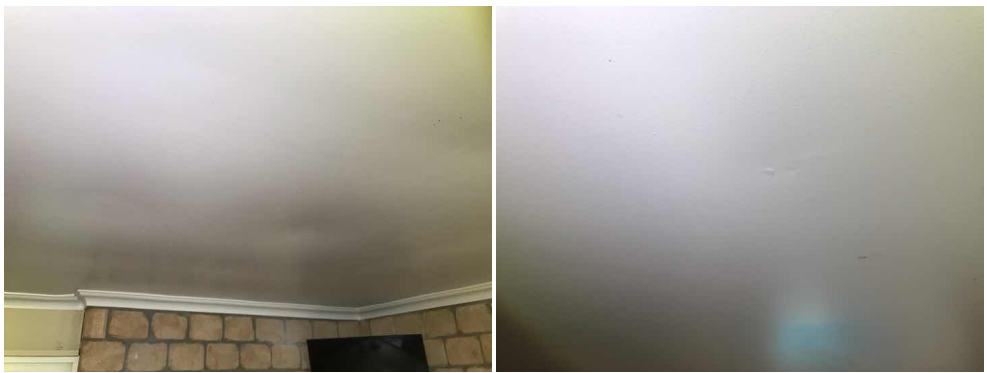
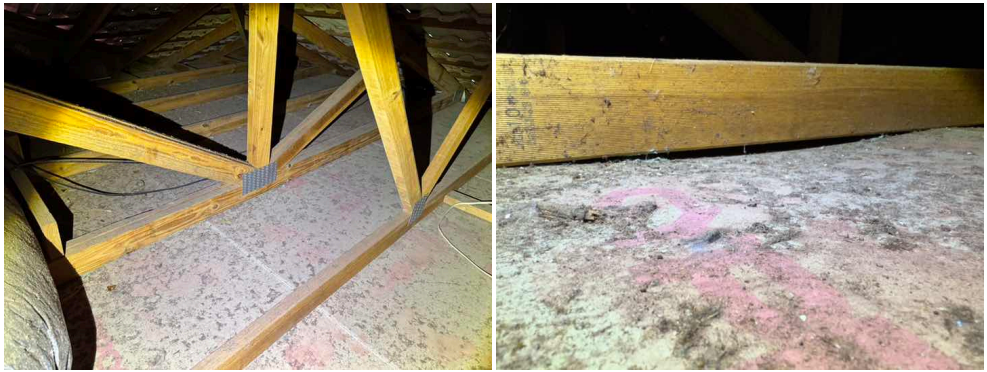
Ceiling Lining Condition

Screw popping observed to the ceiling lining. Glue has separated in some areas. Engage a licensed plasterer to assess and repair.

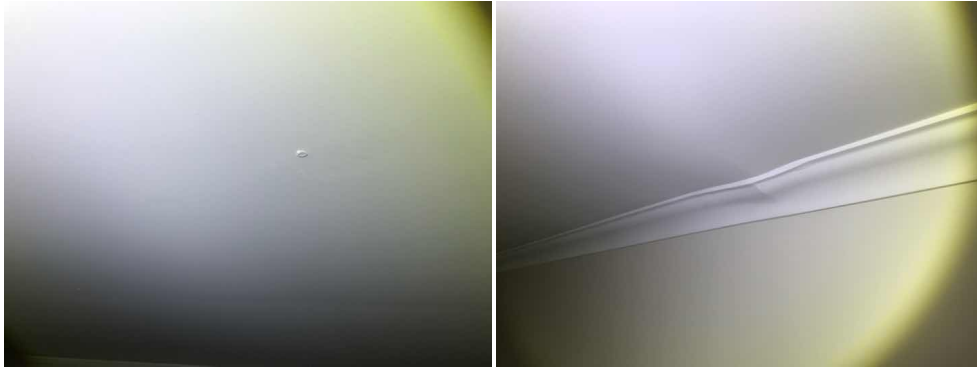
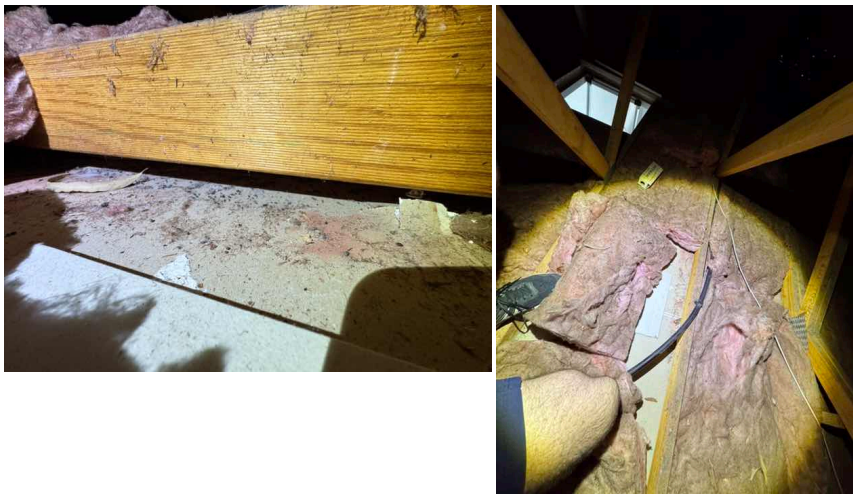
Ceiling sagging - Requires repair. - Recommendations: I recommend you contact a licensed plasterer for further advice and recommendations on repairs.

Screw popping observed to the ceiling lining. Glue separation has occurred. Engage a licensed plasterer for maintenance repairs.

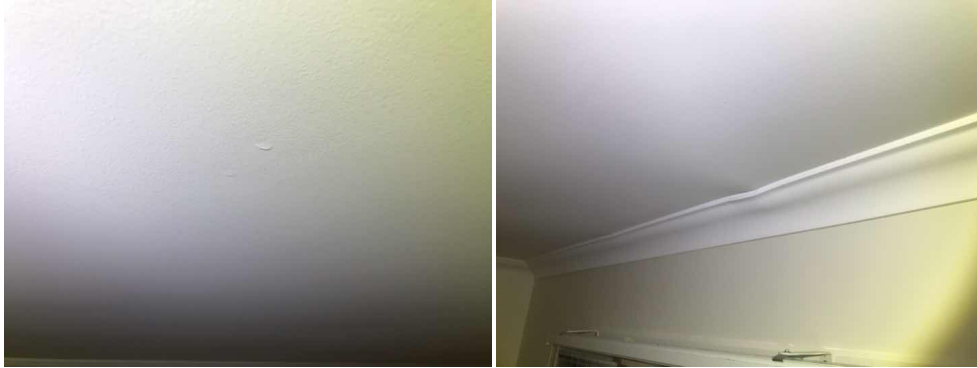
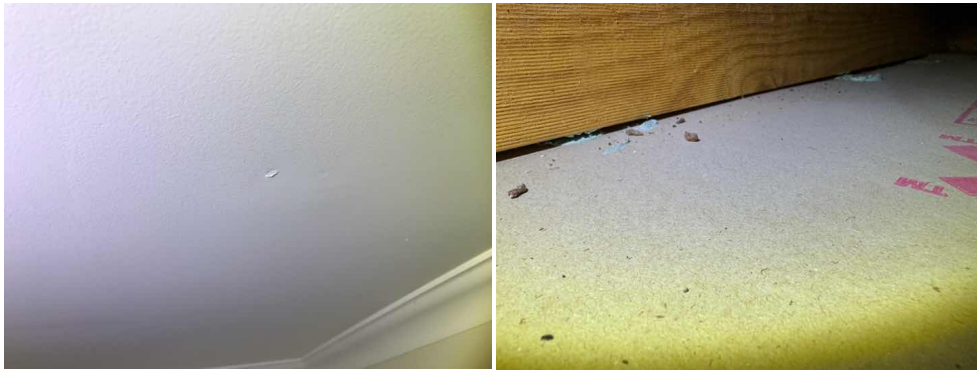
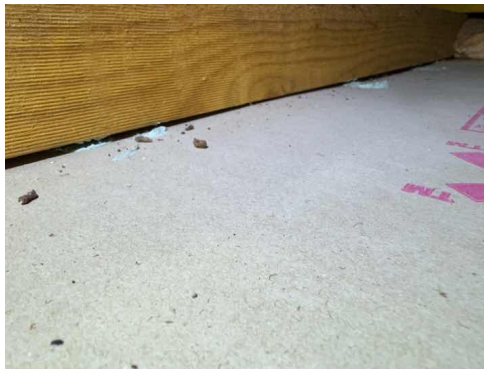
Ceiling

Screw popping observed to the ceiling lining. Glue has separated in some areas. Engage a licensed plasterer to assess and repair.

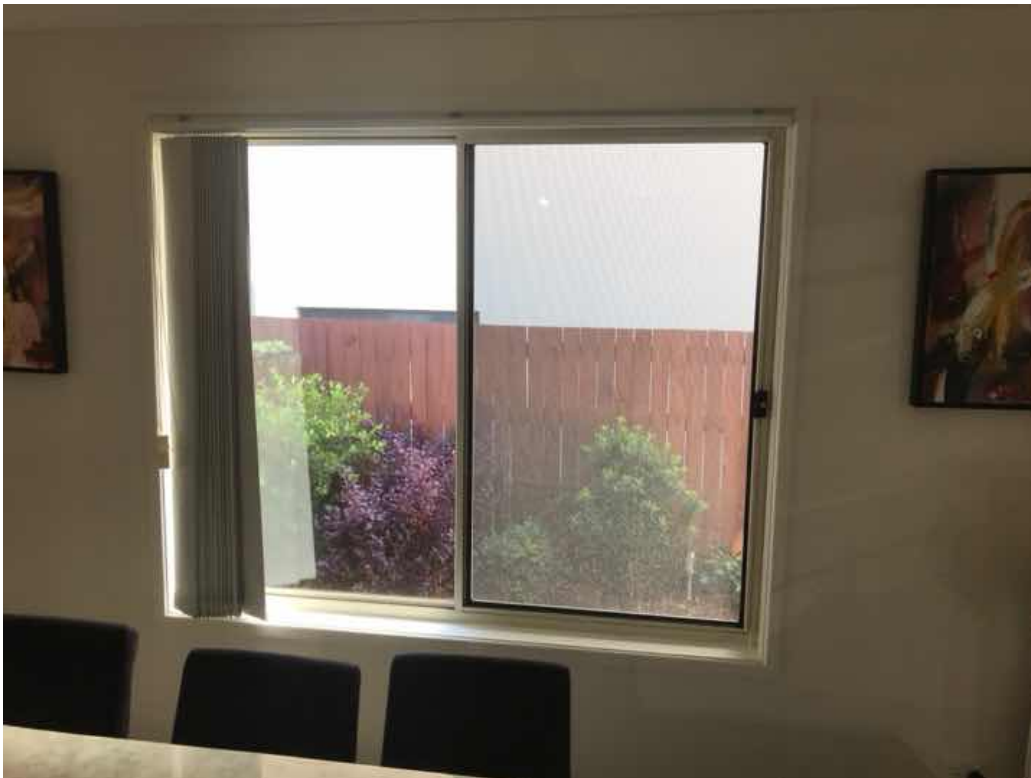
Windows

Hard to slide. Replace wheels

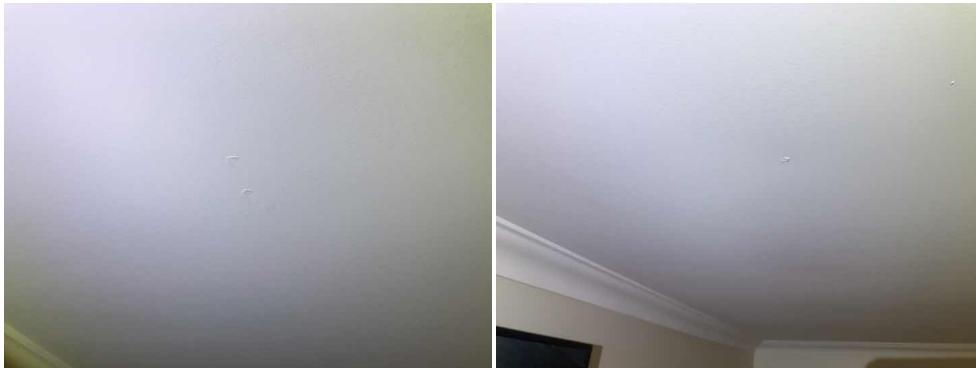
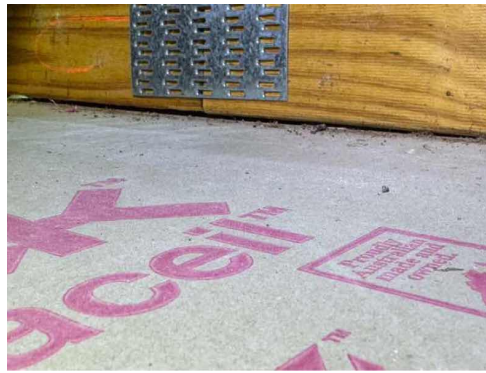
Ceiling

Screw popping observed to the ceiling lining. Glue has separated in some areas. Engage a licensed plasterer to assess and repair.

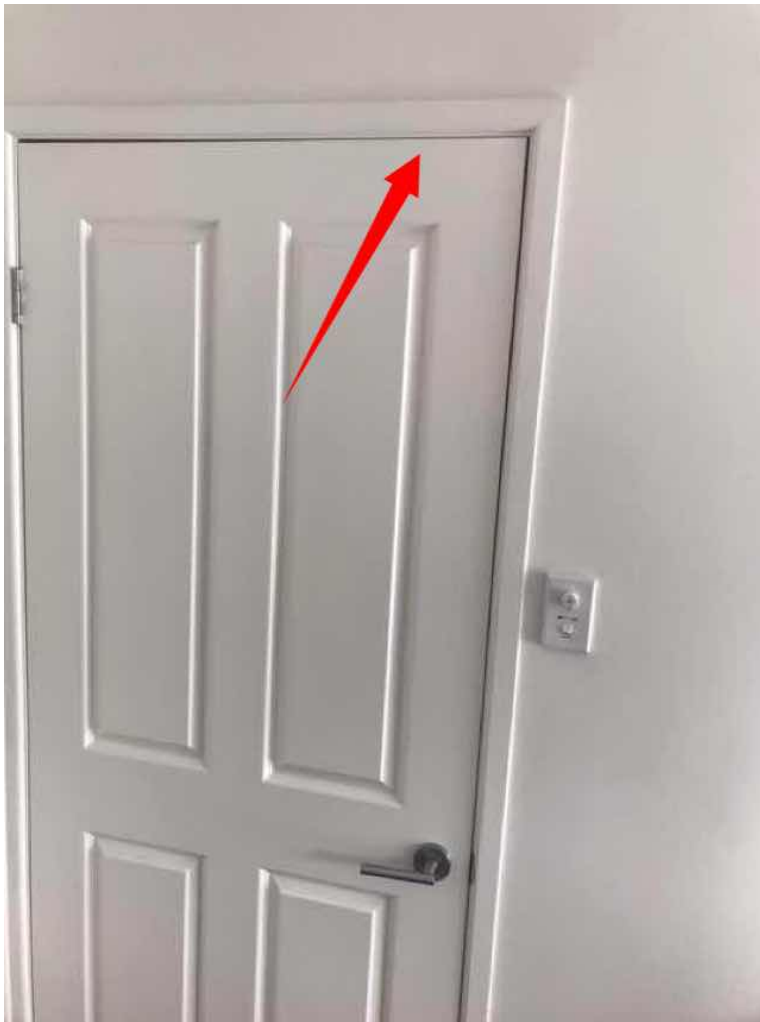
Door

Binding door - Doors that bind on the frame can relate to some differential settlement in the footings, frame movement, age, expansion, shrinkage and the like. It can also be seasonal where it may bind for some months and then open and close sufficiently. Monitoring over time or a more invasive inspection is only method of ascertain cause. Recommendations: A qualified carpenter should be engaged for advice and recommendations.

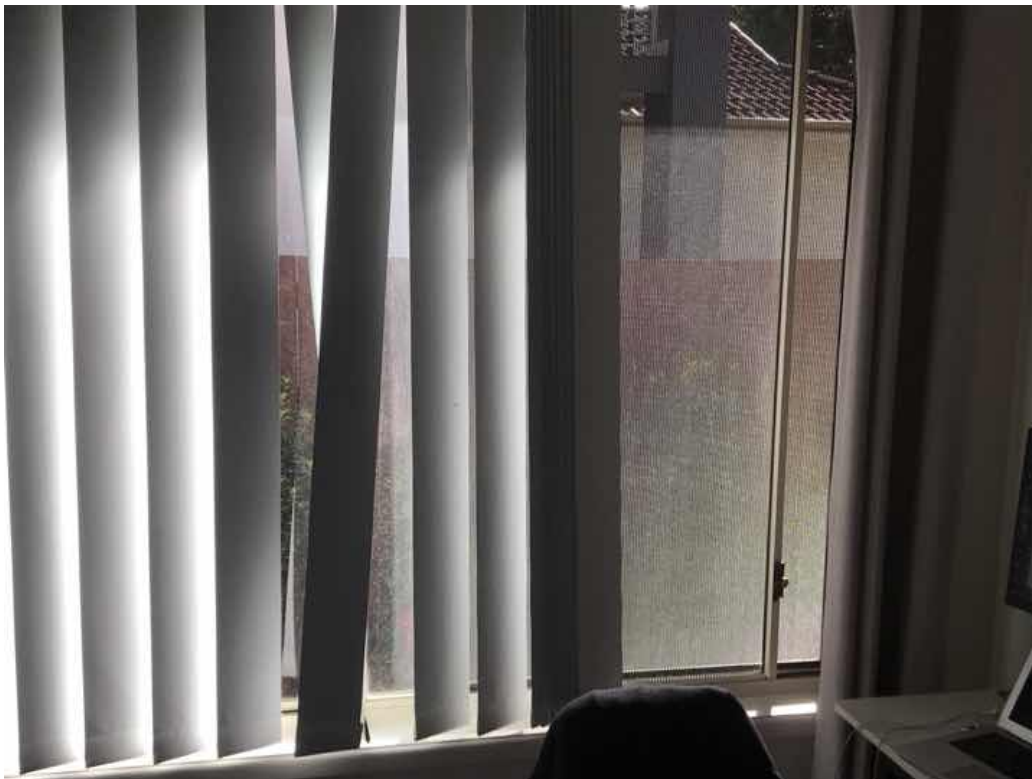
Windows

Hard to slide. Replace wheels

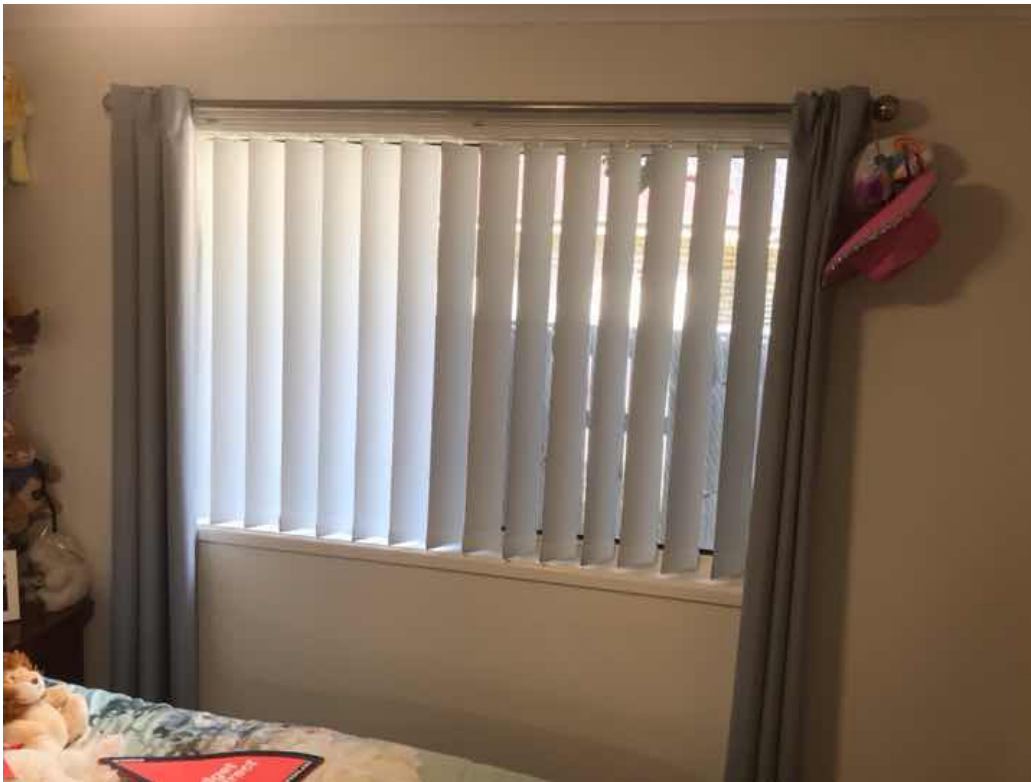
Windows

Hard to slide. Replace wheels

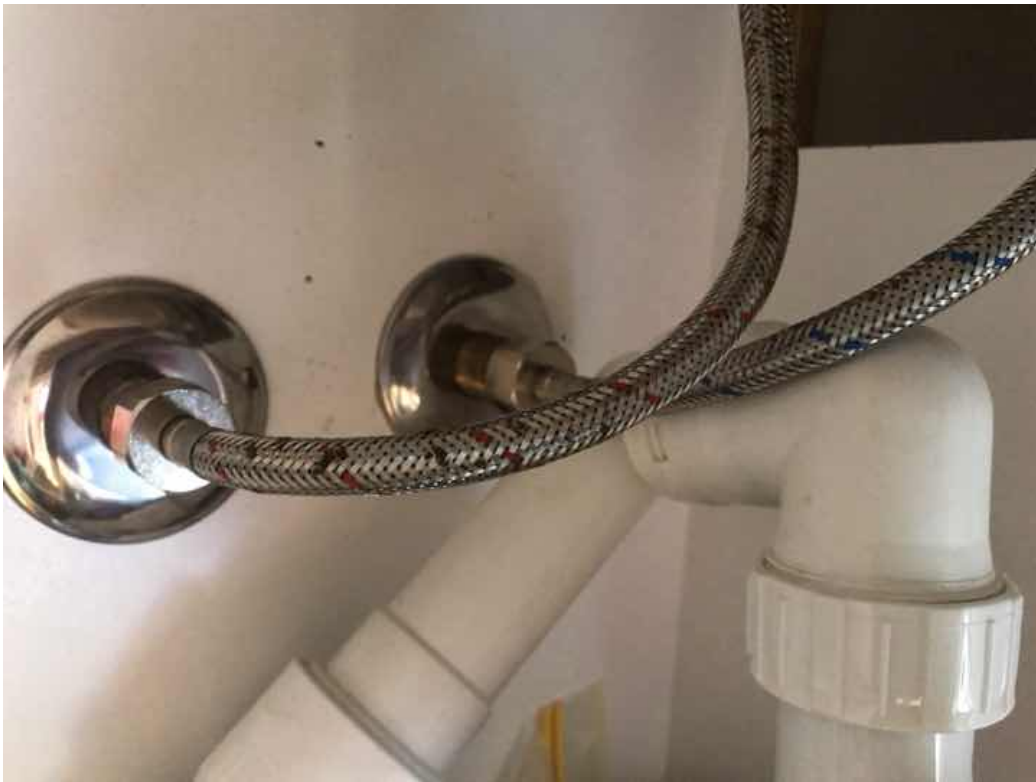
Sink

The flexible hose is rusting. Recommend replacing to prevent any water leaks. Engage a licensed plumber for replacement.
