28 Warbler Street, Inala, Queensland, 4077 Australia

## **Pre-Purchase Standard Property & Timber Pest Report**

14th May, 2024

Report number:	24/326
Inspection Date:	14th May, 2024
Property Address	28 Warbler Street, Inala, Queensland, 4077 Australia

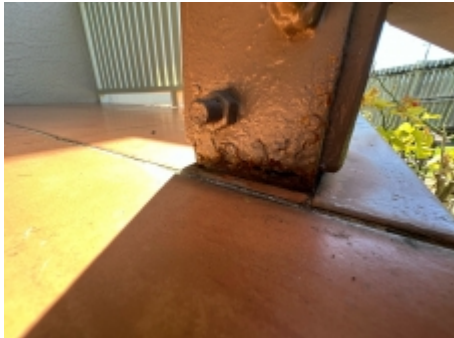
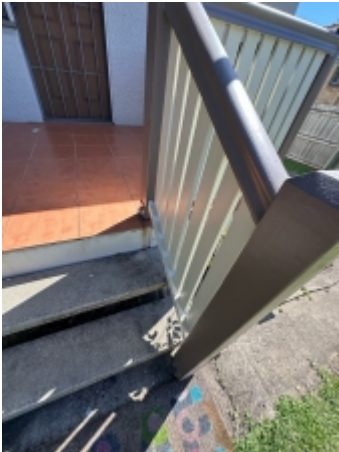
Preventative maintenance required to front veranda saddle.

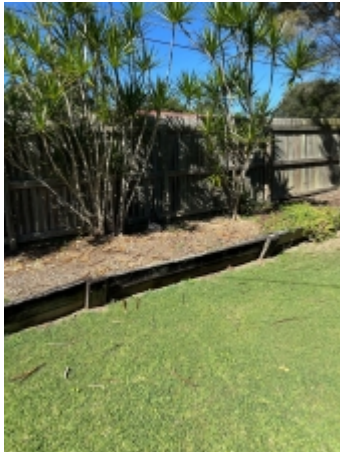
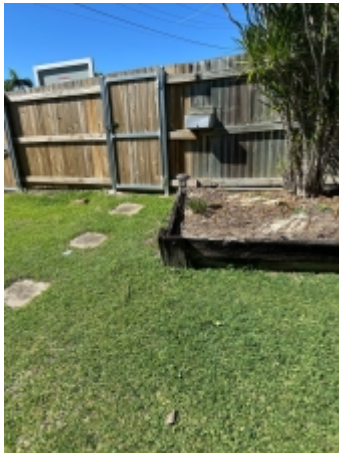
Front garden retaining wall requires repair

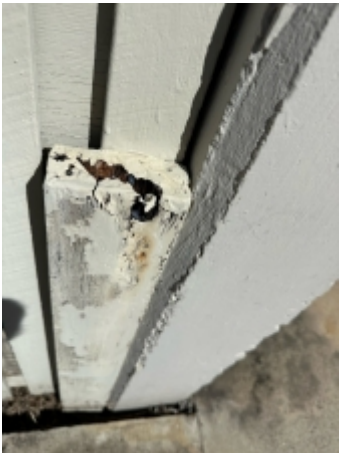
Moisture damage to some timber battening materials

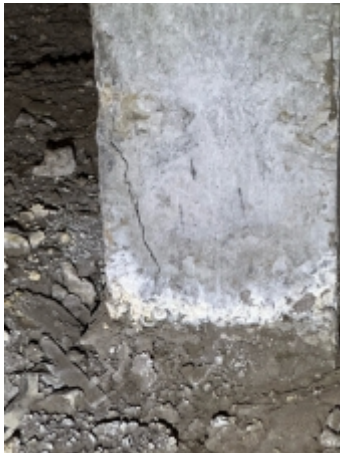
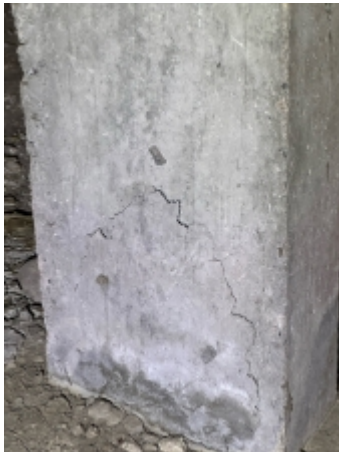
A couple of columns show signs of early development of cracking

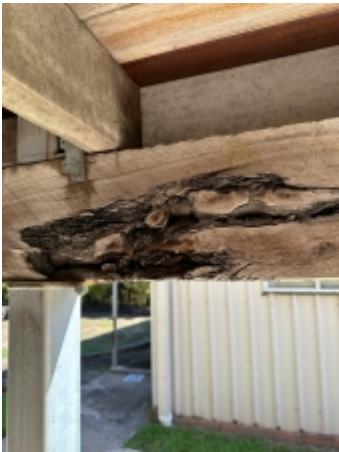
Knot in bearer of rear timber deck

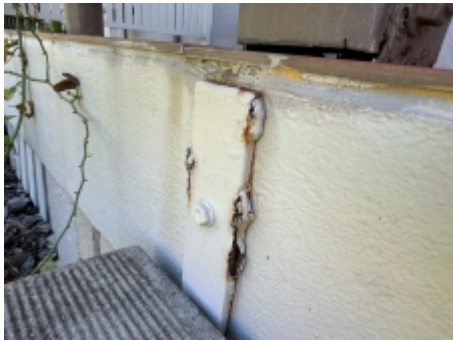
Preventative maintenance required to steel string

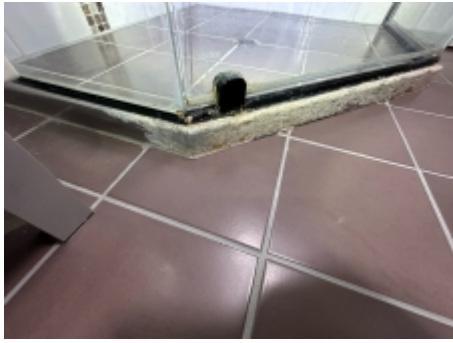
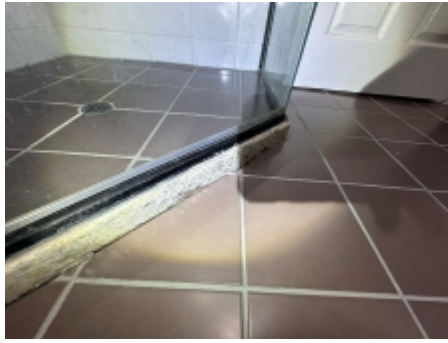
Oxidation of shower stall angle.

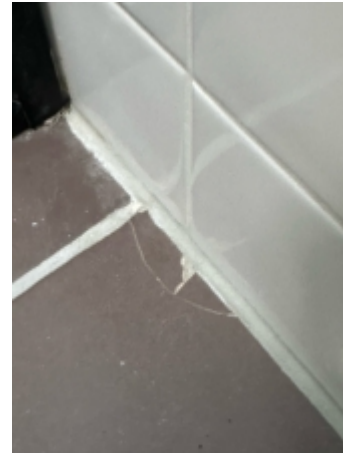
Small crack in shower stall floor tile

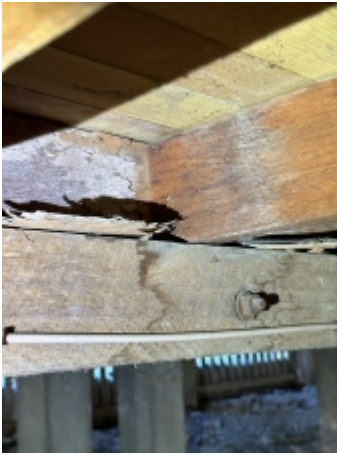
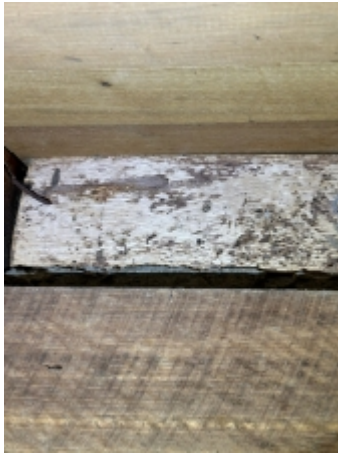
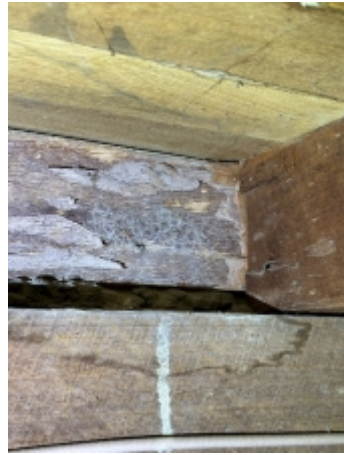
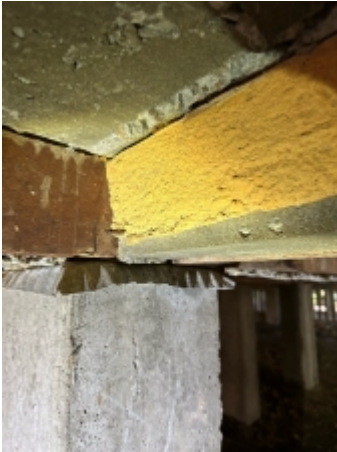
E1 Active (live) termites	No evidence was found
E2 Subterranean termite management proposal	A Proposal is recommended
Additional Comments	
E3 Termite workings and/or damage	No evidence was found
E4 Previous termite management program	No evidence was found.
E5 Frequency of future inspections: The next inspection to help detect termite attack is recommended in:	3 months
E6 Chemical delignification	No evidence was found.
E7 Fungal decay	No evidence was found.
E8 Wood borers	The following evidence was found:
Location	Subfloor
The Wood Borer is believed to be:	Lyctid Borer
Additional Comments	Previous borer damage to soft Timbers under the dwelling

Some evidence of previous borer activity
