## Building Report

4/73 Sixrth Ave, Maroochydore

# VISUAL BUILDING INSPECTION REPORT

**This report complies with Australian Standard AS 4349.1 - 2007 Inspection of Buildings.**

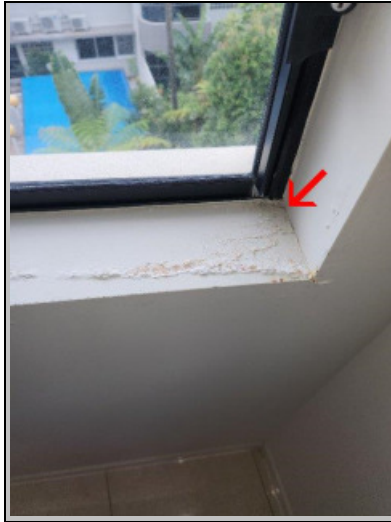
Dining room:

The condition of the walls is generally good. Patching & or painting touch ups required to the following areas.

A Licensed painter should be called to make a further evaluation and repairs or rectification as needed.

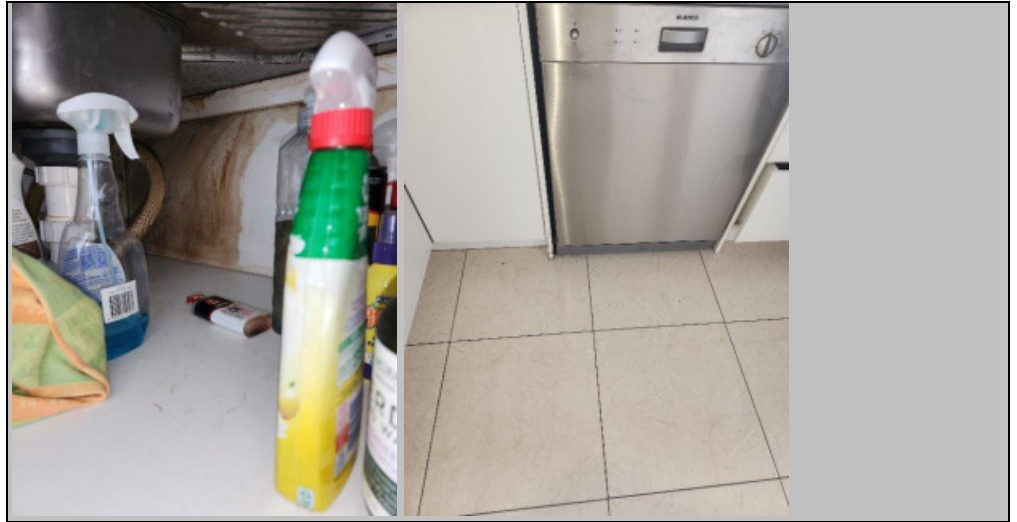
The condition of the fixtures is generally fair. Past water damage to cupboards, no current leaks.

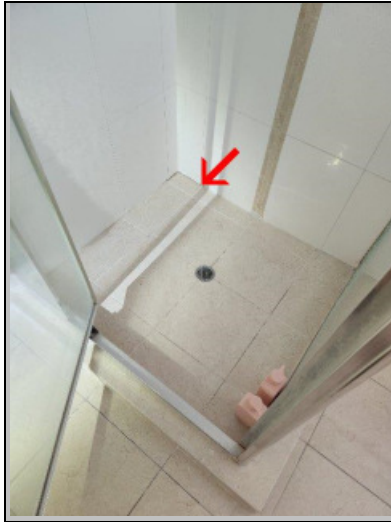
The condition of the tiles is generally fair. Anti fungal sealants required to internal joins of tiled surfaces to prevent moisture penetration.

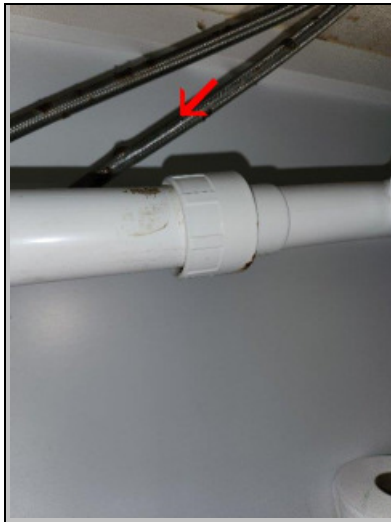
The basin & taps appear serviceable. Braided flexi Hoses should be checked regularly for corrosion, if corrosion is noted to the braid they should be changed before they burst.

The toilet appears to be in working order. Minor plumbing repairs will be needed to restore proper operation.

A Licensed plumber should be called to make a further evaluation and repairs or rectification as needed.

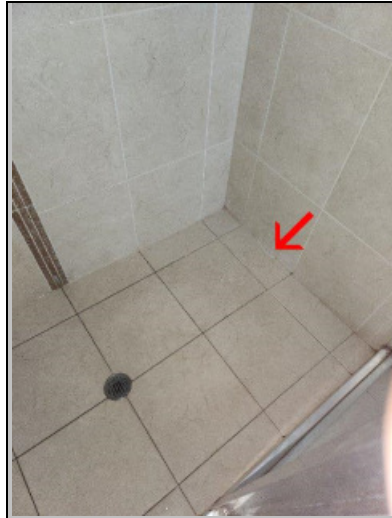
The condition of the tiles is generally good. Anti fungal sealants required to internal joins of tiled surfaces to prevent moisture penetration.

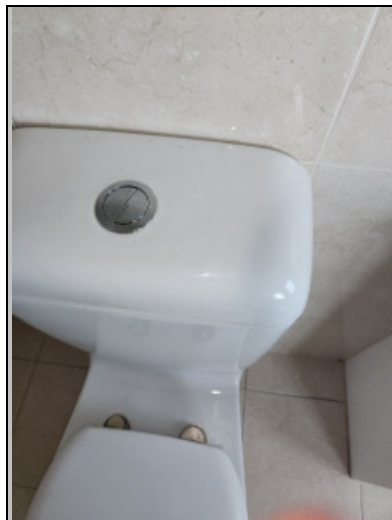
The toilet appears to be in working order. Minor plumbing repairs will be needed to restore proper operation.

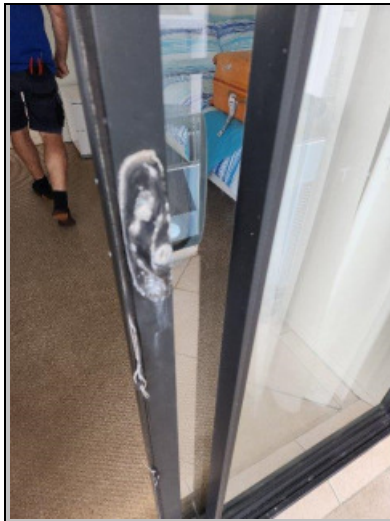
The condition of the exterior of the windows is generally fair. Corrosion is present to window frames, maintenance required.

A licensed carpenter should be called to make a further evaluation and repairs or rectification as needed.

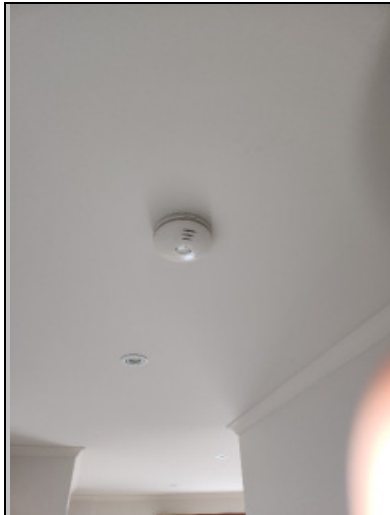
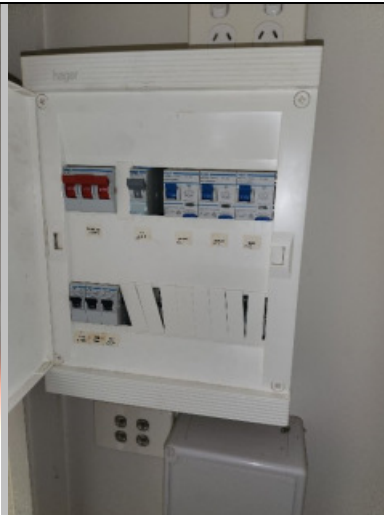
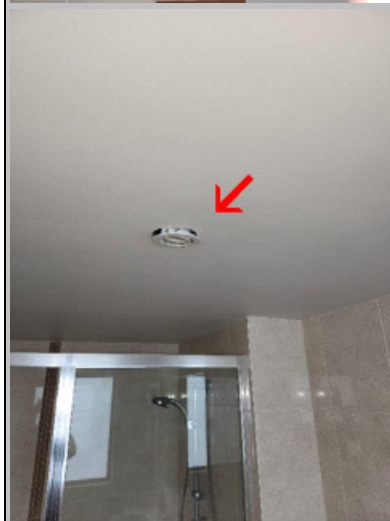
A safety switch is present but has not been tested, only a licensed electrician can advise as to what the safety switch is connected too. Smoke detectors are fitted however, the positioning, operation or adequacy was not tested and is not commented on. Upgrade required to meet new laws.

Loose light fitting, maintenance recommended.
