# Building Condition Structure Inspection

**9 Southsea Road , Quinns Rocks, WA, 6030**

Report/Agreement #	16092211394148
Inspection Date:	16 Sep 2022
Inspection Time:	11:39 am

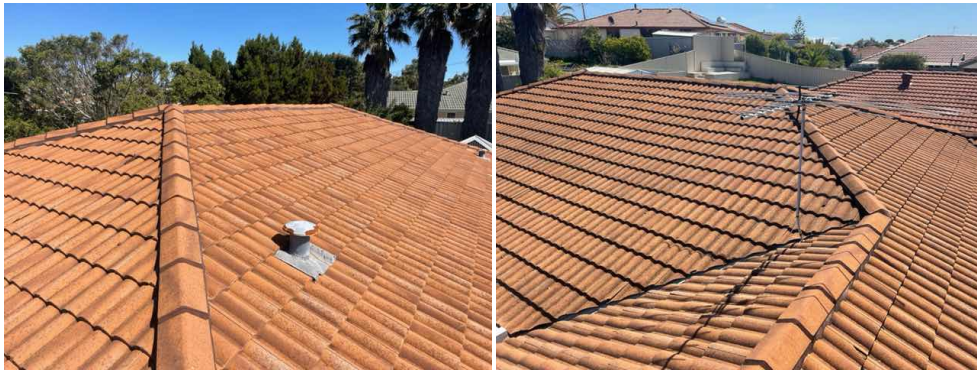
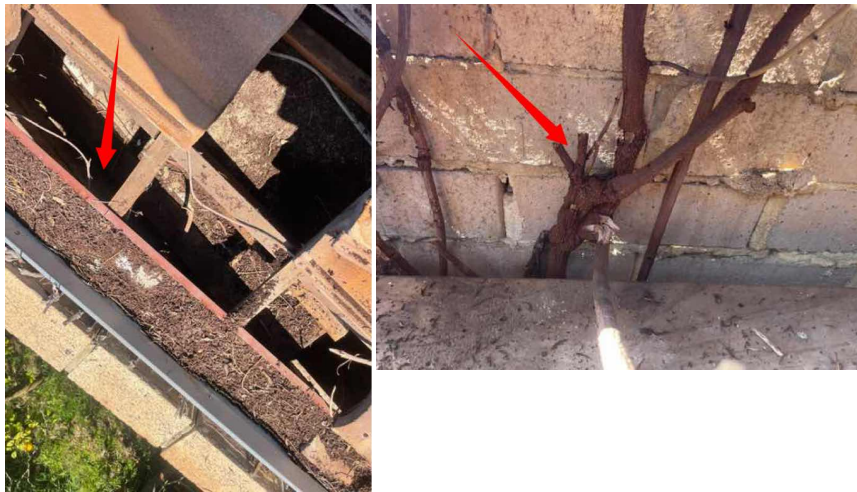
Of the visible areas, the general condition of the roof is in fair serviceable condition for its age overall.

We did note a tree limb growing through the roof void/cavity brickwork lifting certain roof tiles above the master bedroom. The tree limb requires to be removed and tiles/flashing reinstated sufficiently.

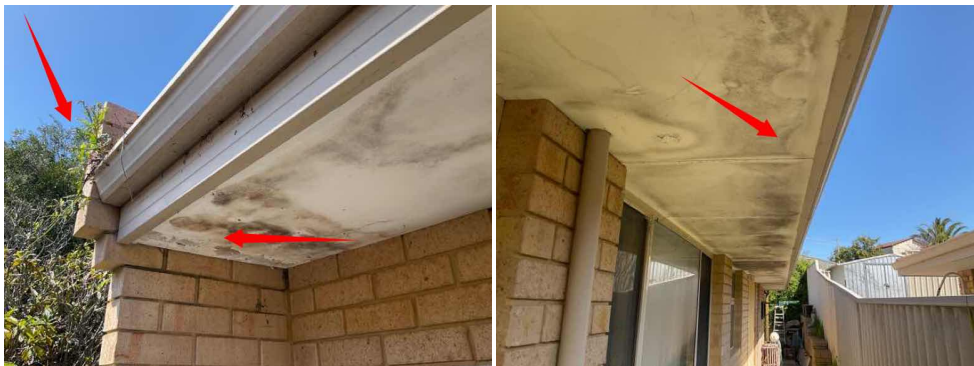
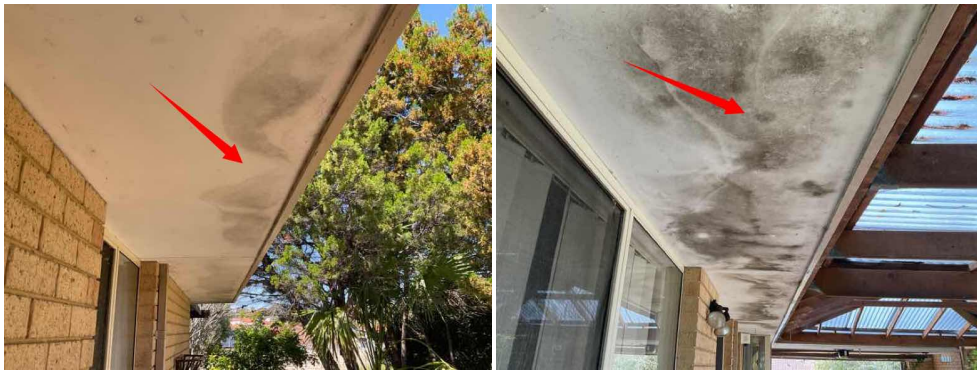
The soffit lining (eaves) are in a serviceable condition overall however showing old water staining throughout most areas due to overflowing gutters.

The front right hand side eave adjacent to the master bedroom is water effected due to weeds blocking gutters. The gutters need cleaning in this area.

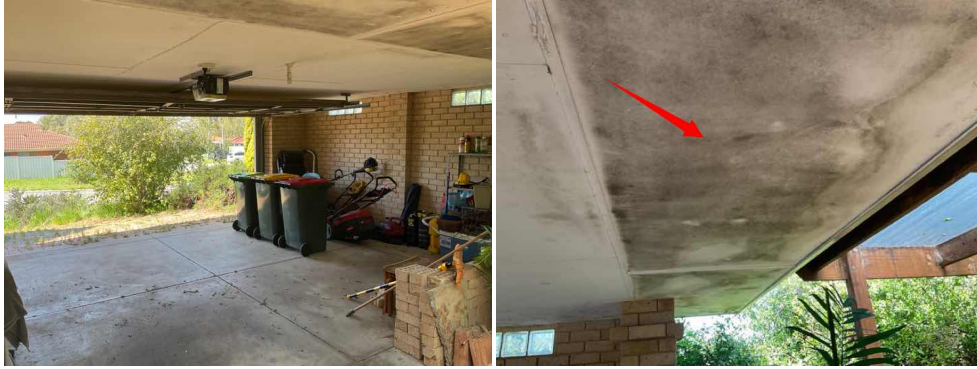
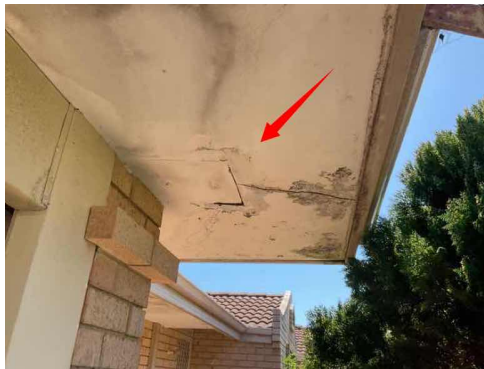
The ceiling is showing old water staining apparent. Stain blocking and repainting can easily be carried out.

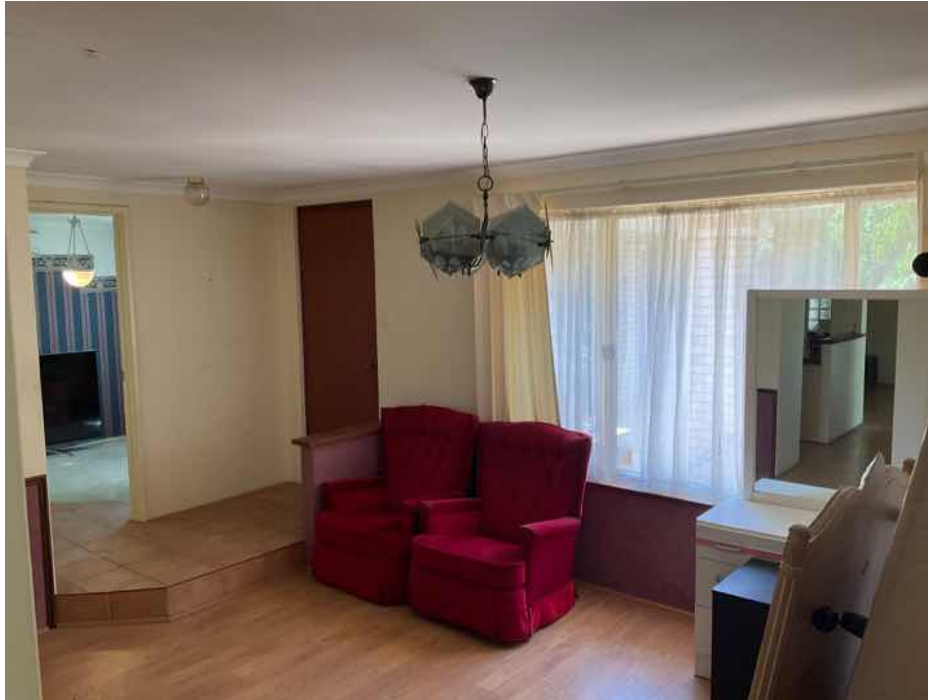
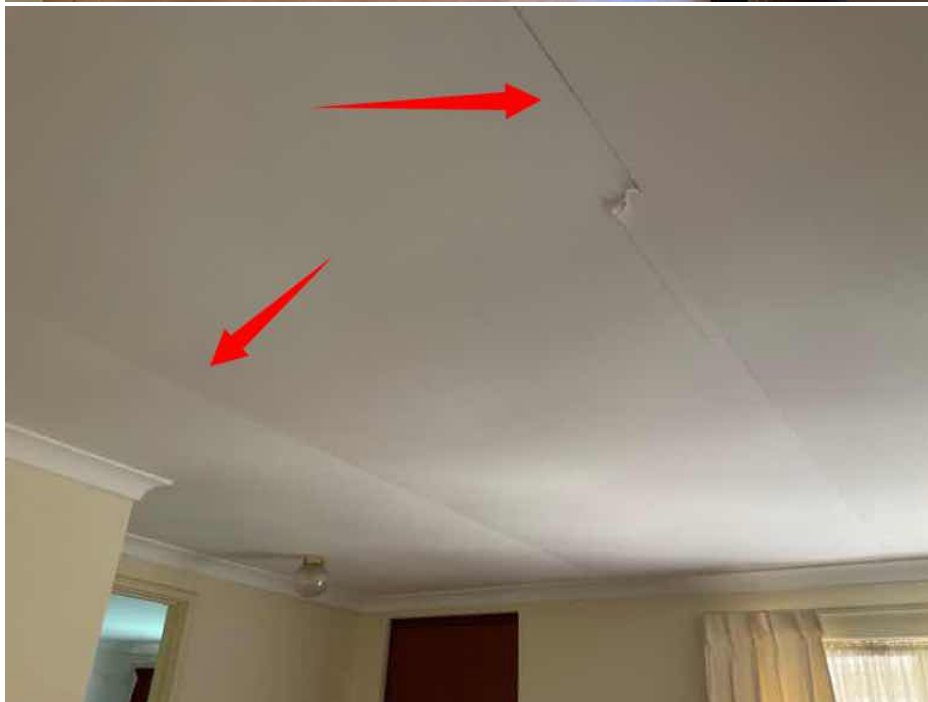
The ceilings within the room are showing general movement/accentuation lines on the sheet joins, suggesting the glue is slowly breaking down between the sheet itself. Cornice cracking is also evident.

The ceilings may be able to be re-screwed and glued but ultimately replaced.

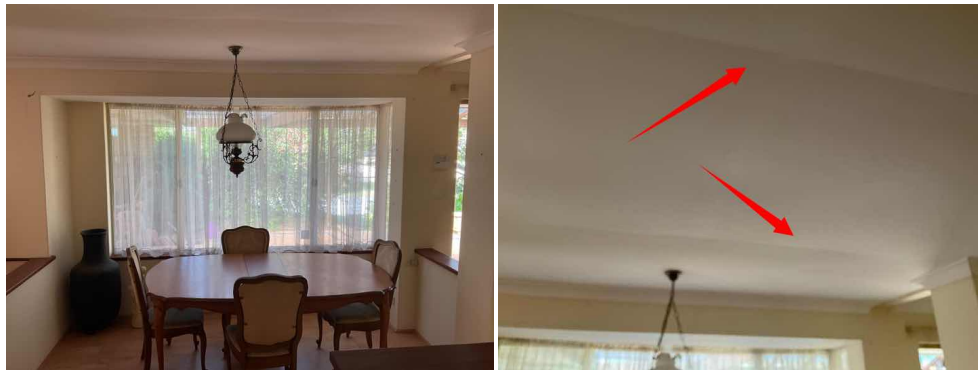
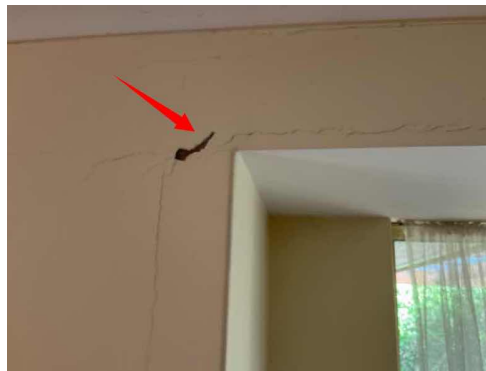
The ceilings within the room are showing general movement/accentuation lines on the sheet joins suggesting the glue is slowing breaking down between the sheet itself. Cornice cracking is also evident.

General movement cracking to the bulkhead plaster is apparent. This is currently not a structural concern and easily repaired as required.

The ceilings may be able to be re-screwed and glued but ultimately replaced.

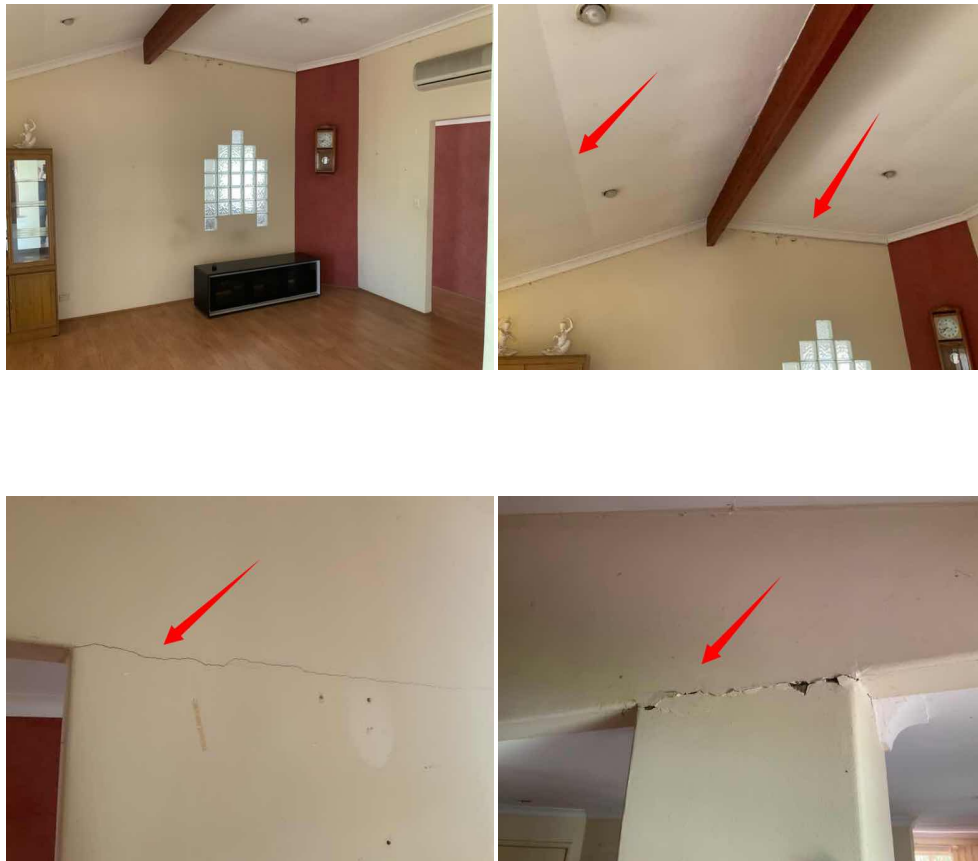
The ceilings within the room are showing general movement/accentuation lines on the sheet joins suggesting the glue is slowly breaking down between the sheet itself. Cornice cracking is also evident.

General movement cracking to the entrance walk through wall area into the bedroom hallway is apparent, currently not a major structural concern and easily repaired as necessary.

The structural support column within the room is showing general movement cracking as a consequence of movement from the support steel/lintel running across the column.

The ceilings may be able to be re-screwed and glued but ultimately replaced.

We would suggest this is a structural defect where recommendation for repair from a structural engineer is required.

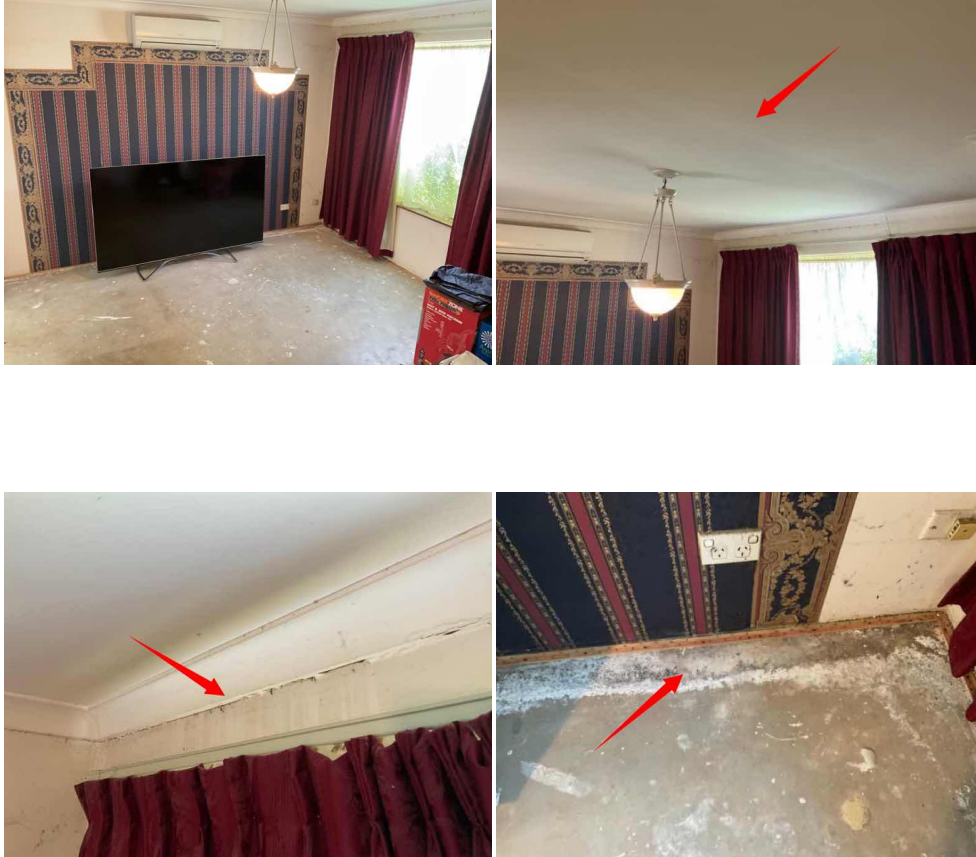
Staining/salts to the slab is apparent as a consequence of damp and leaking into the far cavity wall. This we believe is due to overflowing exterior gutters in this area.

Accentuation lines on the ceiling joins aswell as cornice movement is apparent. The ceilings in this room may be able to be re-glued, screwed and flush repaired.

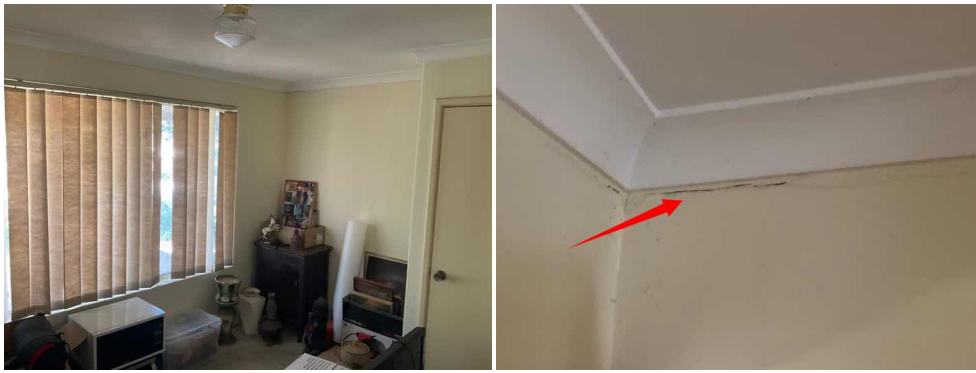
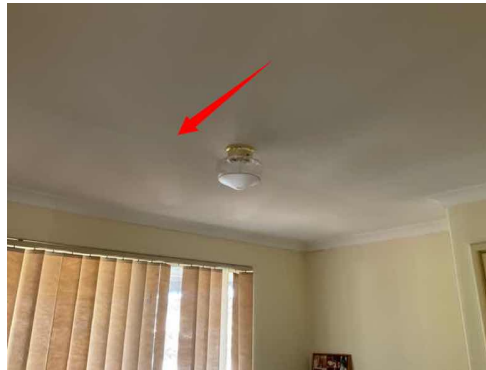
Accentuation lines on the ceiling joins aswell as cornice movement is apparent. The ceilings in this room may be able to be re-glued, screwed and flush repaired.

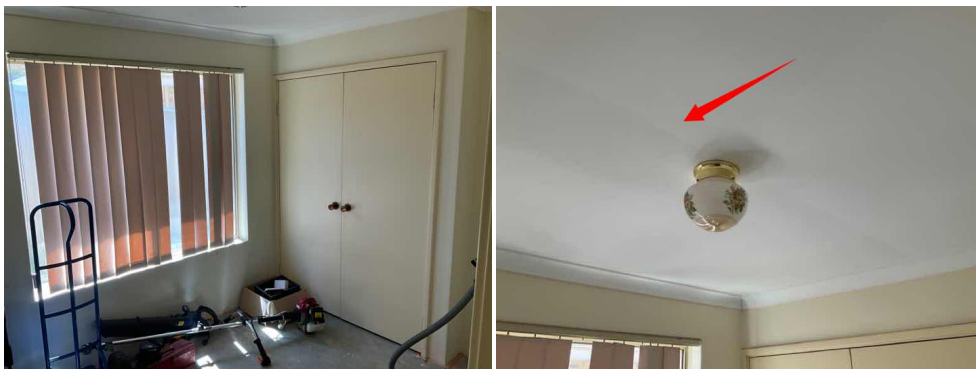
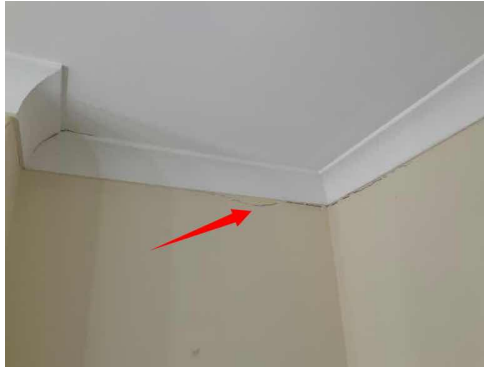
Accentuation lines on the ceiling joins aswell as cornice movement is apparent. The ceilings in this room may be able to be re-glued, screwed and flush repaired.

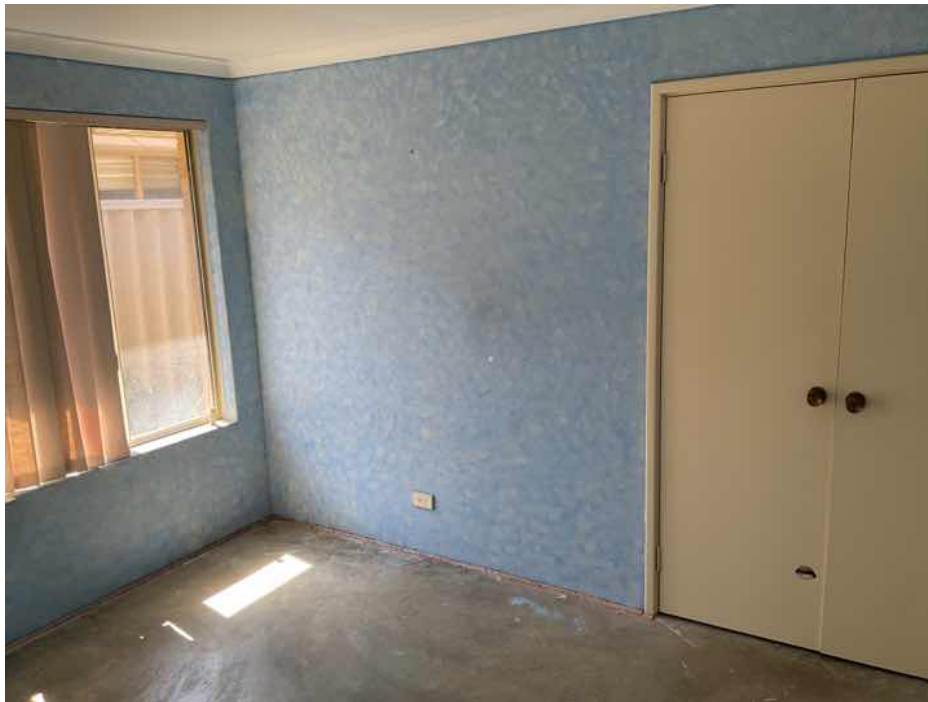
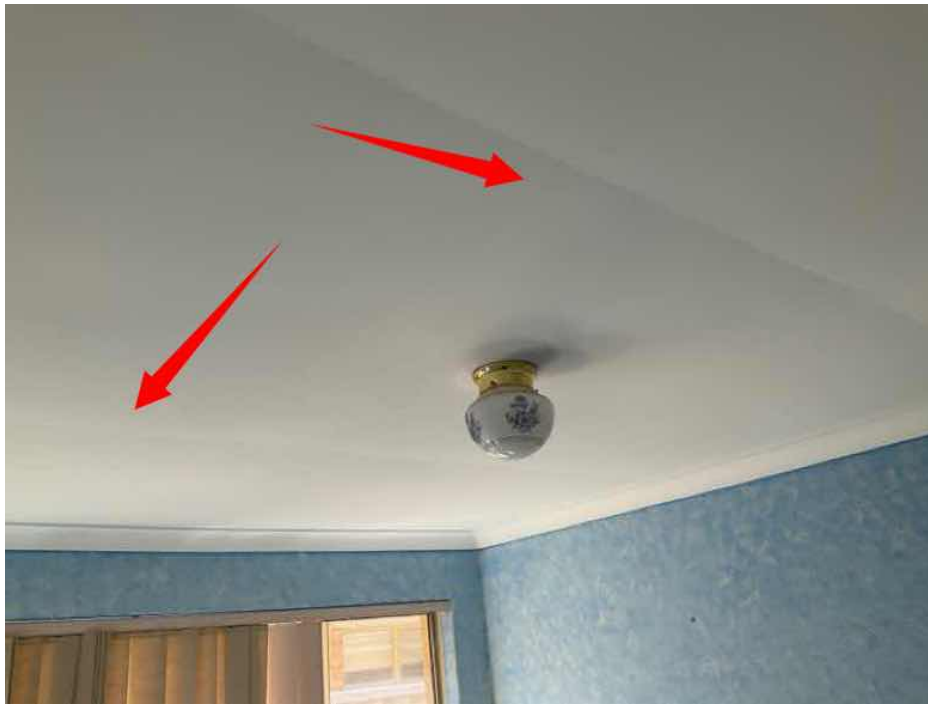
Accentuation lines on the ceiling joins as well as cornice movement is apparent. The ceilings in this room may be able to be re-glued, screwed and flush repaired.

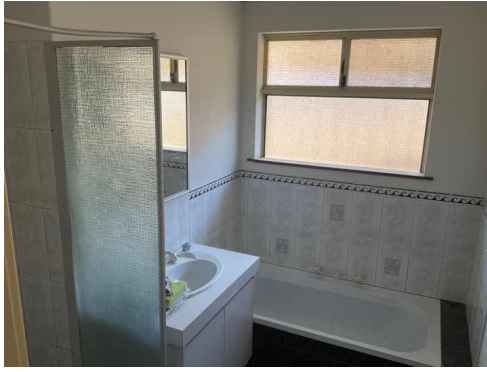
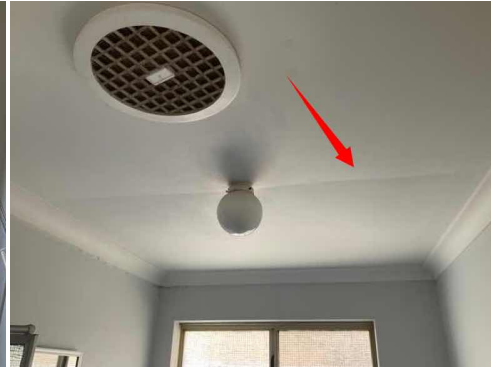
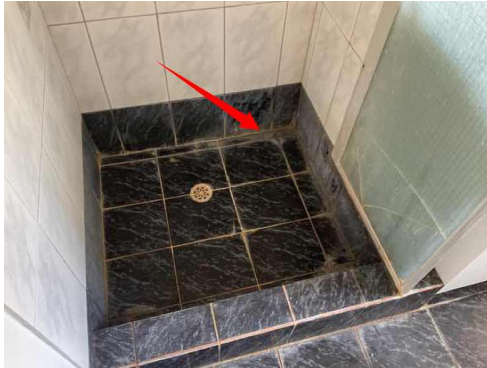
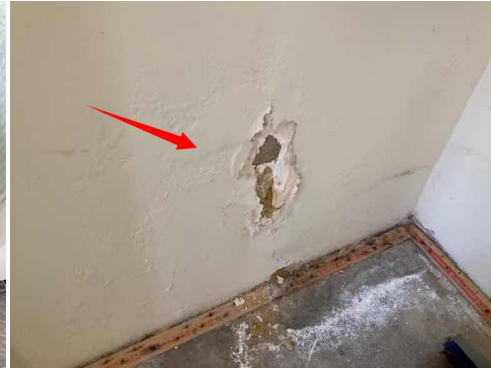
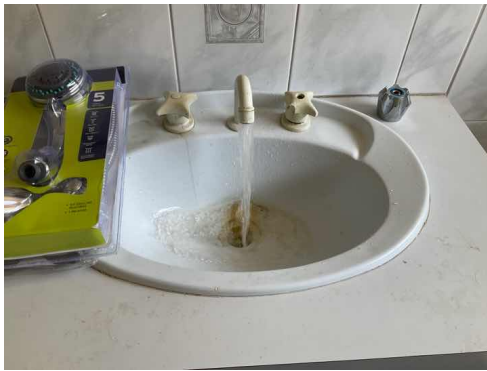
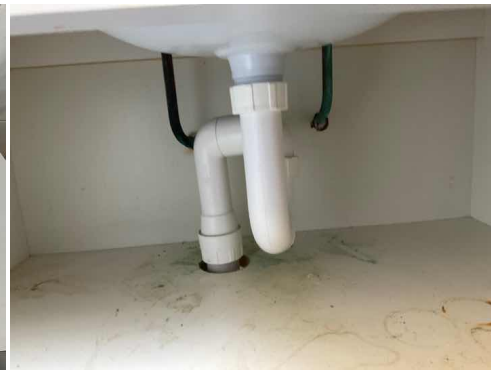
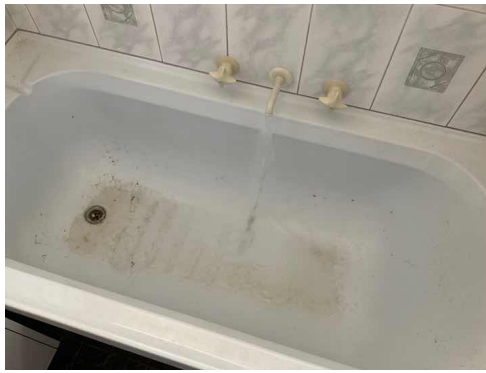
Accentuation lines on the ceiling joins as well as cornice movement is apparent. The ceilings in this room may be able to be re-glued, screwed and flush repaired.

The plumbing was working when tested. The shower recess is leaking to the surrounding walls and will require modifications moving forward.

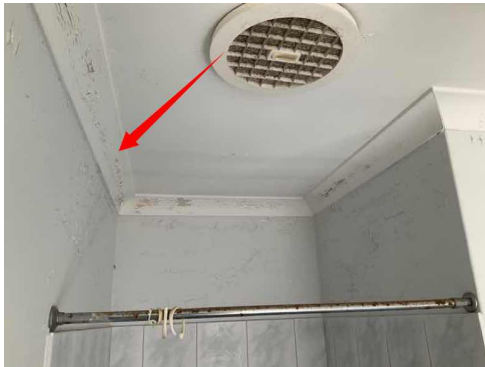
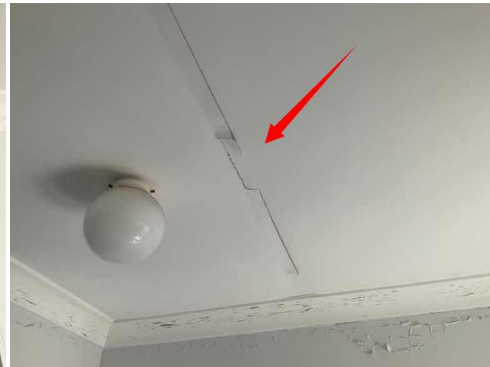
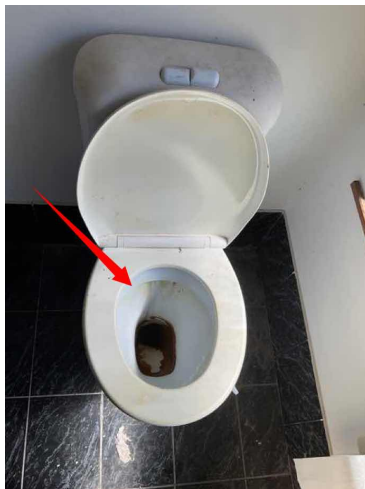
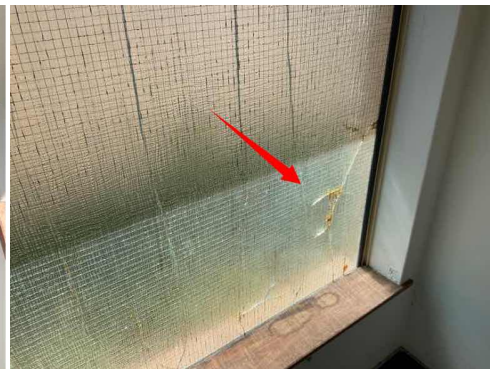
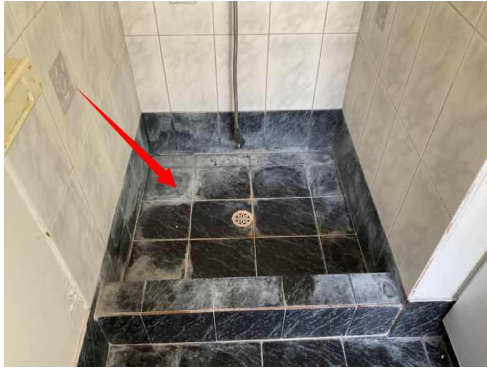
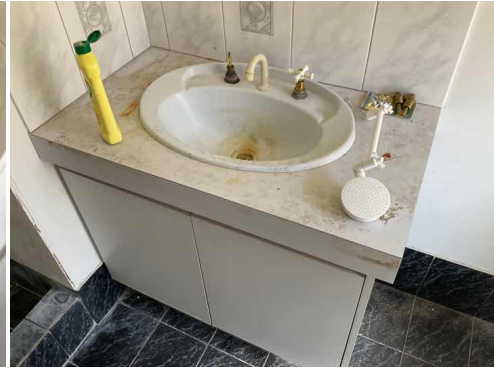
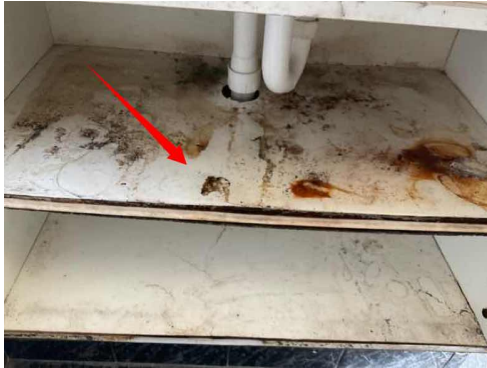
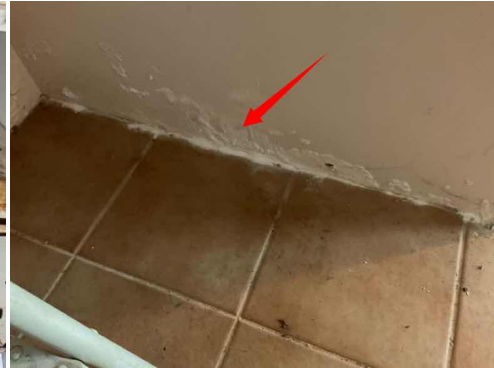
Of the visible areas, the general condition of this bathroom is showing to be in serviceable condition overall however repairs are required.

The toilet cistern, vanity unit, exhaust fan and window glazing requires replacing. The shower recess is leaking and requires modifications.

The ceiling is showing peeling paint/staining apparent due to lack of sufficient working exhaust fan. The ceiling is also showing a movement crack that be repaired, the ceiling in general can be rubbed back and repainted.

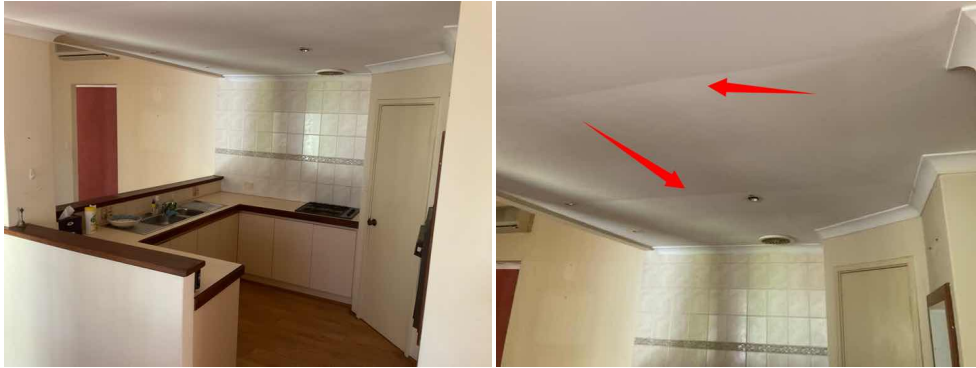
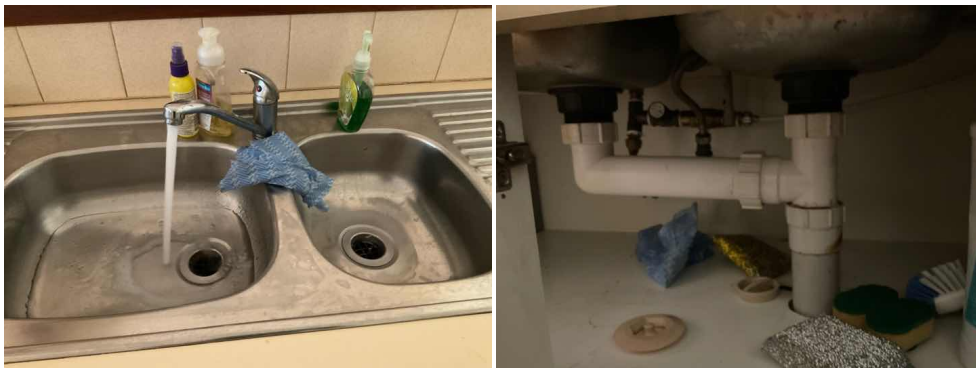
The ceilings within the room are showing general movement/accentuation lines on the sheet joins suggesting the glue is slowly breaking down between the sheet itself. Cornice cracking is also evident.

The ceilings may be able to be re-screwed and glued but should ultimately be replaced.

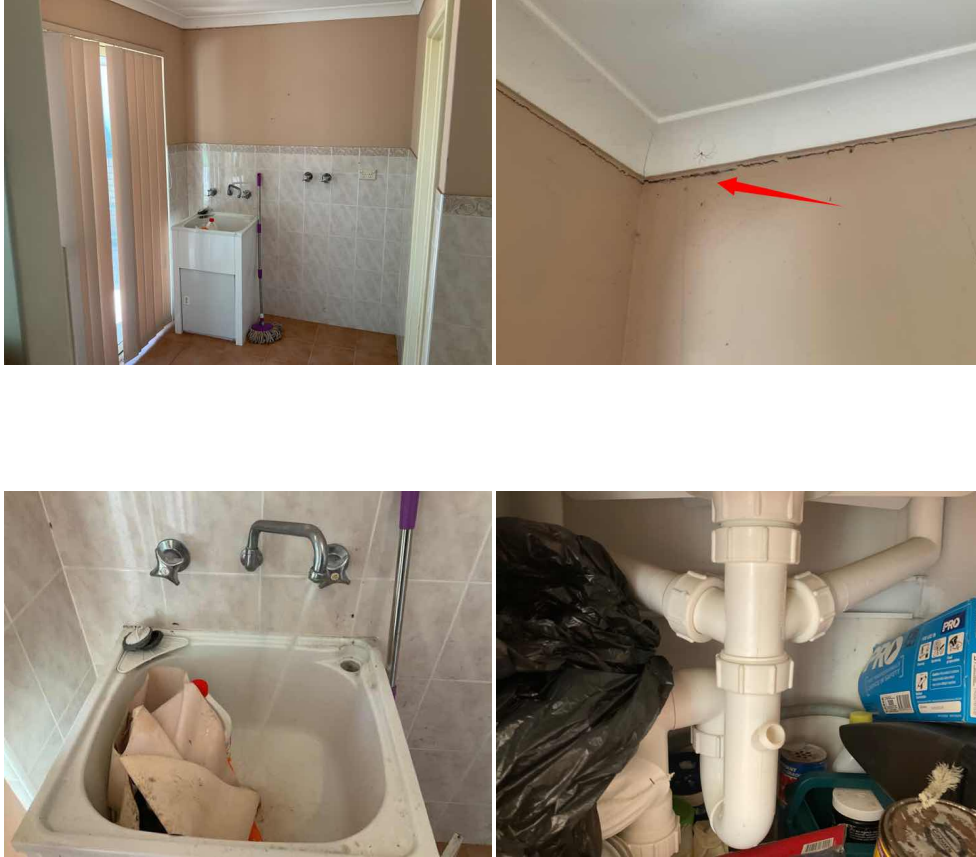
General movement cracking is apparent to certain cornices, currently no cause for concern easily repaired by a professional painter as required.

The trough door requires repairing, also the outlet to the plumbing replacing.
