# BRENT HENNESS PPI

**PRE-PURCHASE INSPECTIONS**

*7/1 PETER CLOSE HORNSBY HEIGHTS NSW 2077*

## Visual Pre Purchase Building Inspection Report

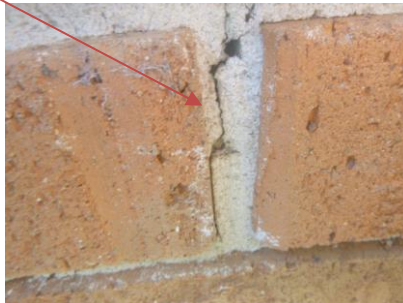
The cracked areas	Photo of crack in report	Approximate width & length of the cracking
<p>To the <u>external</u> brickwork of this as inspected dwelling on rear wall</p> <p>To the <u>internal</u> walls and ceilings in some rooms as stated within the body of this report, being category "2" as shown in the photographs below</p>	<p>YES,</p> <p>As in the body of this report</p>	<p><u>Exterior</u> 2mm &amp; 50mm in length</p> <p><u>Internally</u> under 2mm and up to 50mm in length</p>

MINOR CRACK TO REAR WALL MORTAR

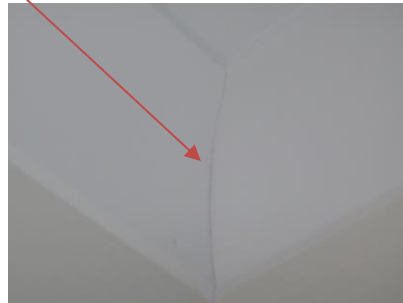
REAR SIDE WALL HAS MINOR CRACK

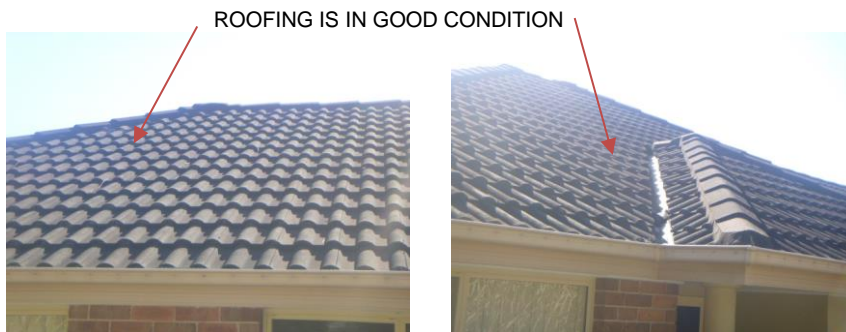
1. Gutters & valley gutters: need minor repair to gutterguard
2. Gutter rusting: no
3. Bird proofing: none noted
4. Gutters & downpipes leaking: no
5. Concrete tile roofing is in good condition with minor shrinkage cracks to ridge capping cement
6. The roof flashings: ok
7. Chimneys condition (if applicable): no
8. Loose or damaged TV aerial mast and or connections: n/a
9. The eave lining timber storm moulds: no gapping noted (*Gapping is an indication of possible settlement to this nominated area of the dwelling, therefore check the drainage of surface waters is adequate at these gapping points.*)

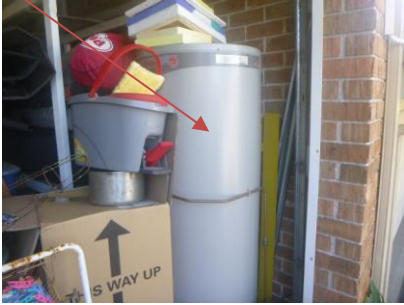
**315 LITRE ELECTRIC WATER HEATER**

9. Hot Water unit: 315 litre electric unit A clear hose should be fitted to the overflow pipe and redirected into an appropriate drainage inlet point, (*A LICENSED PLUMBER SHOULD BE CONSULTED FOR FURTHER ADVICE, IF REQUIRED. The age of the existing unit is unknown.*)  
(*NOTE: we do not test the pressure relief valves on freestanding hot water units as this valve may break, seize or leak due to lack of testing over a period of time by the owners of properties.*) **NOTE:**  
*hot water units with storage tanks must have the temperature set above 60degrees to prevent bacteria forming within the tank and unit itself*

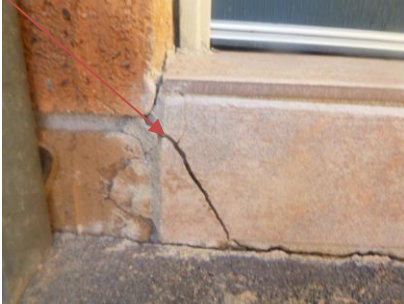
11. Retainer walls have minor cracks
12. Rear bottom course bricks need sealing to core holes

**MINOR CRACKING TO RETAINER WALL**

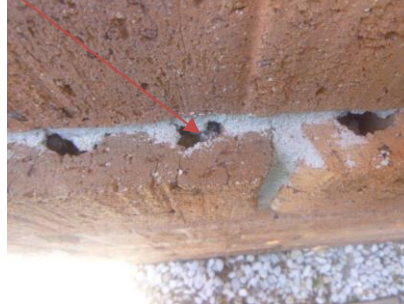
17. Bathroom shower exterior tile is loose & wall has minor water damage
18. Exterior brick walls have minor cracks & some sealing needed to core holes
19. Rear fence has some sections that are out of plumb

**CORE HOLES NEED SEALING**

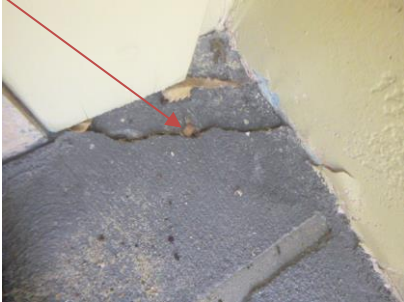
10. Concrete paths have cracks & undulations
11. Concrete slab edge is not exposed (maintain regular 12 monthly re-inspections to the property)
12. Garage timber entry door has minor damage at base

**CRACKING TO REAR CONCRETE PATH**

4. Site drainage: average
5. The driveway: concrete has minor cracking
6. Paths & paved areas: concrete has cracks & undulations
7. Town Water area.
8. Fences: timber/metal

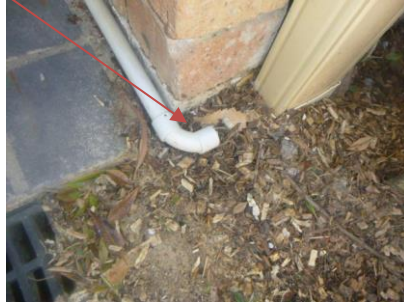
13. Garage concrete slab has cracking
14. Garage ceiling has undulations
15. Air conditioner overflow pipe leaks to slab edge
16. Ensuite shower & bathroom shower screen need sealing at base

**OVERFLOW PIPE LEAKS TO SLAB EDGE**
