PRE PURCHASE TIMBER PEST INSPECTION REPORT

2/85 Arthur Street
Grafton NSW 2460

Building Inspection Report

Property Address: 2/85 Arthur Street
Grafton NSW 2460

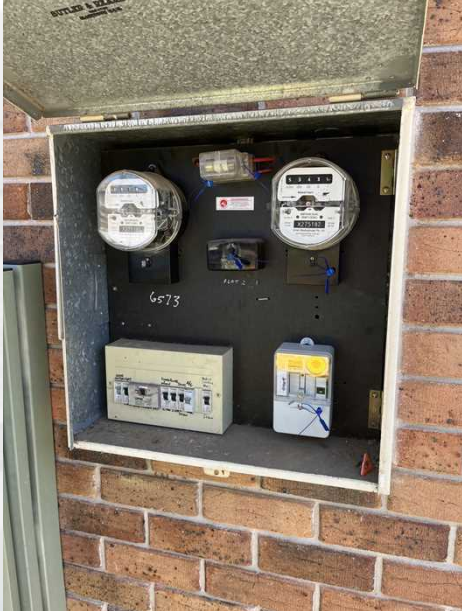
Meter box, No durable notice to indicate any recent termite treatment or post construction management system installed

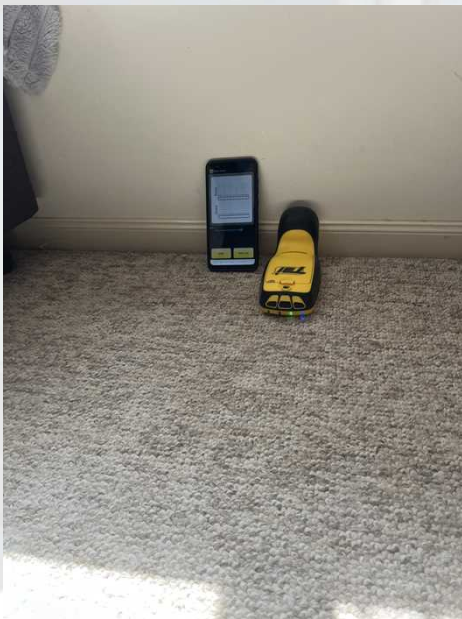
No abnormalities on T3i Radar on internal accessible areas to indicate any live termite activity time of inspection

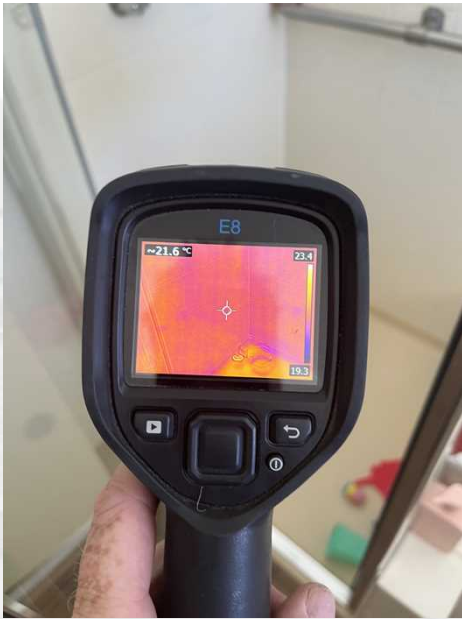
Thermal scan used in conjunction with Tramex moisture meter observed no abnormalities to indicate any live concealed termite nesting at time of inspection.

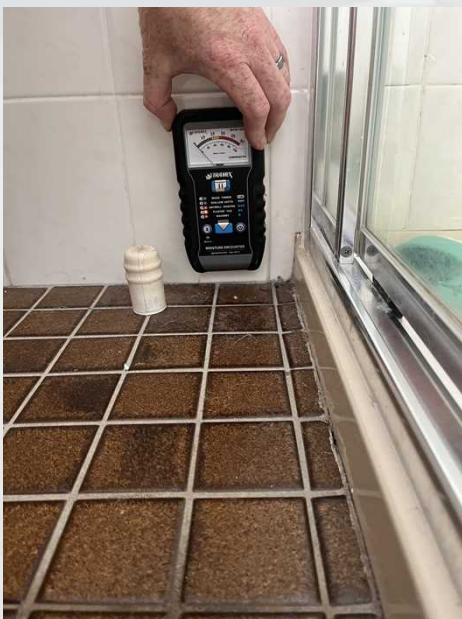
All accessible internal wet areas, Tramex moisture meter observed no high moisture readings at the time of inspection.

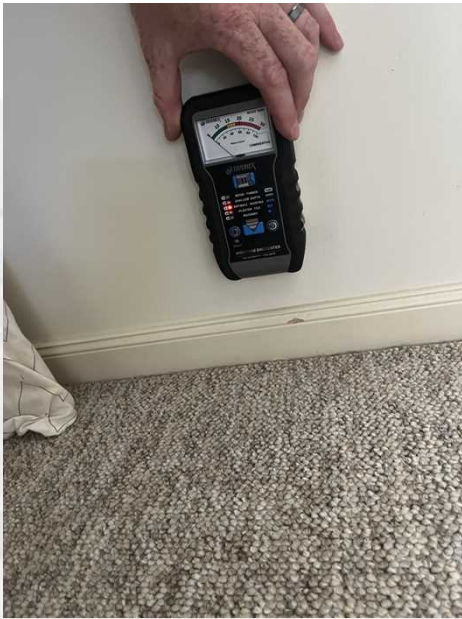
All accessible internal dry walls, Tramex moisture meter observed no high moisture readings at the time of inspection.

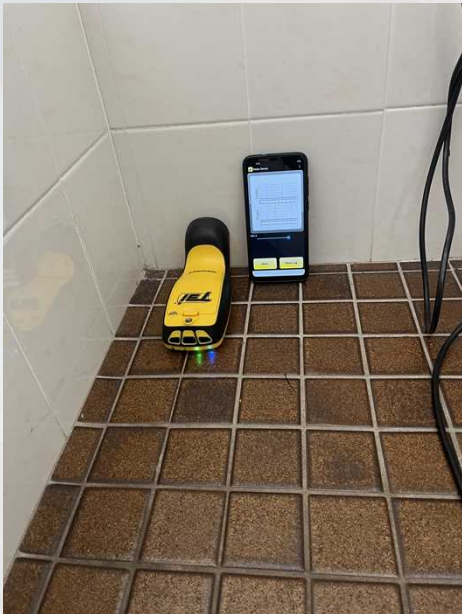
All accessible internal walls and wet areas, there was nko abnormalities on Termatrac T3i termite radar to indicate any termite activity at the time of inspection.

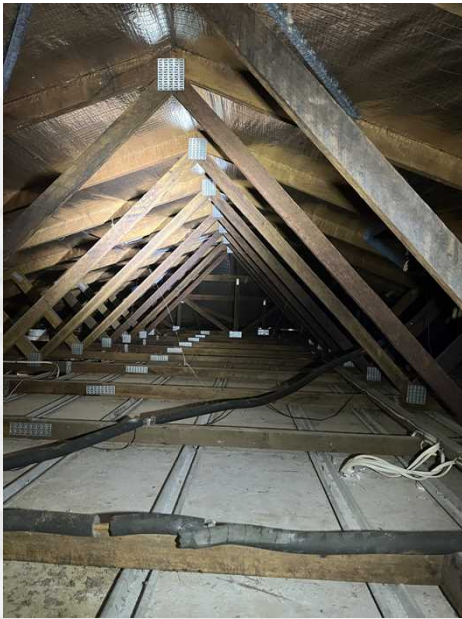
The roof void was inspected, no visible evidence of timber pest activity at the time of inspection

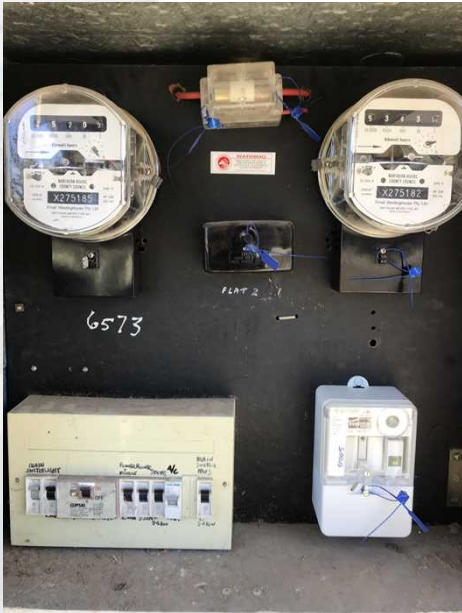
No safety switch identified in meter box.

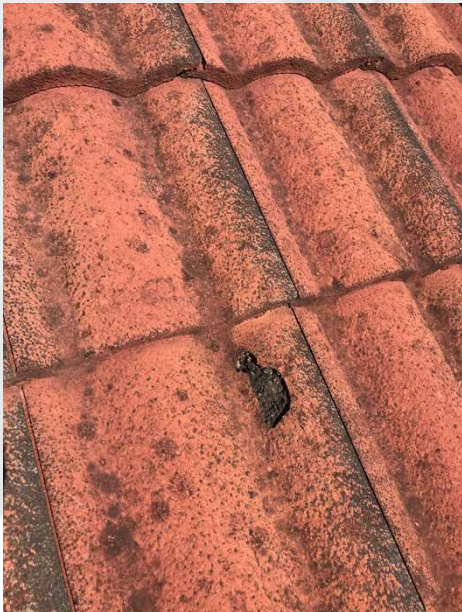
A deteriorated tile identified above entry. A few chipped tiles identified.

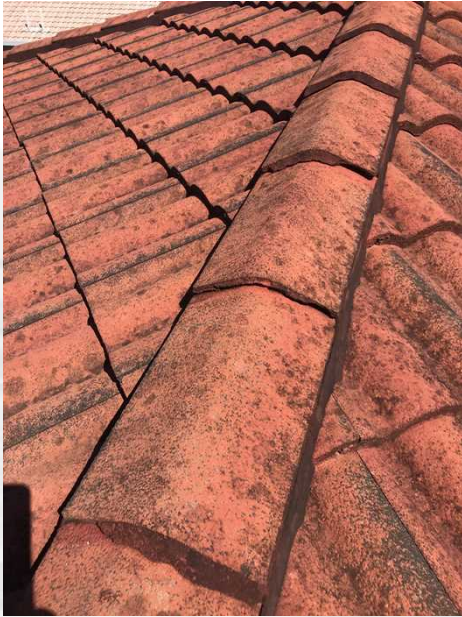
Cracking to the pointing of capping tiles observed.

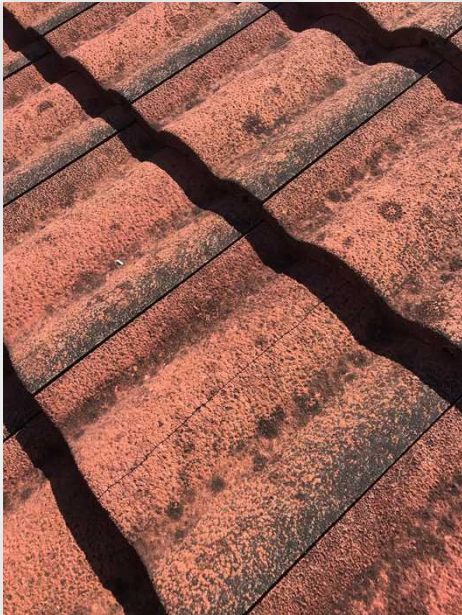
Couple of cracked tiles identified requiring replacement.

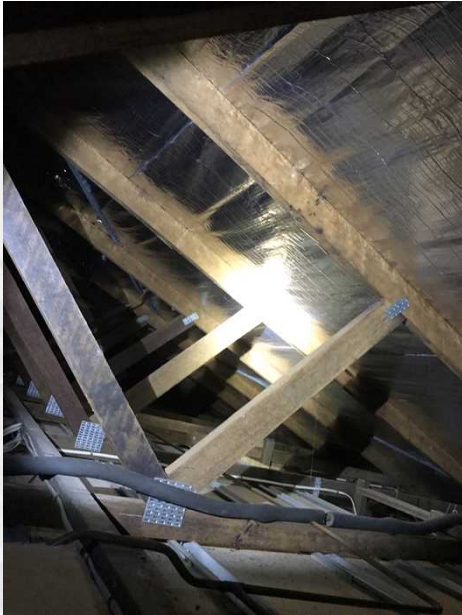
Roof space presents as original in construction without insulation.No full access possible due to lack of safety switch.

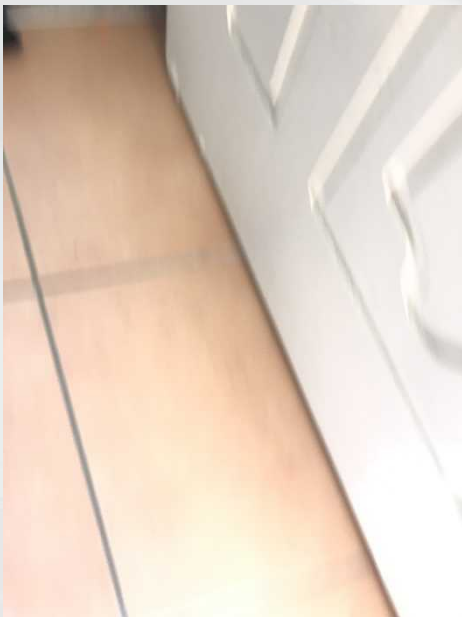
Minor weather damage to entrance door.

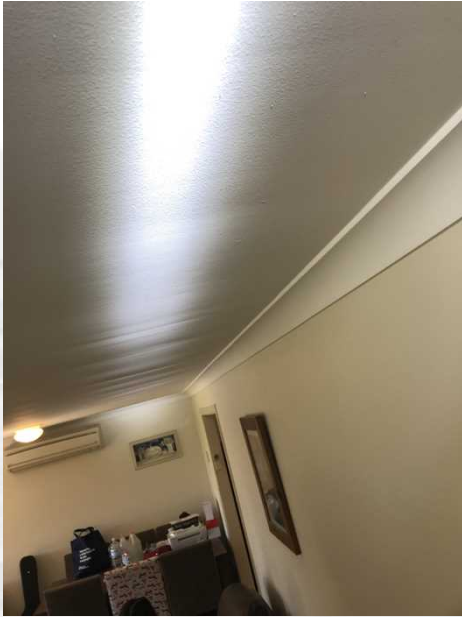
Minor age related sagging observed to plasterboard ceilings.
