Building & Pest Report

11 Ball Street Colyton

11 Ball Street Colyton NSW

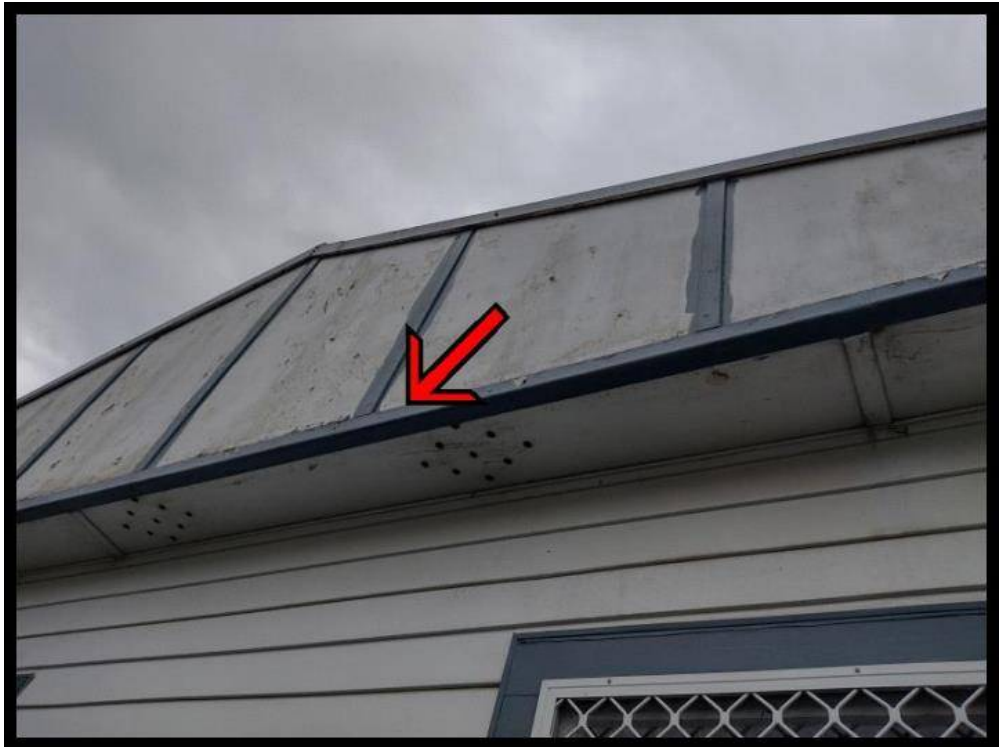
Fascias & Bargeboards Type & Condition:

The overall condition of the fascias/bargeboards is fair. Minor wet rot decay is present to timber fascias and barge boards. The paint work is deteriorating and maintenance is required.

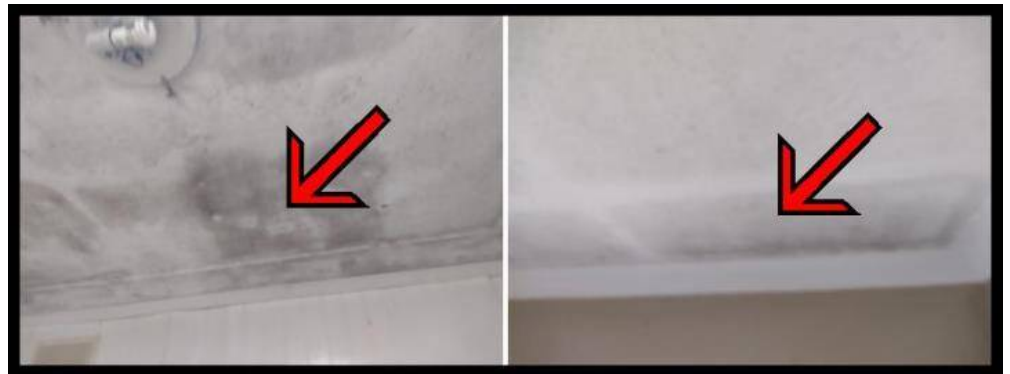
Ceiling Condition:

The condition of the ceilings is generally poor. Mould was noted to the ceilings. The cause of this should be investigated and rectified. Repairs are required to ceiling linings.

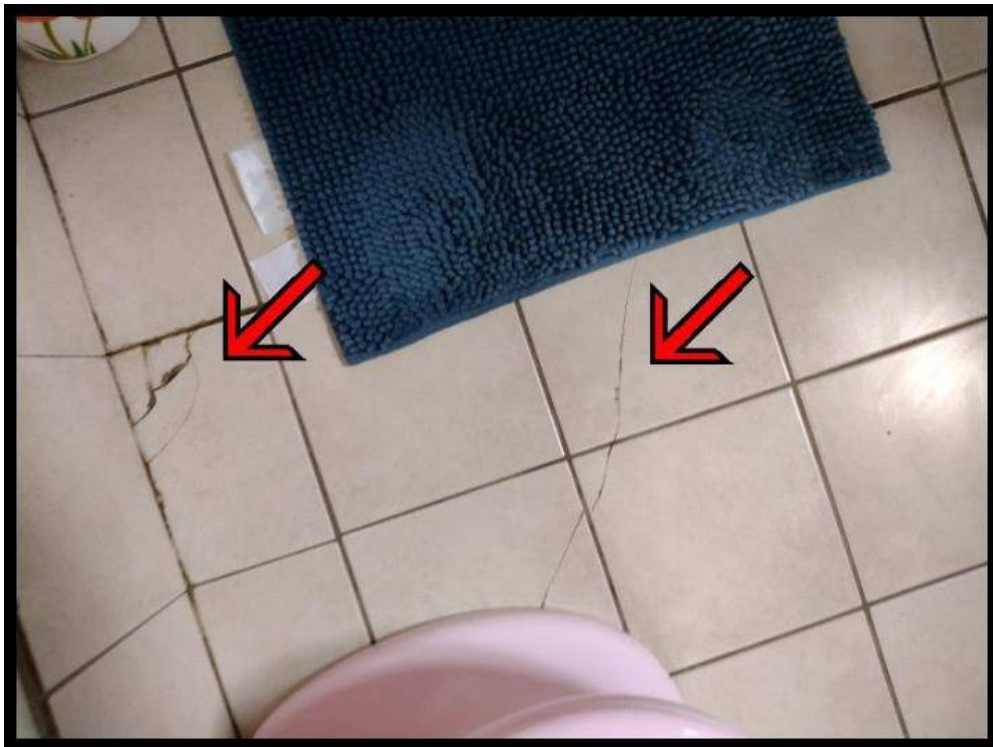
Floors General Condition:

Some cracked, drummy and loose tiles were noted. These will require relaying.

Some cracked, drummy and loose tiles were noted. These will require relaying.
Granny Flat.

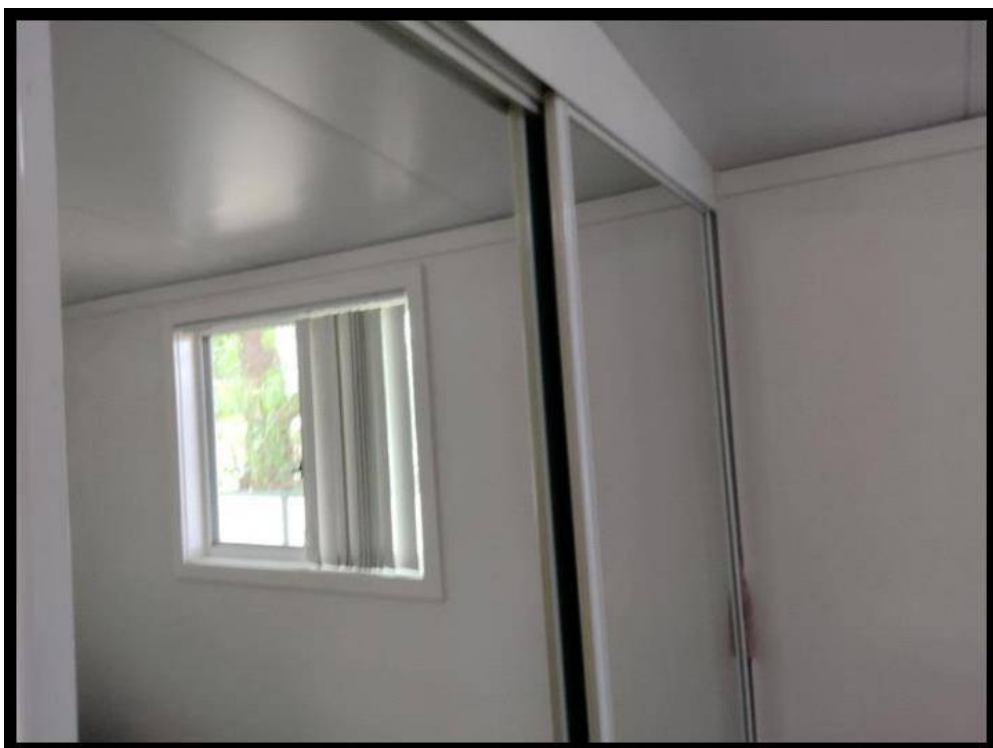
Type and Condition

The doors are mirrored sliding style. The condition of the built-in wardrobes is generally good.

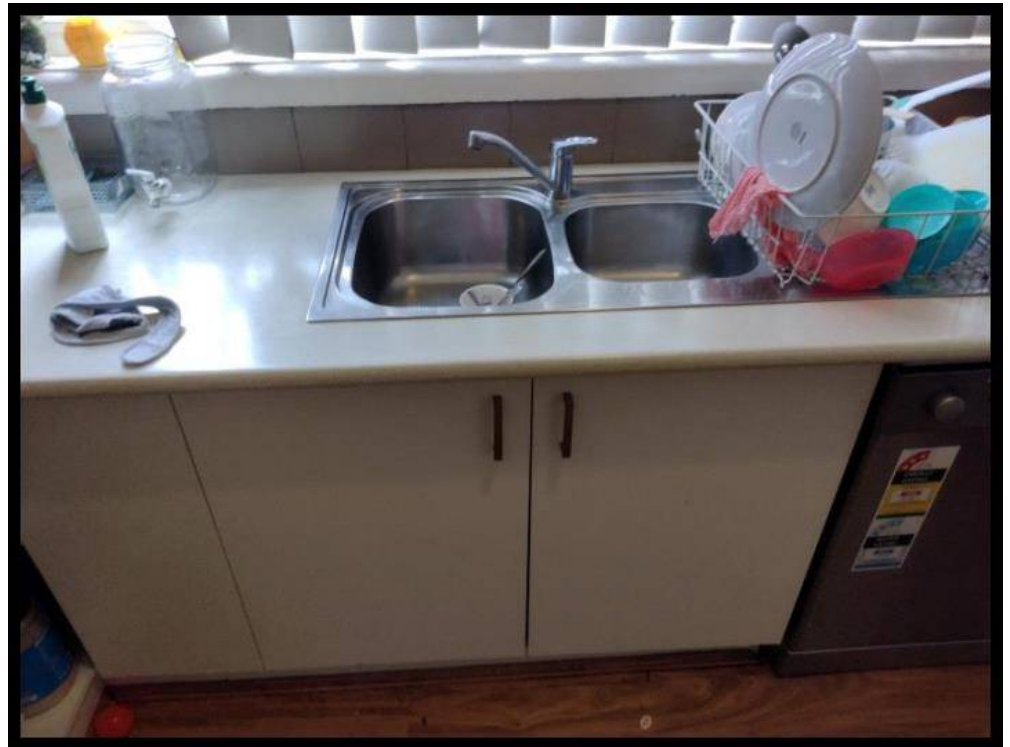
Kitchen Fixtures:

The condition of the fixtures is generally fair. Wear and tear is noted to cabinets and/or doors and some maintenance or repairs will be required. Adjustment is required to some door and drawers to ensure smooth operation.

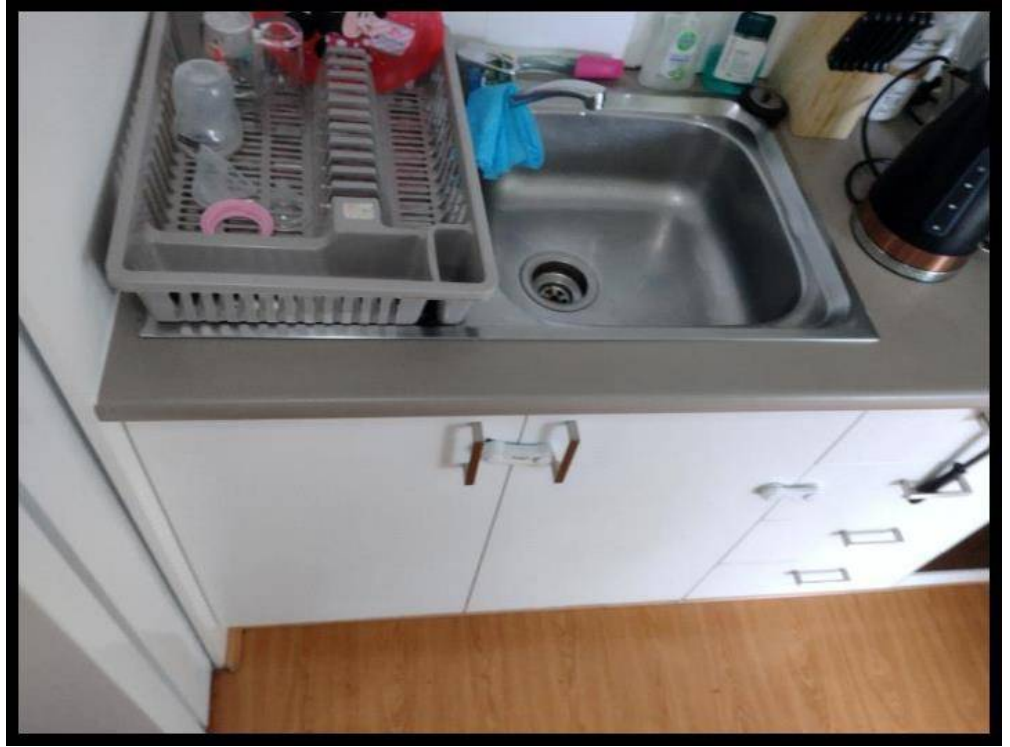
Kitchen Fixtures:

The condition of the fixtures is generally fair.

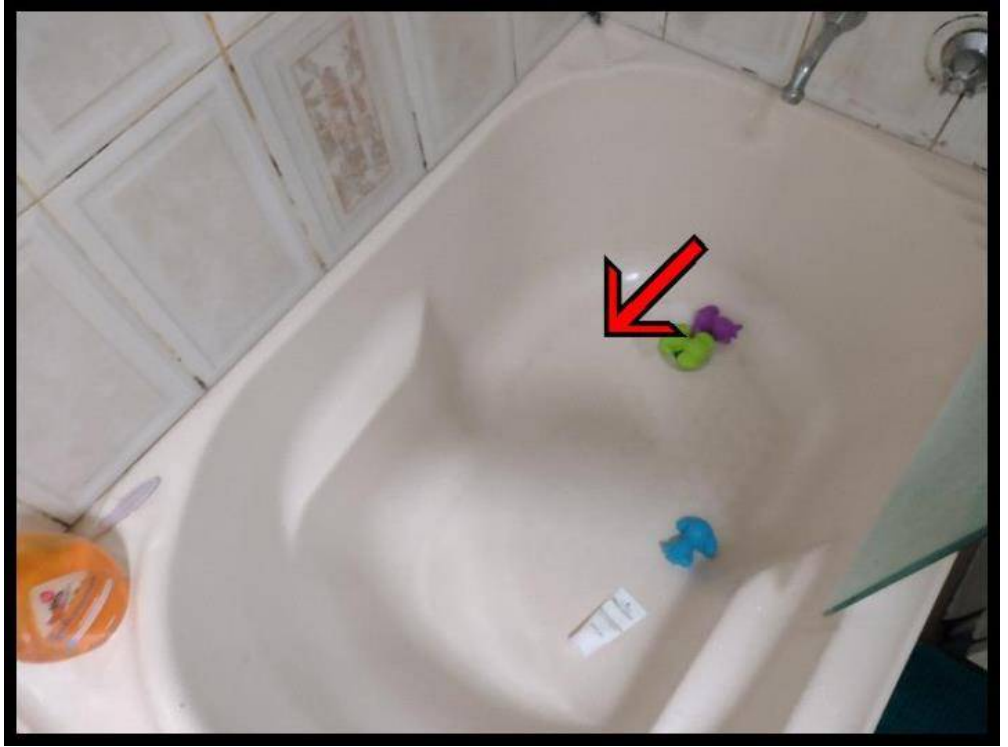
Shower/Bath Condition:

The shower is located over the bathtub. The area will need to be kept well sealed to prevent water penetration to surrounding areas.

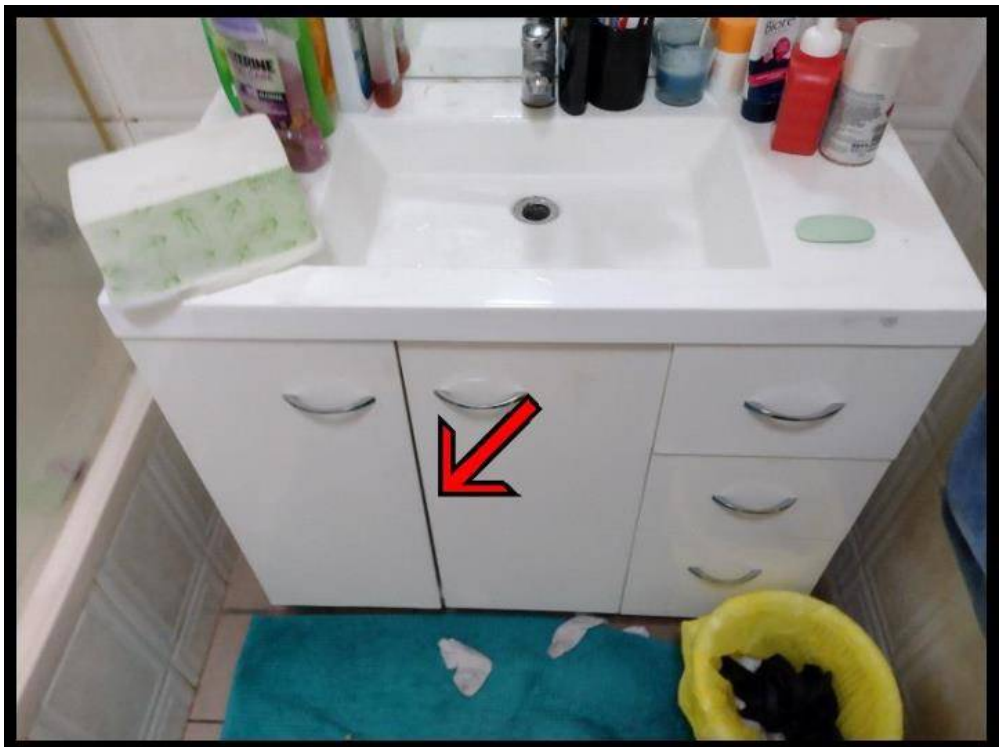
Vanity Unit:

The condition of the vanity unit is generally fair. Wear and tear is noted to vanity cabinet.

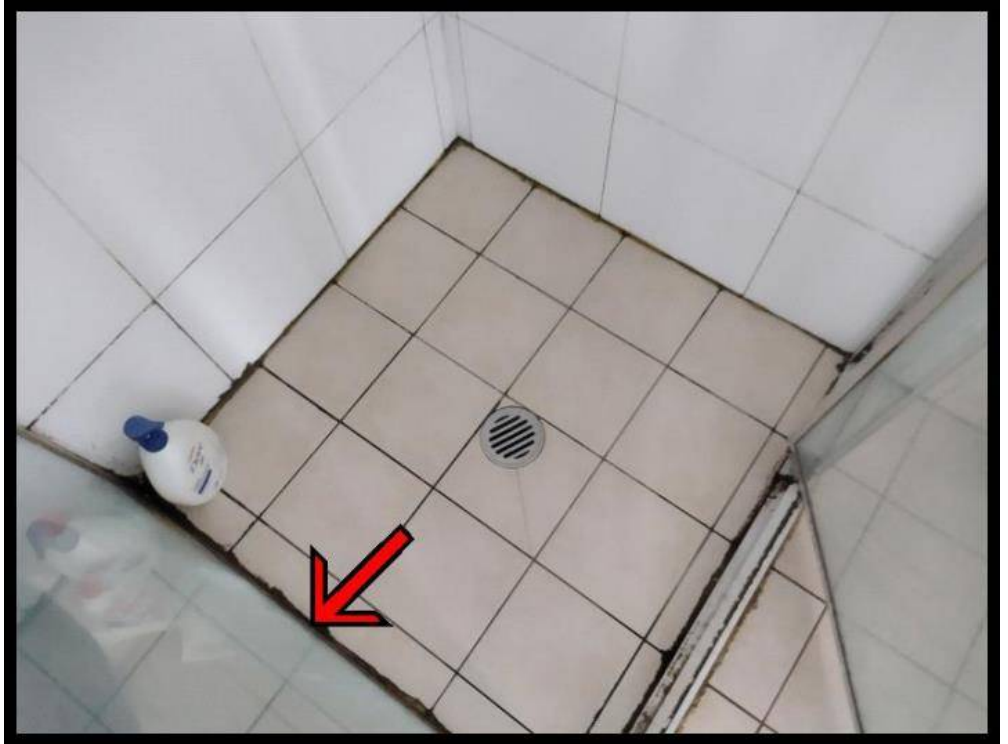
Shower/Bath Condition:

Silicone sealant has been applied to the interface of the floor and walls in the shower recess in an apparent attempt to prevent water penetration to surrounding areas. This method of repair can only be considered to be temporary. Further waterproofing may be necessary. Evidence suggests the shower has been leaking in the past. Leakage may allow damage to surrounding components. Rectification will be required and the extent of works should be determined by a Licensed Builder.

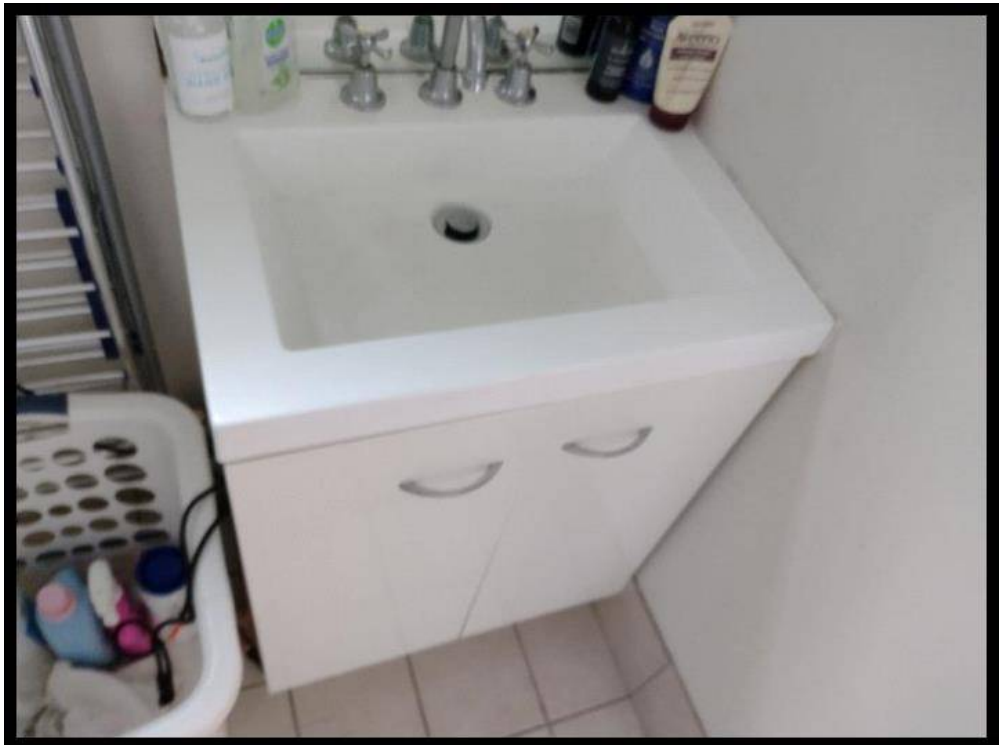
Vanity Unit:

The condition of the vanity unit is generally good.

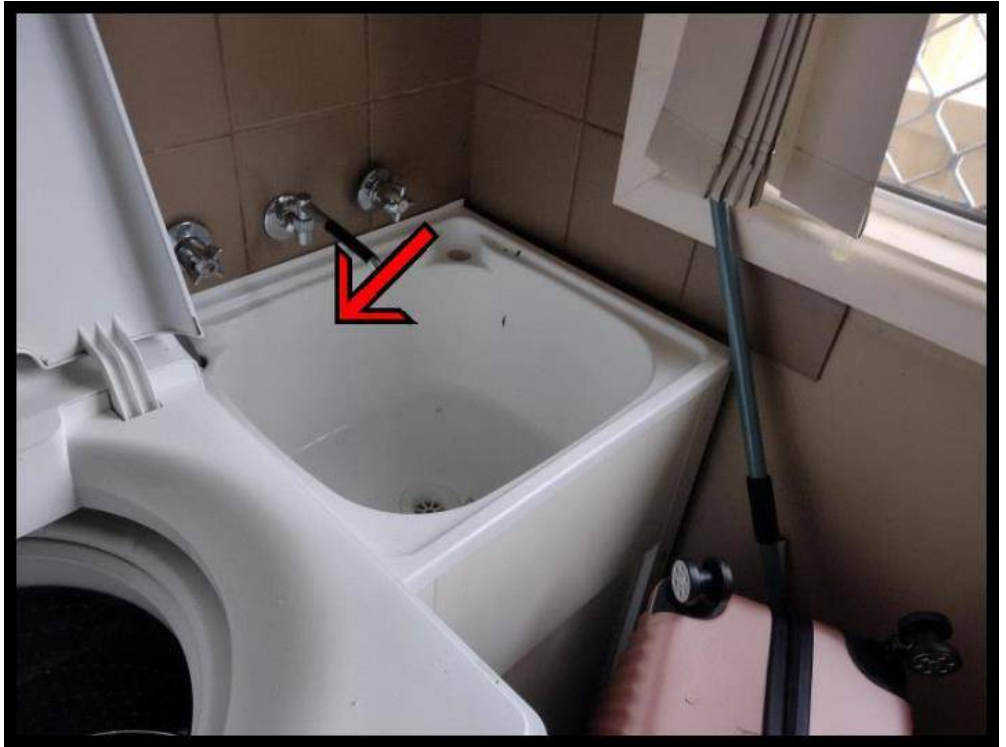
Tub & Taps:

The tub and taps appear serviceable.

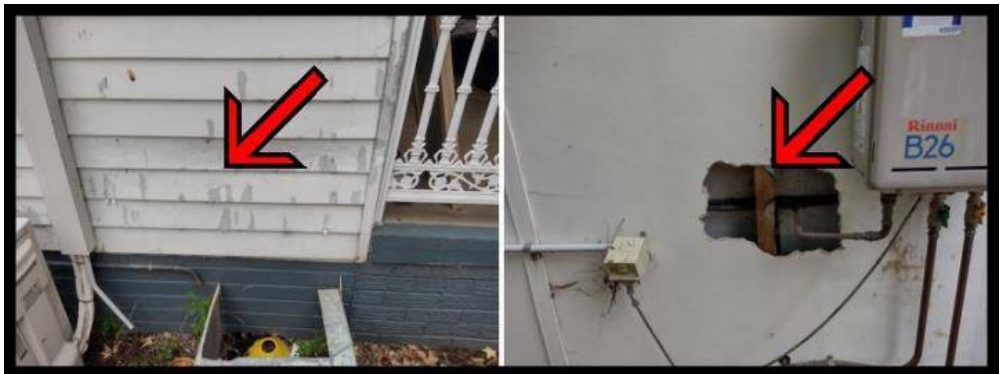
General Condition:

The condition of the walls is generally fair. Cladding is damaged, repairs and maintenance will be required. Paint deterioration was present to external surfaces. Maintenance and/or repairs will be required.

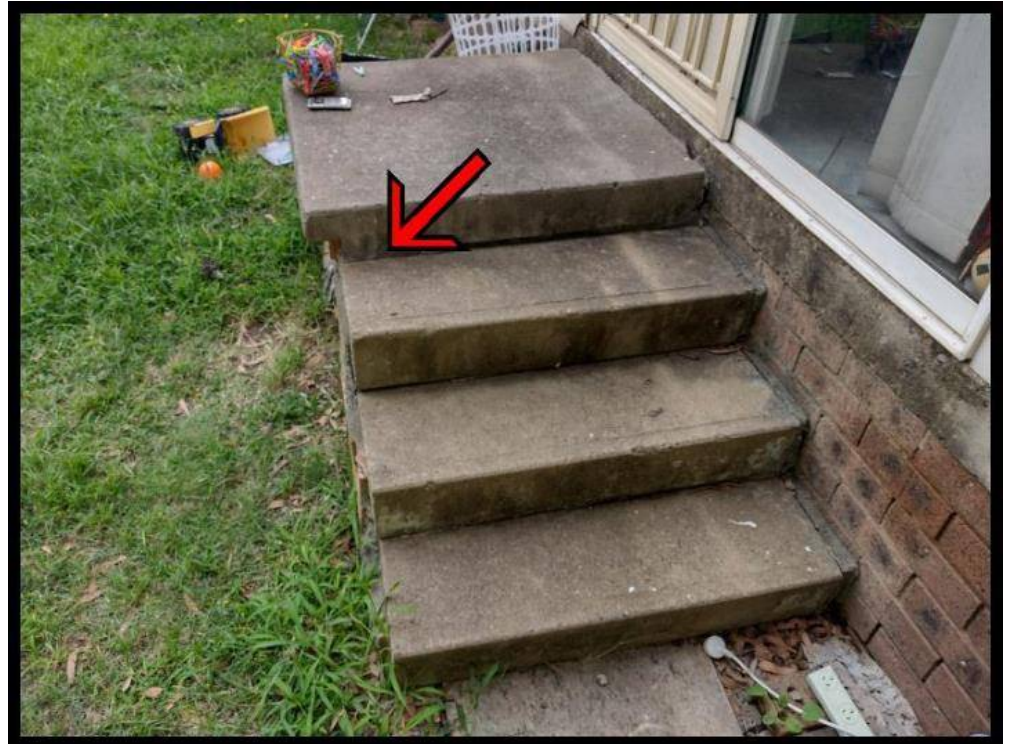
Type & Condition:

The stairs are constructed primarily from concrete. Movement is evident to the stairs. This will require some maintenance or repair.

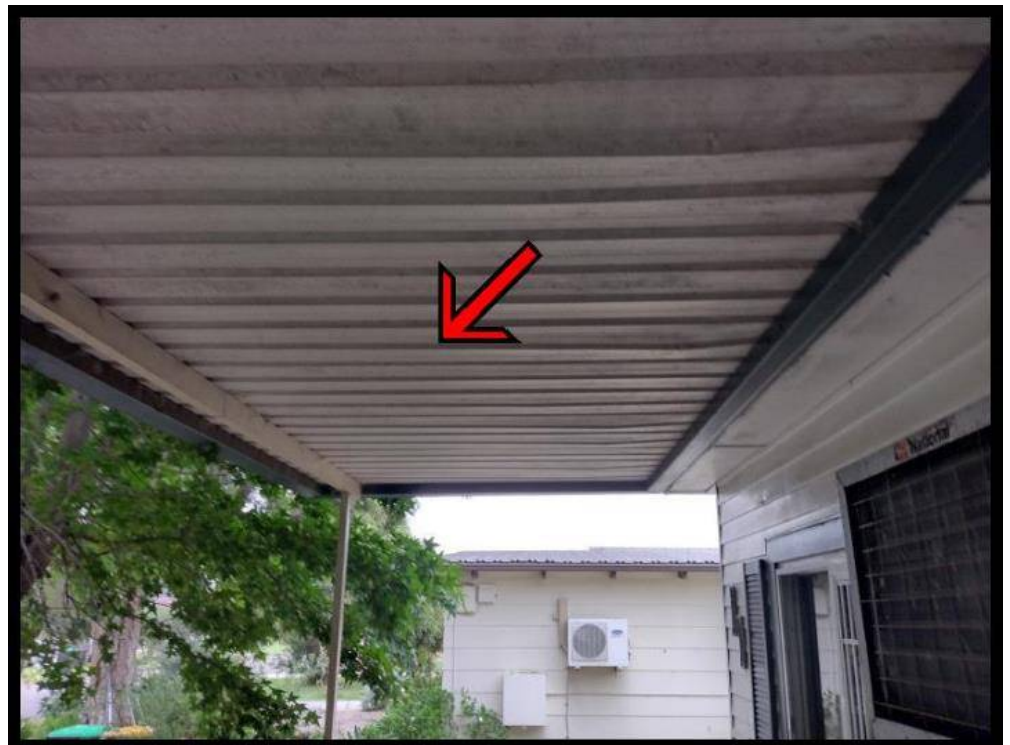
Roof is covered with:

Metal decking:

Roof Covering Condition Detail: The overall condition of the roof coverings is fair.

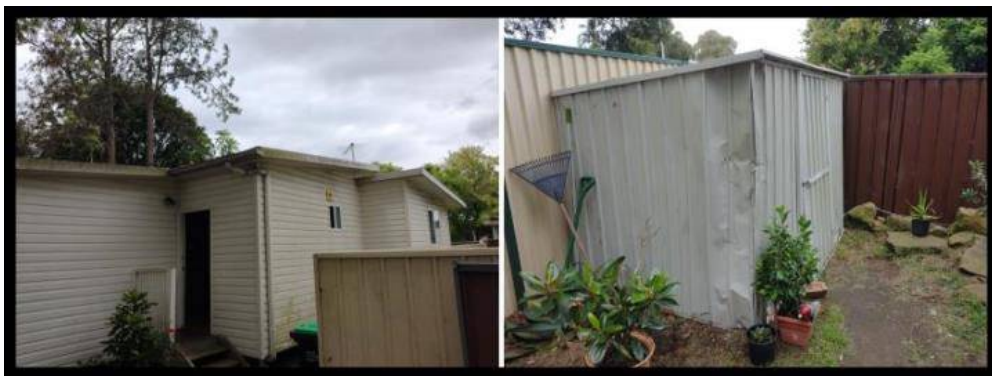
Type of Outbuilding:

Metal garden shed: Granny flat:

General Condition: The structure is generally in fair condition.

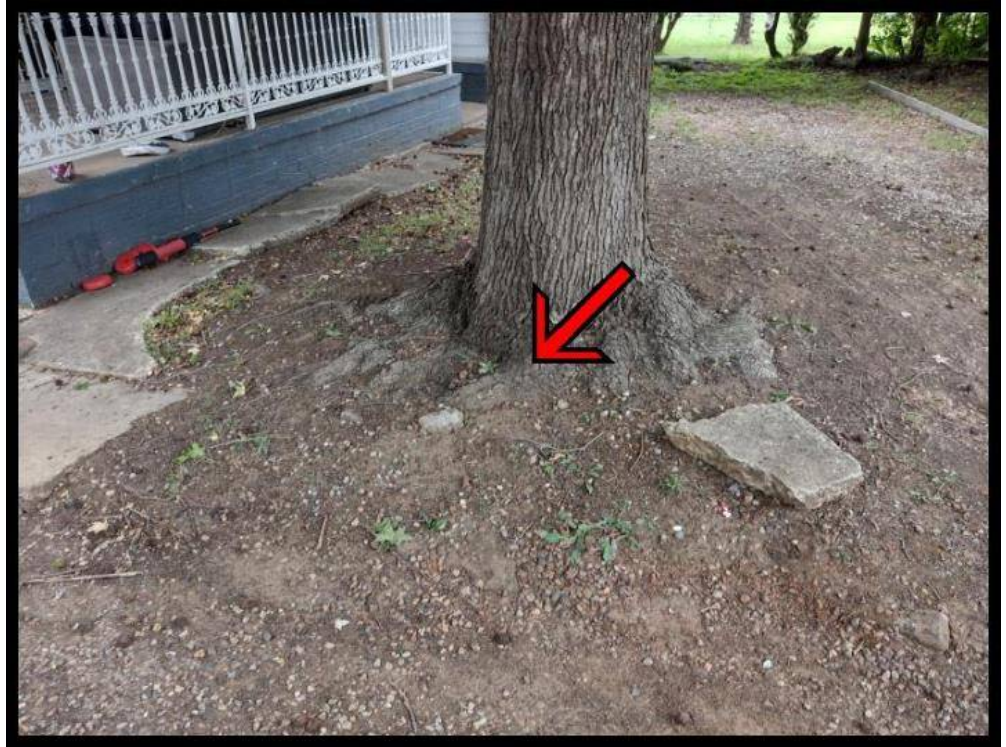
Type & Condition:

The paths/paved areas are being adversely affected by tree roots. This should be rectified and repairs carried out.
