## BUILDING & PEST INSPECTION REPORT

21 Parklands St  
Calamvale, QLD 4116

BYB  
25/09/2025

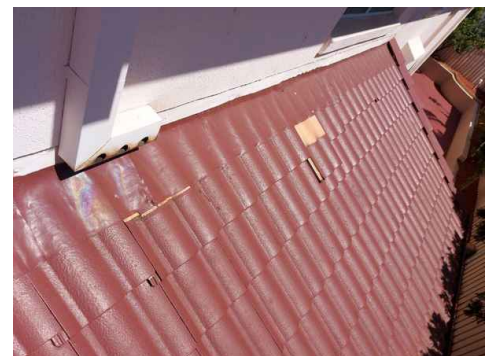
Displaced tiles can lead to water ingress in subsequent damage.  
Recommend repair by a roof tiler as soon as possible.

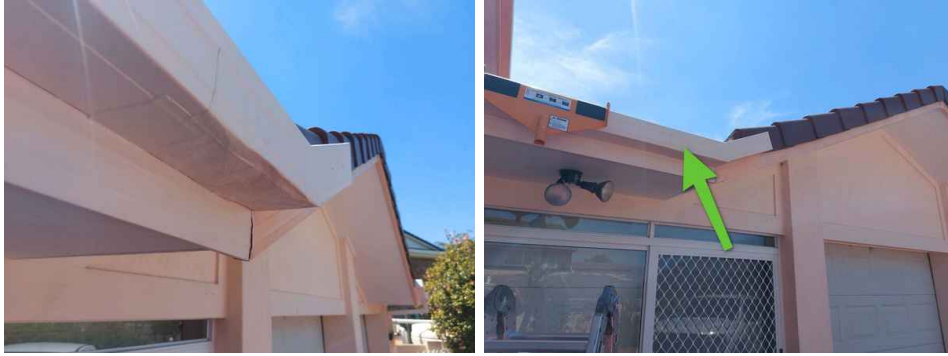
## 10.4.1 Roof Drainage Systems

**ADVANCED CORROSION**

Gutters/downpipes exhibited advanced corrosion in areas and required repair or replacement. The Inspector recommends that you consult with a qualified contractor to gain an idea of options and costs for replacement.

Note: Defective rainwater systems can lead to building damage, and encourage timber pest activity.

Contact a qualified gutter contractor

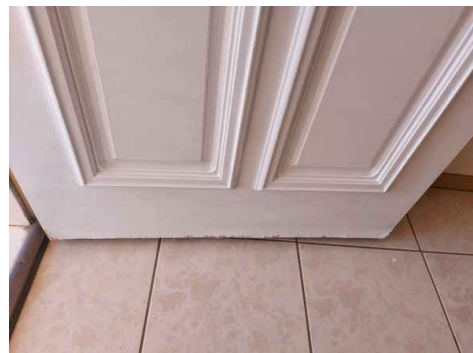
#### MOISTURE DAMAGE

There was moisture damage/ decay to the door/ frame/components. Correction and further evaluation are recommended.

Contact a qualified professional.

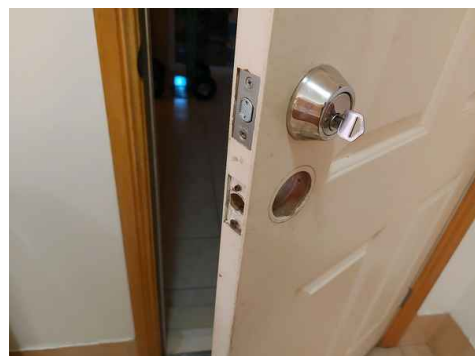
**MISSING  
HARDWARE**

Door(s) had missing hardware.

Further evaluation and correction recommended

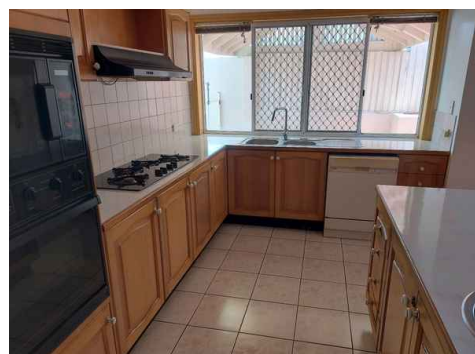
**MODERATE  
DETERIORATION**

The kitchen cabinets exhibited moderate general deterioration.

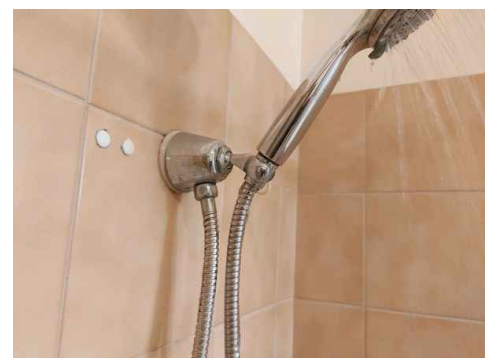
### 15.2.1 Shower

### SHOWER HEAD/HOSE LEAKING

The shower head/ hose is leaking. This is may due to deterioration. It may simply require a new seal or tightening. Replacement is relatively inexpensive.

Contact a qualified plumbing contractor.

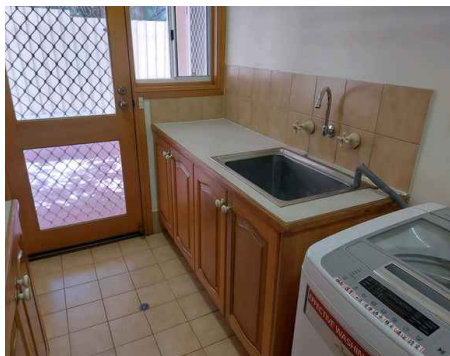
#### General: Deteriorated fixtures/cabinet

The fixtures are showing signs of deterioration. Maintenance, repairs or replacement are recommended.

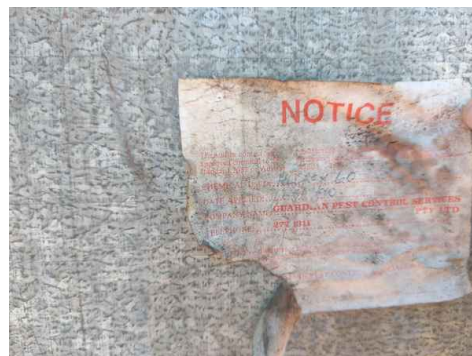
Based on the **durable notice(s) observed on site**, the existing termite management system is considered to be **past its expected service life**.

We strongly recommend that the client **engage a qualified termite management specialist** to:

- Assess the current status of the property's termite protection, and
- Provide advice and recommendations for installing or updating a compliant termite management system in accordance with **AS3660 – Termite Management**.

Contact a qualified pest control specialist.
