## **Pre Purchase Timber Pest Report**

**37 Bulada Street Bungaribee**

**25505-P**

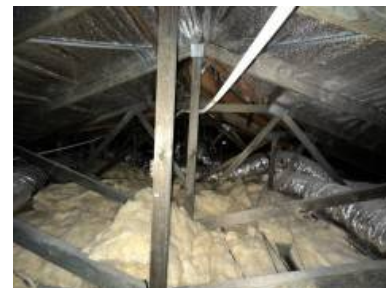
No Timber Pest activity was detected to visible and accessible timbers at the time of the inspection.

It should be noted that inspection within this area was limited as noted. This comment regarding the absence of evidence of Timber Pest activity refers to the accessible inspected areas and timbers only.

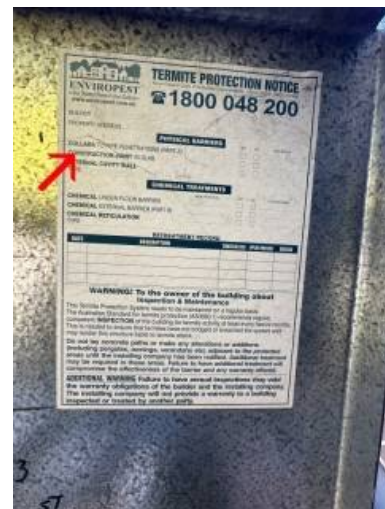
A notice indicates that the property may have been treated during construction in respect to protection against subterranean termite attack. We strongly recommend any prospective purchaser attempt to verify this information and obtain copies of all relevant documentation.
