Inspection Report

House Inspect Australia

51 Beach Road, Wangi Wangi , NSW, 2267

Building Inspection

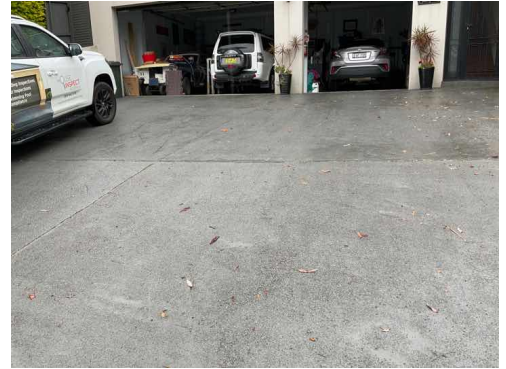
Driveway Condition

Common cracks & settlement were observed on the driveway. Maintenance is recommended. Note: Whilst these cracks appeared to be minor at the time of inspection, we strongly recommend you monitor these cracks and if worsening occurs contact a concreter for further advice.

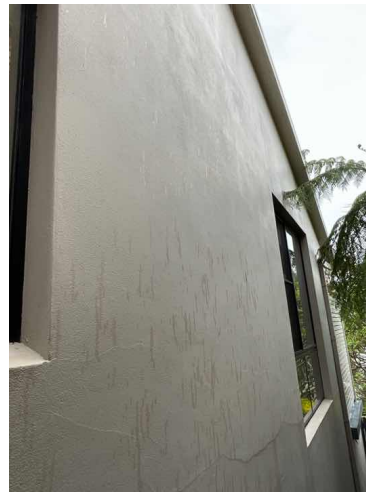
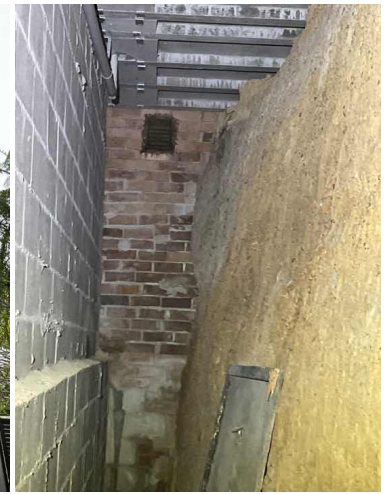
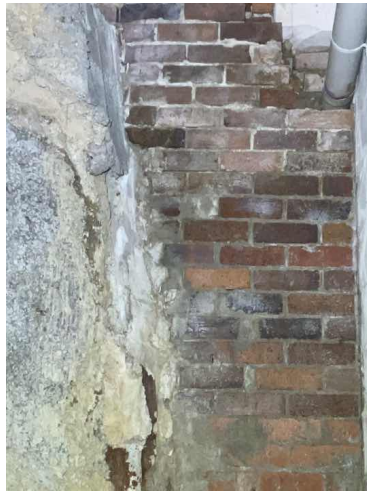
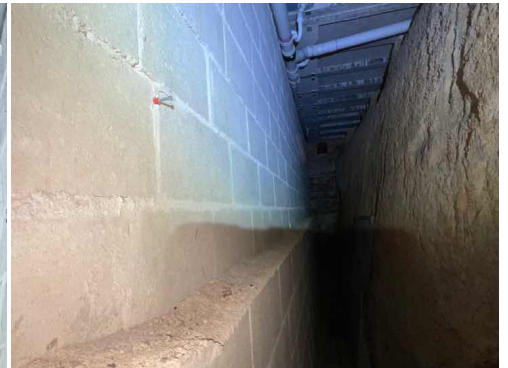
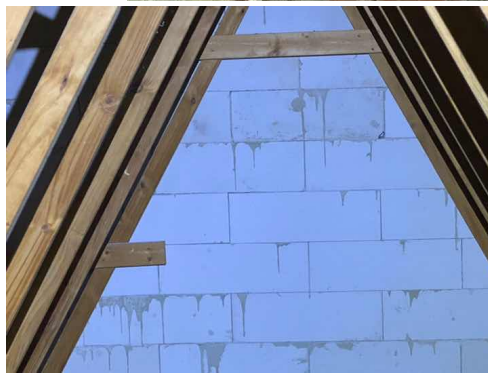
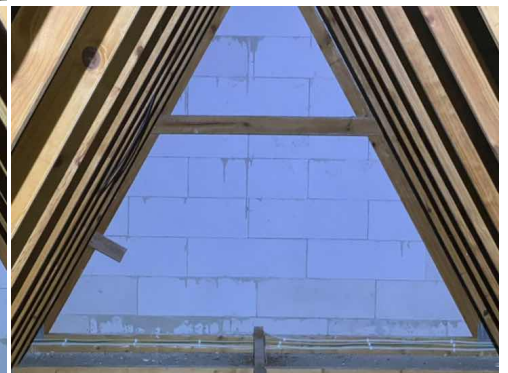
There appears to have been some settlement in the building which has caused some cracking to the walls. These cracks are categorized as 0 to 2. This can also cause some doors to bind or be out of square. In the inspectors opinion these cracks are due to settlement, usually due to ground movement and subsequent movement to building materials can be expected. Any cracks should be monitored and if cracks increase in size, further investigation should be carried out by a structural engineer.

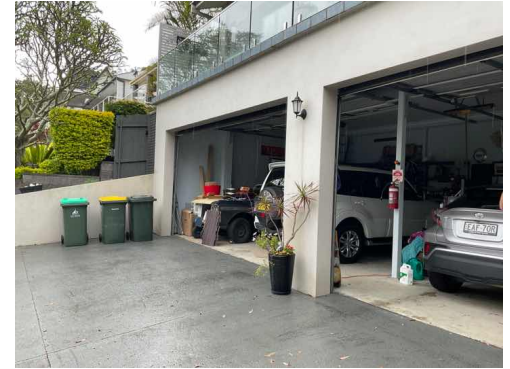
Section of Wall linings have minor damage - **Recommend maintenance repairs to increase longevity of linings**

Areas identified with minor cracking due to movement/settlement - **This can be rectified with minor maintenance. Suggest Filling and Painting.**

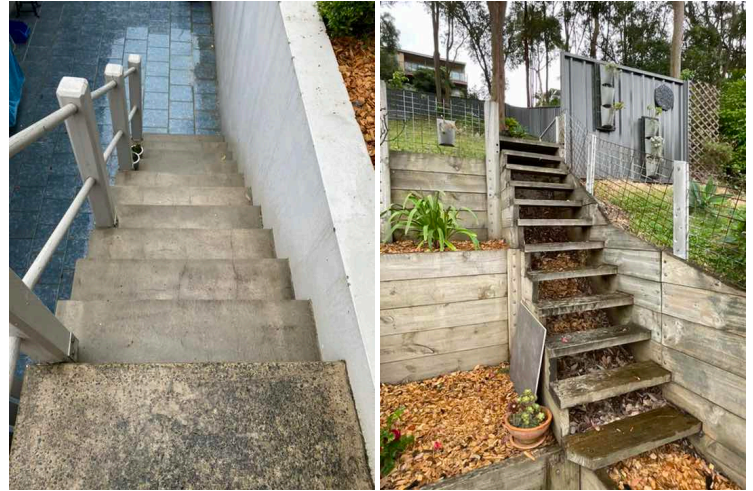
Treads

Settlement/movement cracking.
Recommendations: A qualified brick layer or concreter should be engaged for advice and recommendations.

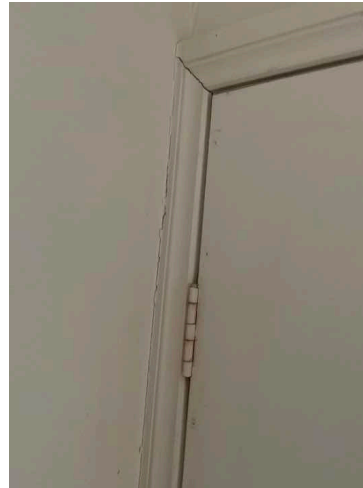
Other Doors

Minor cracking around door architraves. These are contributed to settlement and movement- **Minor maintenance recommended. Fill and Paint**

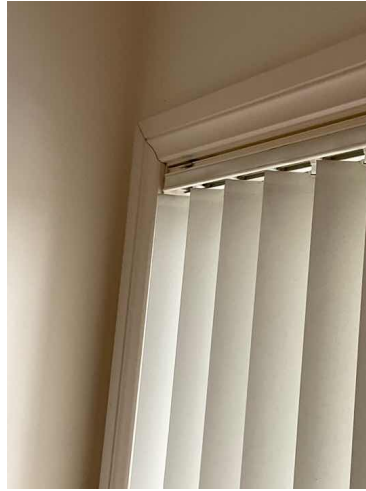
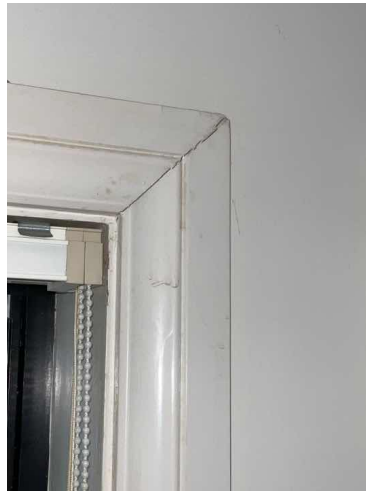
Windows

Minor cracking around window architraves. These are contributed to settlement and movement- **Minor maintenance recommended. Fill and Paint**

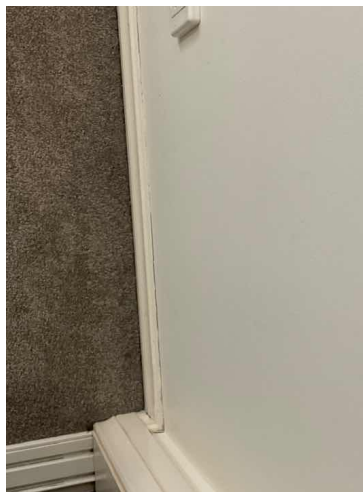
Walls

There are visible cracking where skirting abuts wall. These are considered minor settlement cracks - **It is suggest that a flexible sealant will suffice**

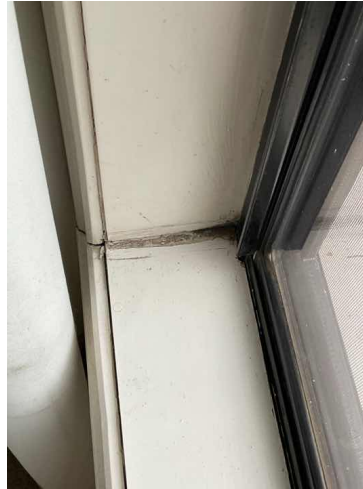
Windows

Paint/Stain to timber work has deteriorated - **Consider minor maintenance. Recommend consulting with a Painter for further advise and recommendations**

Minor cracking around window architraves. These are contributed to settlement and movement- **Minor maintenance recommended. Fill and Paint**

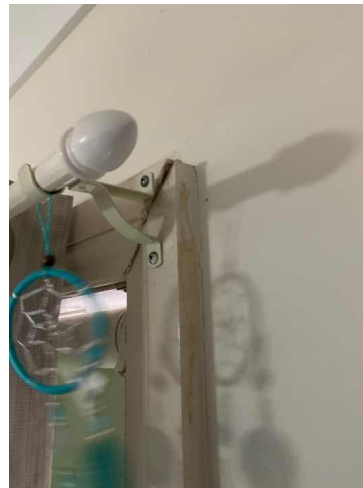
Windows

Minor cracking around window architraves. These are contributed to settlement and movement- **Minor maintenance recommended. Fill and Paint**

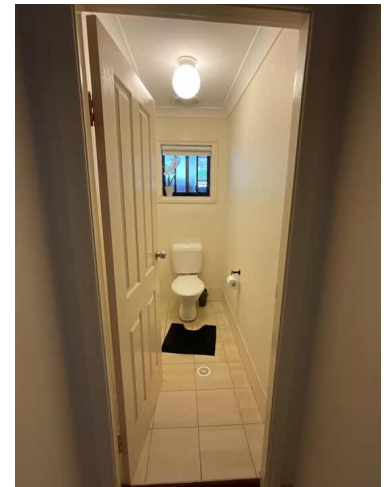
Ceiling

Cornice Cracks Noted - These are typical and generally fill and paint will suffice (**General Maintenance Conditions**) however Monitoring these cracks advised for 12 months and if become wider consult with Plasterer is recommended

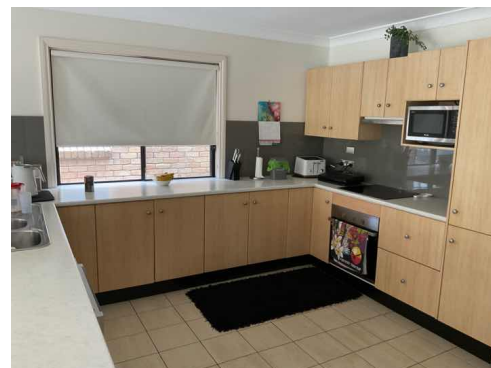
Cupboards And Bench Tops

Section of Splashback have been identified as requiring sealant - **Recommend to have this attended to, preventing likelihood of possible damage**

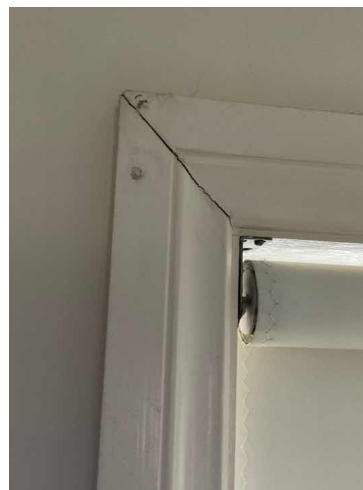
Windows

Minor cracking to architraves. These are contributed to settlement and movement- **Minor maintenance recommended. Fill and Paint**

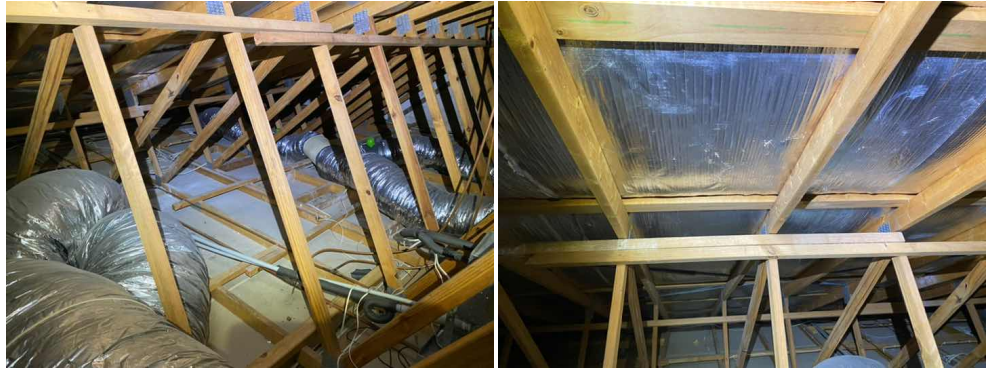
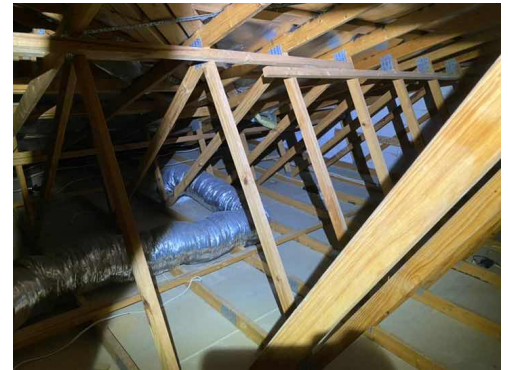
Visible sections of the roof void is in a serviceable condition for age of this dwelling.

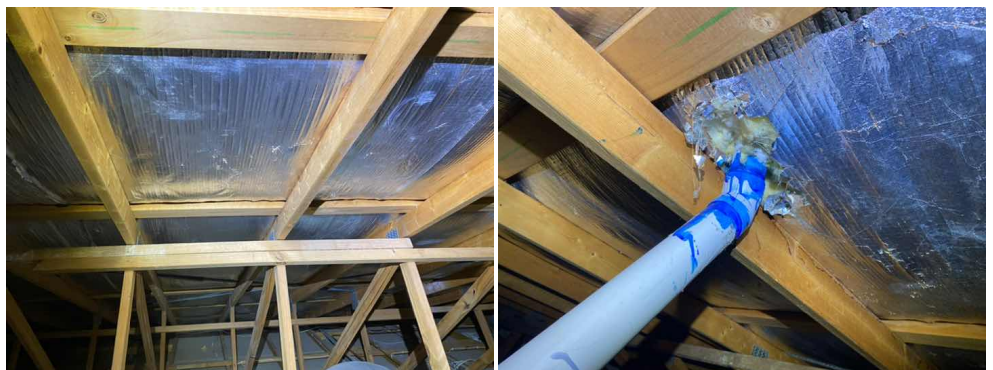
Sarking is installed.

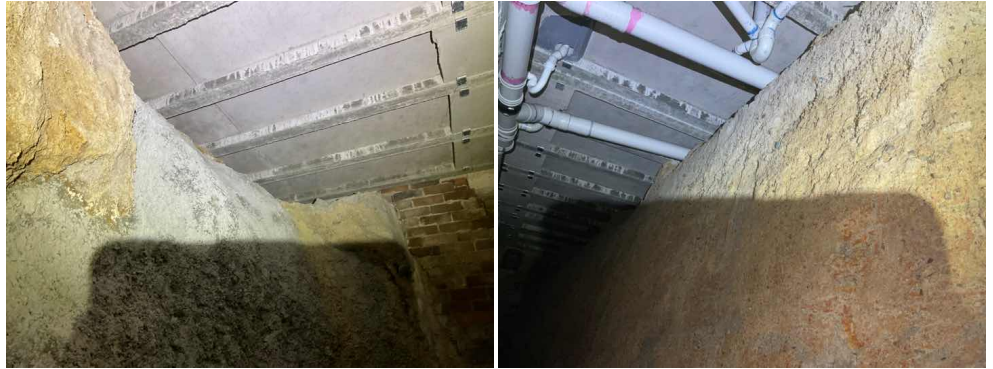
Low access restricted full visual inspection.

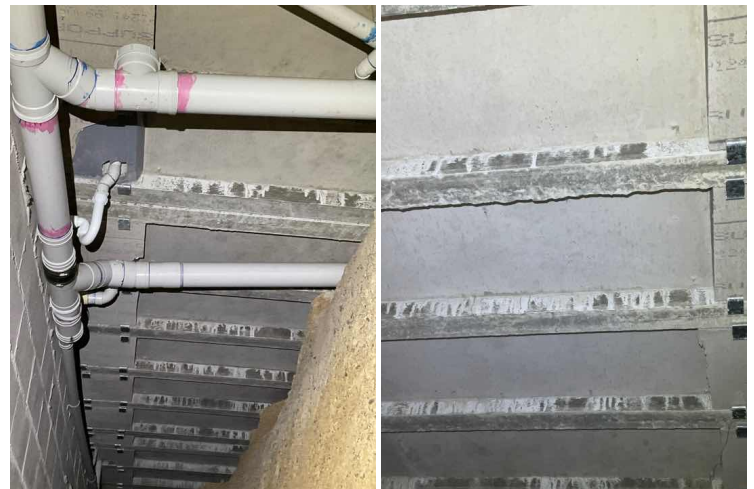
Of areas accessible and visible, the subfloor and components appeared to be in a serviceable condition.

Dampness in sub floor soil. Damp sub floor soil should be avoided as it can cause fungal decay, mould and possibly footings problems. Recommendations: A qualified drainage plumber should be engaged for advice and recommendations.
