**Building, Pest &
Pool Inspections**

Ironside Inspection Services Pty Ltd

10 Lillydale St, Carseldine, QLD, 4054

Pest And Building Inspection

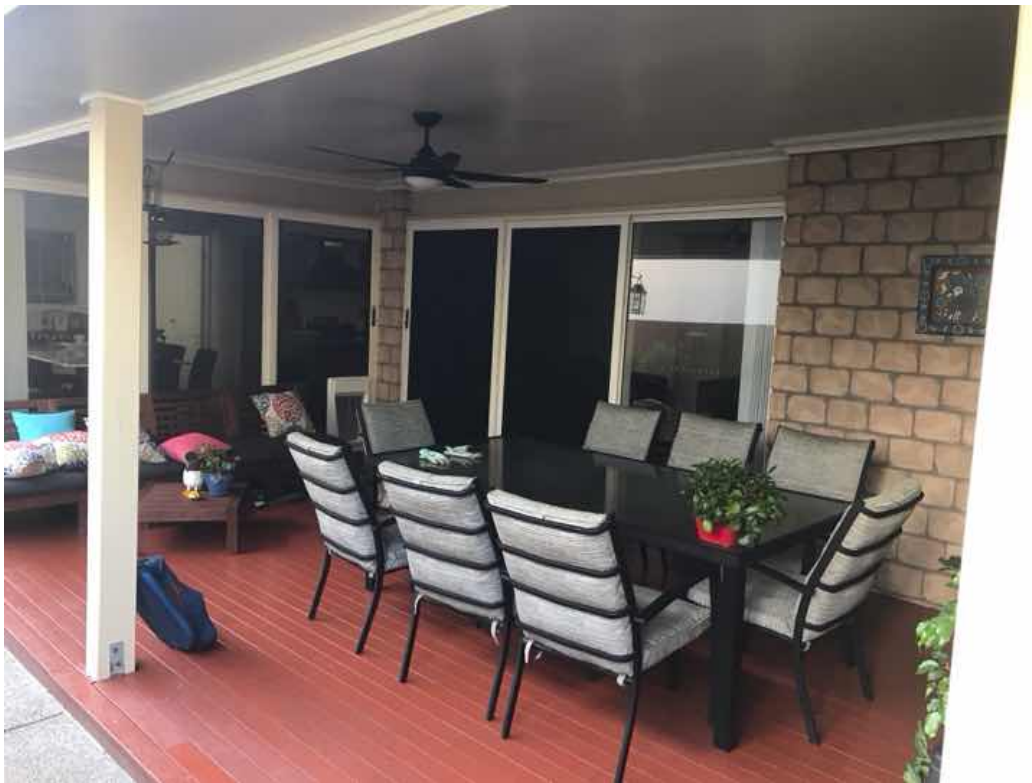
Alfresco Area

Defects exist to an area or component/s requiring assessment by a specialised field. Please read below for details.

Ceiling Lining Condition

Screw popping observed to the ceiling lining. Glue has separated in some areas. Engage a licensed plasterer to assess and repair.

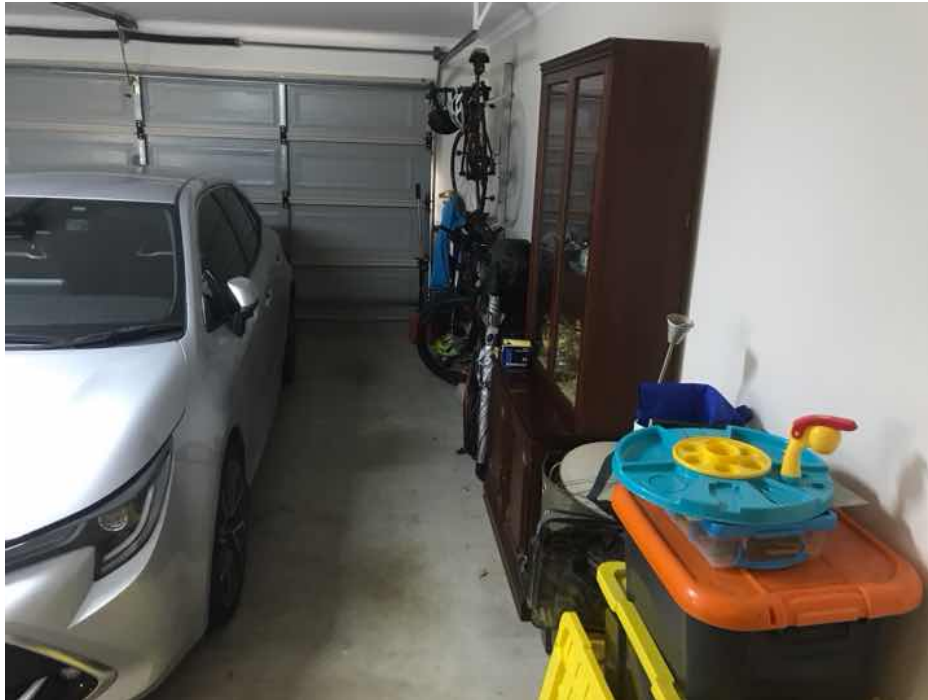
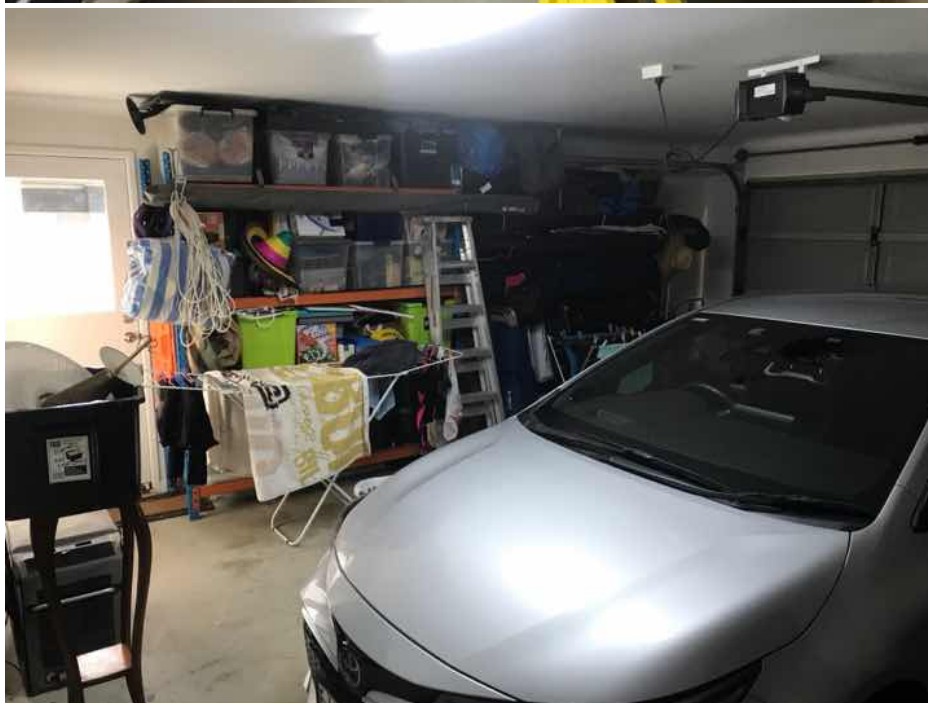
On inspection, defects were present that will require further assessing and recommendations by licensed and qualified trades persons, please read below for details.

Ceiling sagging - Requires repair. - Recommendations: I recommend you contact a licensed plasterer for further advice and recommendations on repairs.

Screw popping observed to the ceiling lining. Glue separation has occurred. Engage a licensed plasterer for maintenance repairs.

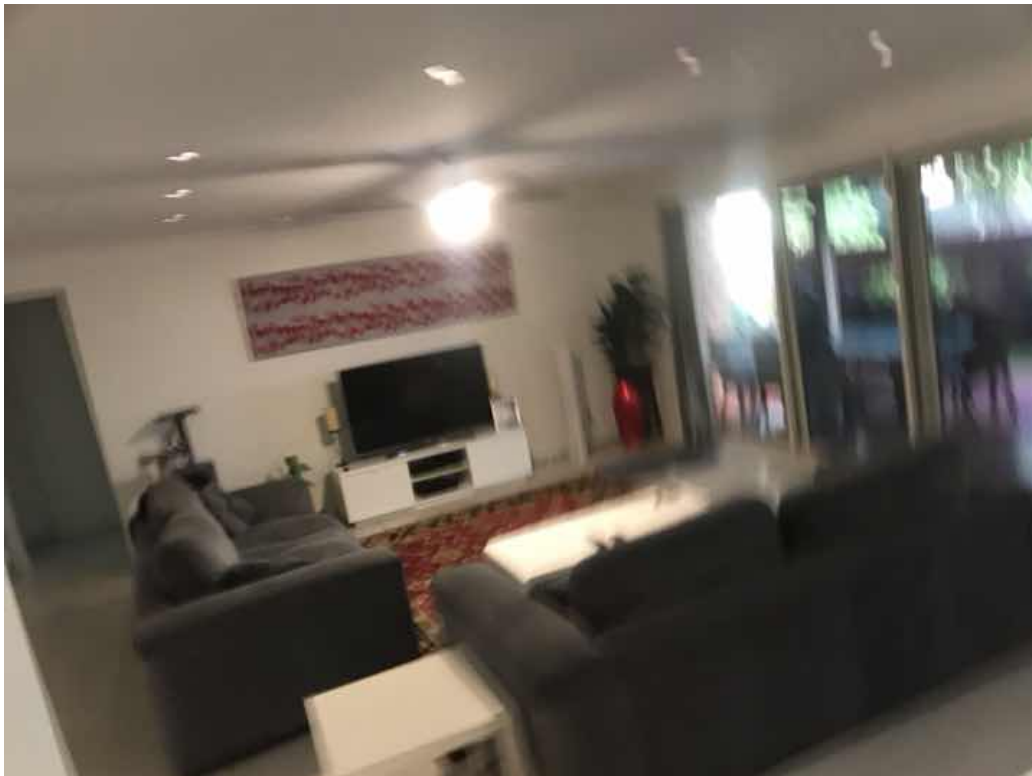
Ceiling

Screw popping observed to the ceiling lining. Glue has separated in some areas. Engage a licensed plasterer to assess and repair.

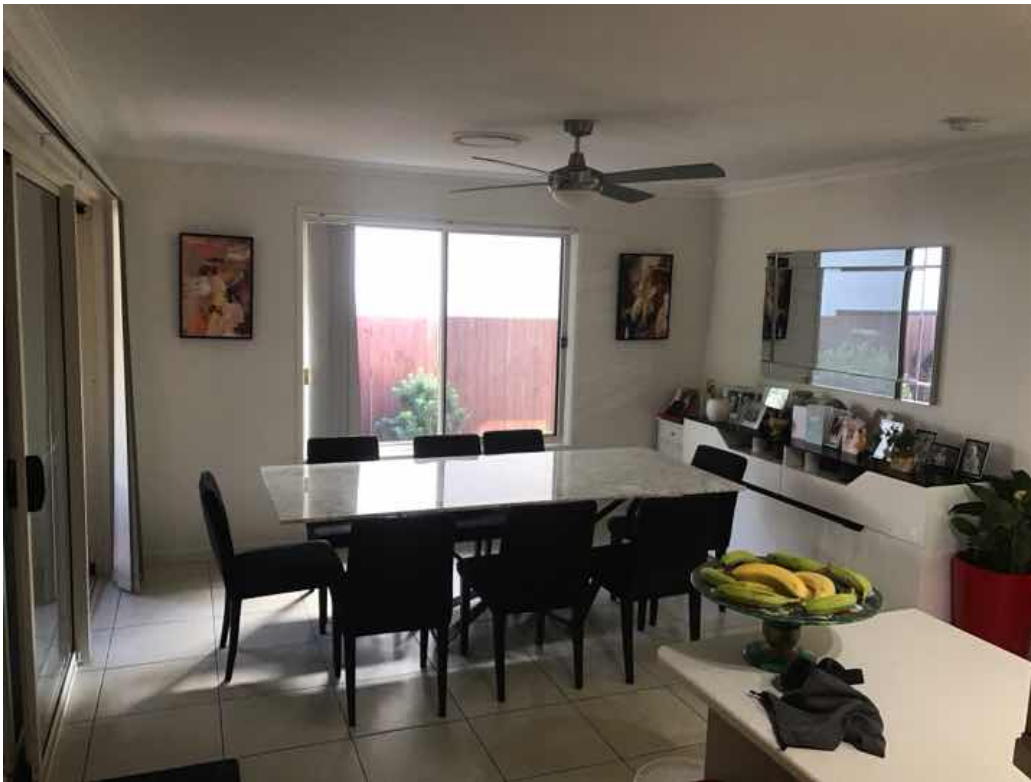
Windows

Hard to slide. Replace wheels

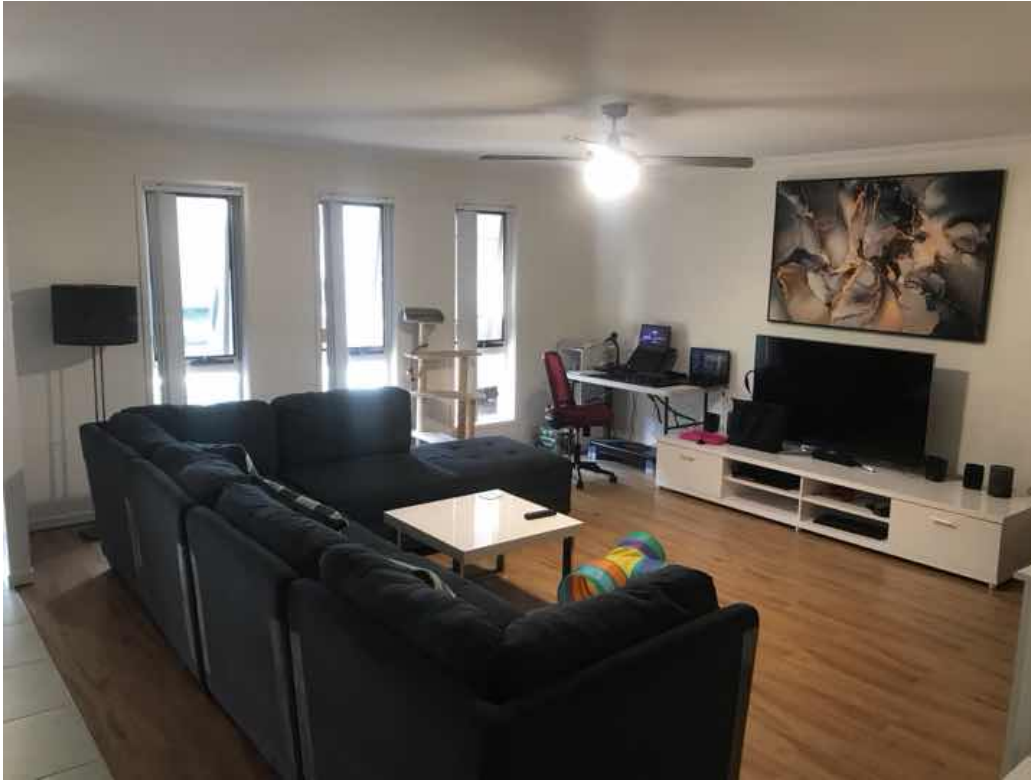
Ceiling

Screw popping observed to the ceiling lining. Glue has separated in some areas. Engage a licensed plasterer to assess and repair.

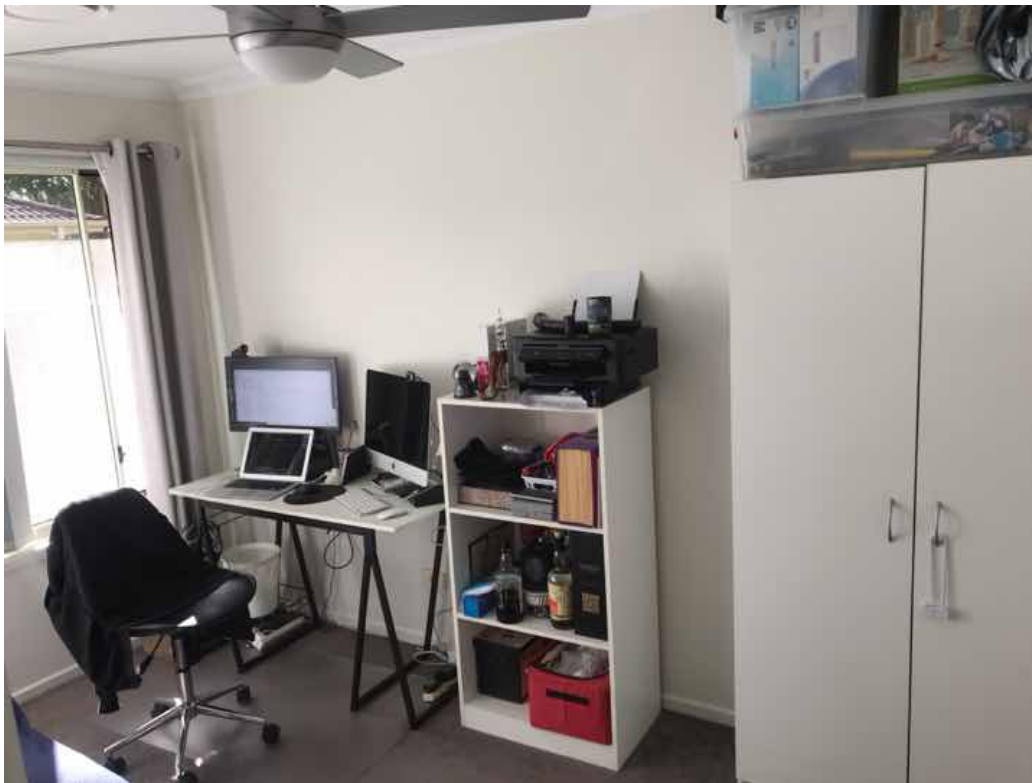
Door

Binding door - Doors that bind on the frame can relate to some differential settlement in the footings, frame movement, age, expansion, shrinkage and the like. It can also be seasonal where it may bind for some months and then open and close sufficiently. Monitoring over time or a more invasive inspection is only method of ascertain cause. Recommendations: A qualified carpenter should be engaged for advice and recommendations.

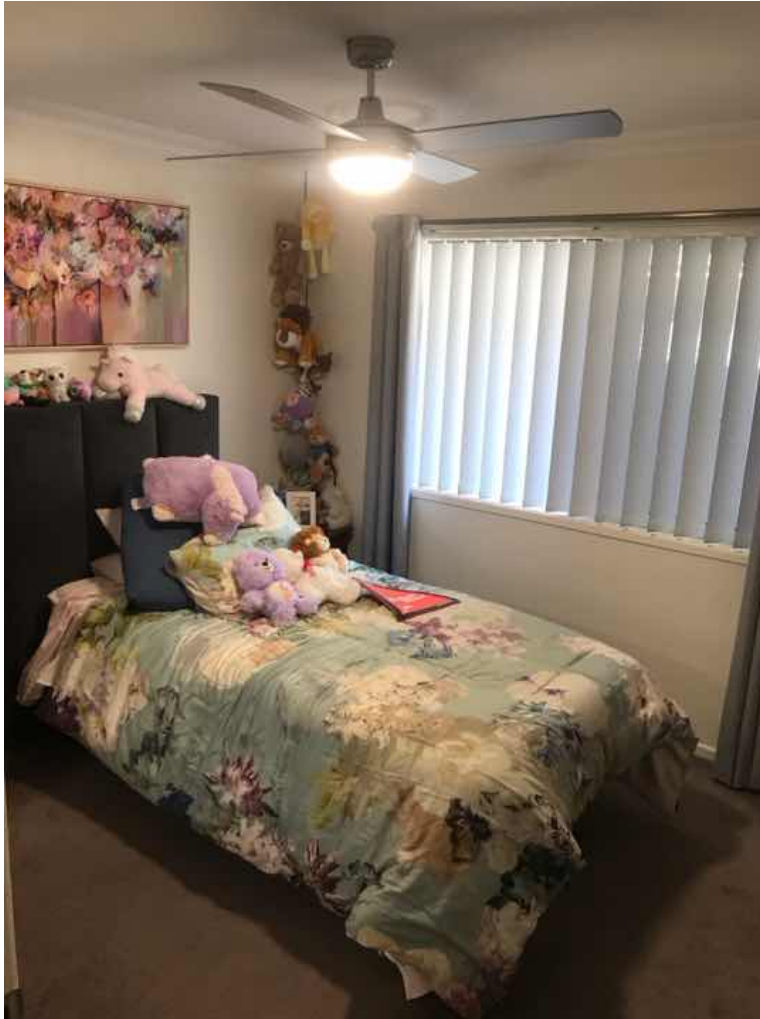
Windows

Hard to slide. Replace wheels

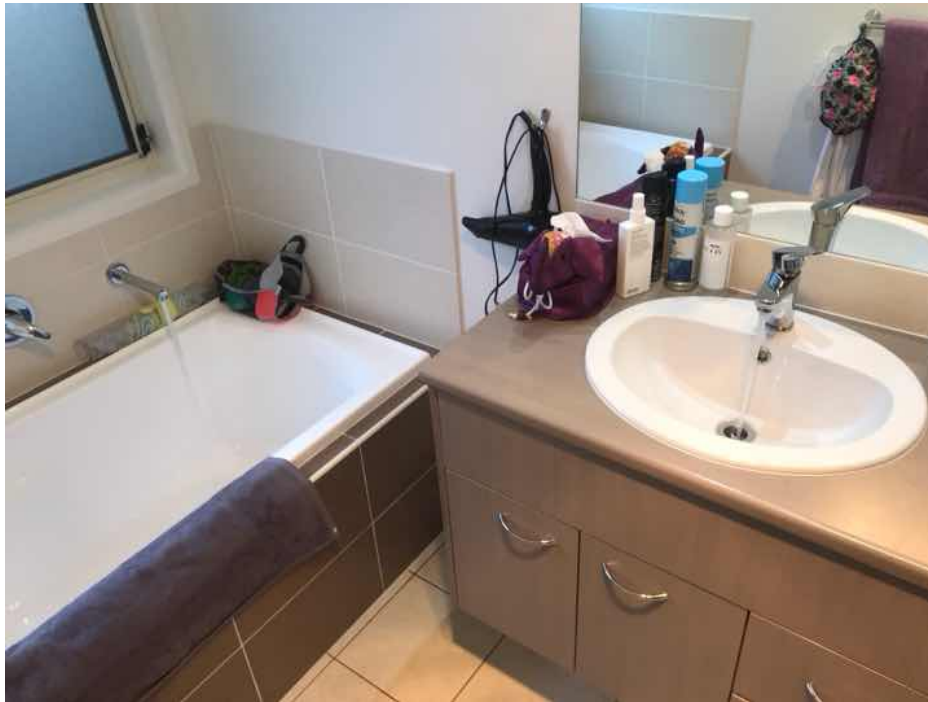
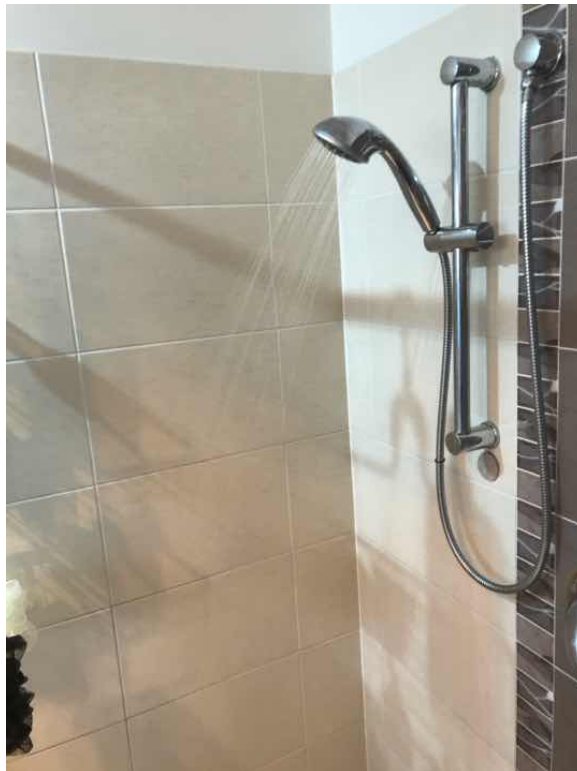
Sink

The flexible hose is rusting. Recommend replacing to prevent any water leaks. Engage a licensed plumber for replacement.

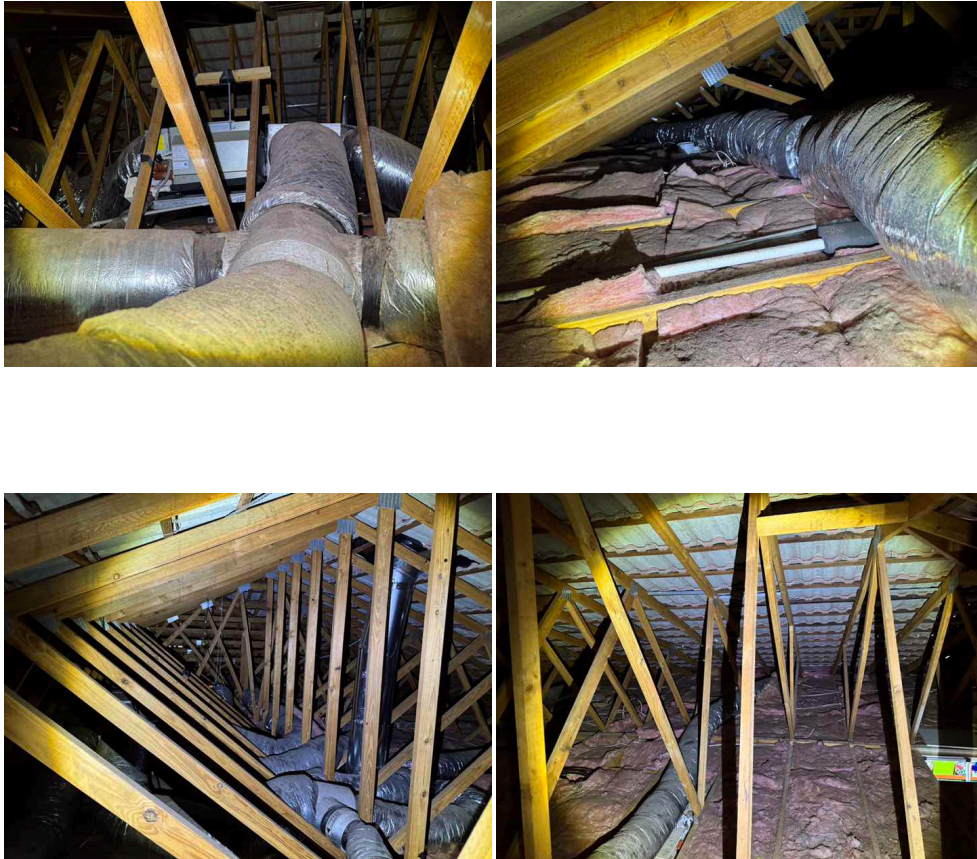
There is heating and/or cooling ducting present in the roof space/void. This is preventing a full inspection from being undertaken.

There is insulation present in the roof space/void. This is preventing a full inspection of ceiling joists from being undertaken.
