28 Warbler Street, Inala, Queensland, 4077 Australia

## **Pre-Purchase Standard Property & Timber Pest Report**

14th May, 2024

Report number:	24/326
Inspection Date:	14th May, 2024
Property Address	28 Warbler Street, Inala, Queensland, 4077 Australia

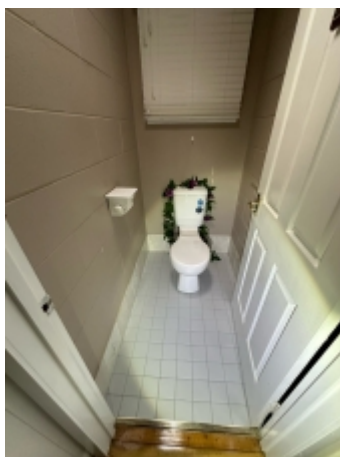
WC

Were there any obstructions that may conceal possible defects?	The following obstructions may conceal defects:
--	---

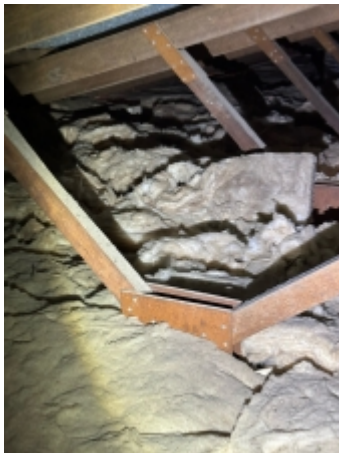
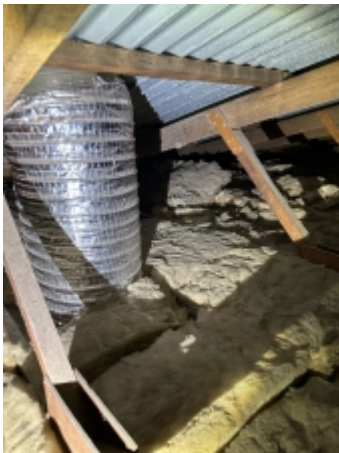
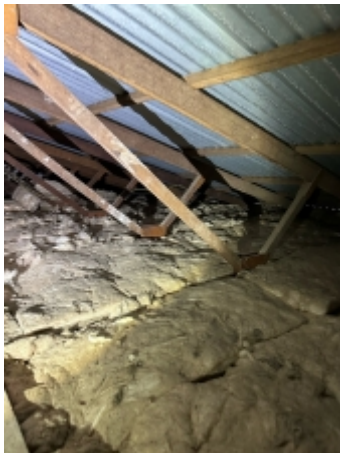
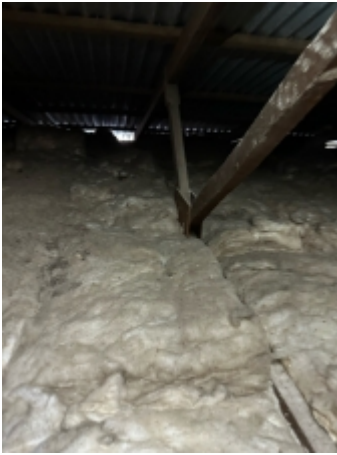
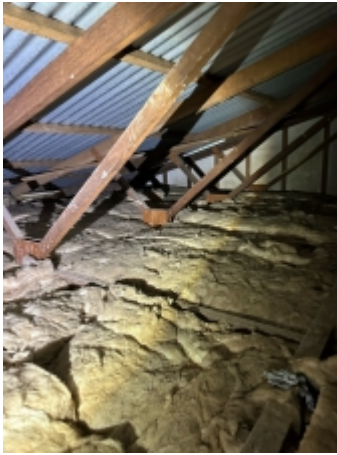
Roof space photos

Annexures to this report	The following are attached
Annexures	<p>All showers were run for the required 10 minutes during the inspection and no moisture was detected in adjoining walls or ceilings below.</p> <p>Roof space The presence of ceiling insulation makes a detailed inspection of the roof space Timbers impractical.</p>
