## Building Report

4/73 Sixrth Ave, Maroochydore

# VISUAL BUILDING INSPECTION REPORT

**This report complies with Australian Standard AS 4349.1 - 2007 Inspection of Buildings.**

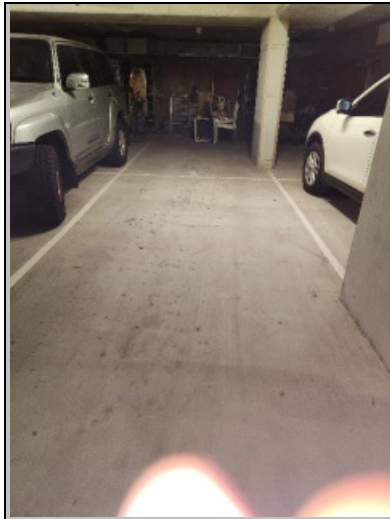
Garage Location:

There is an allocated car space and cage only.

General Overall Condition:

The overall condition of the garage is good.
