# Building Condition Structure Inspection

**9 Southsea Road , Quinns Rocks, WA, 6030**

Report/Agreement #	16092211394148
Inspection Date:	16 Sep 2022
Inspection Time:	11:39 am

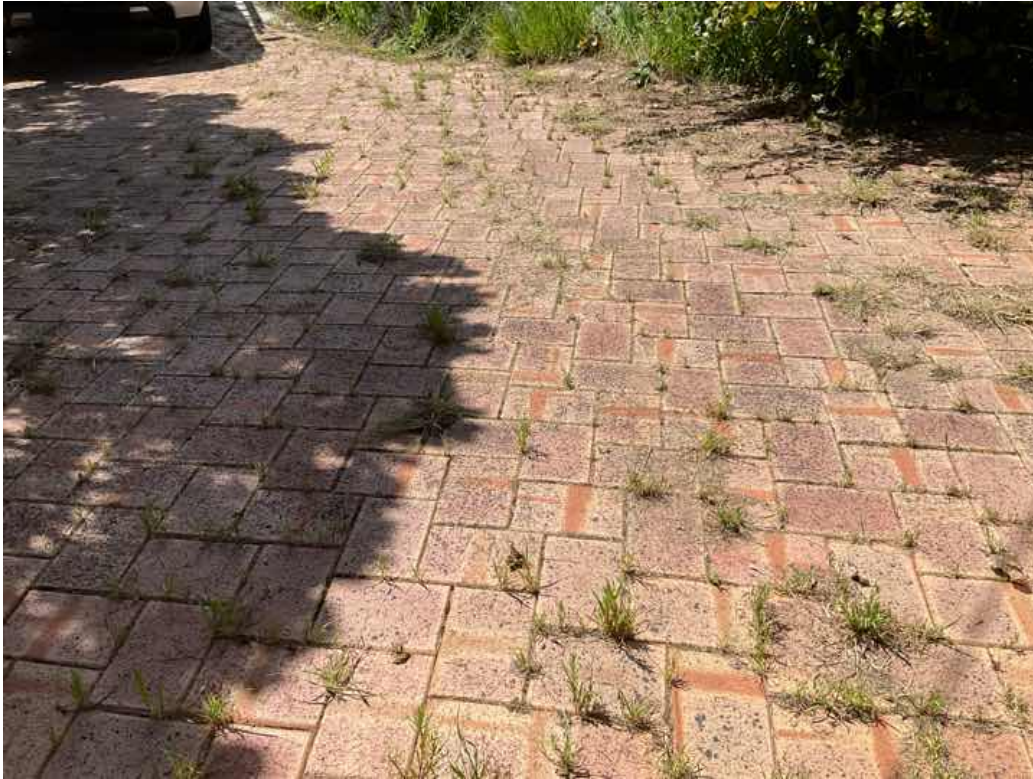
On visual inspection, the general condition of the driveway is in a serviceable condition overall showing no defects.

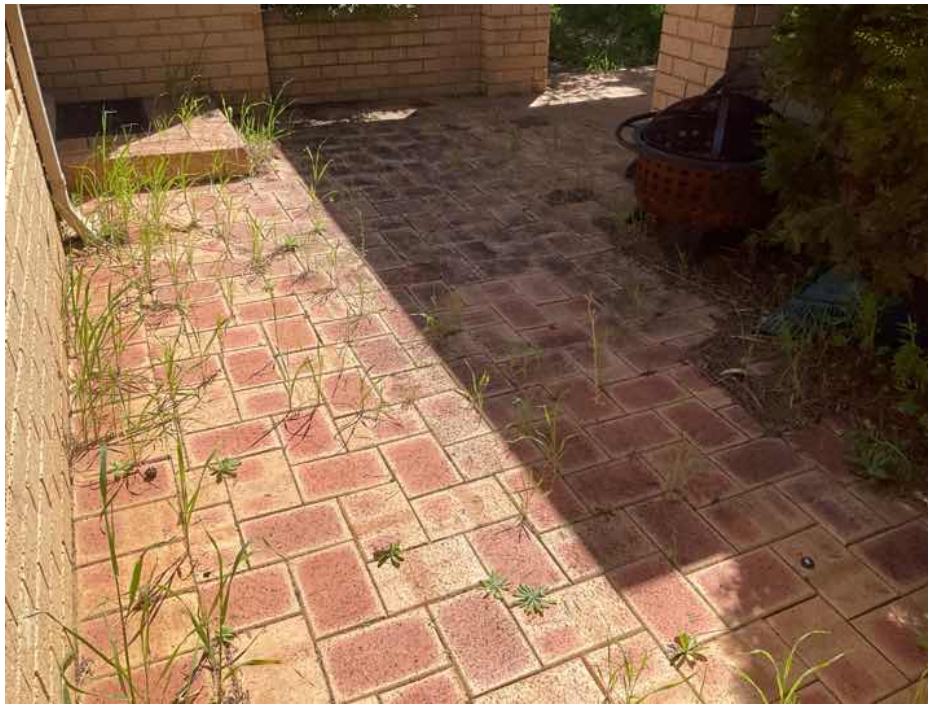
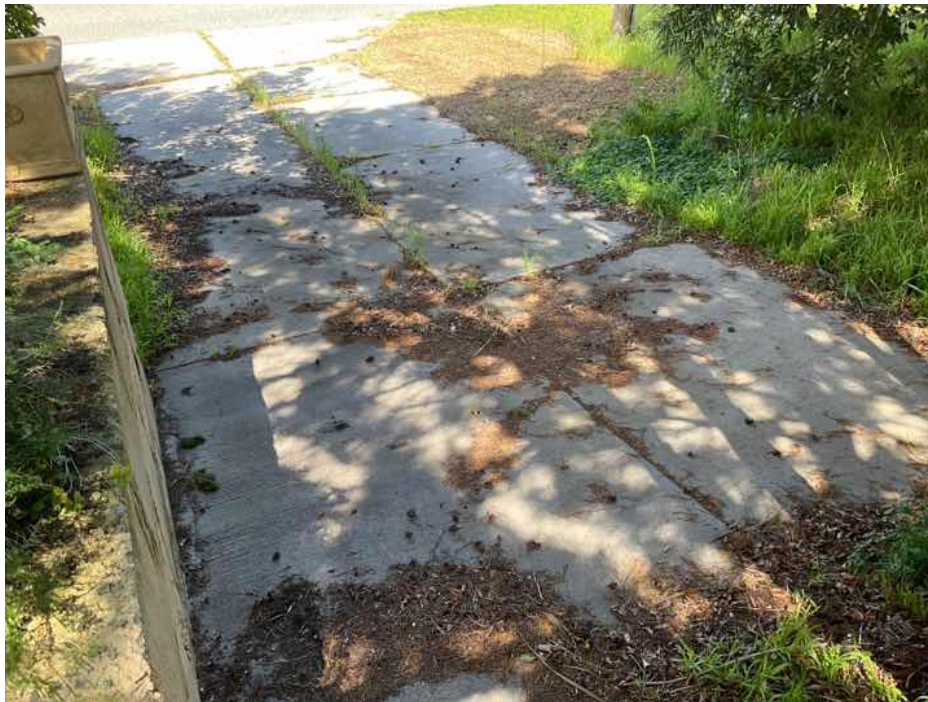
The pathways around the home are in a serviceable condition for the age of this dwelling with no major defects visible.

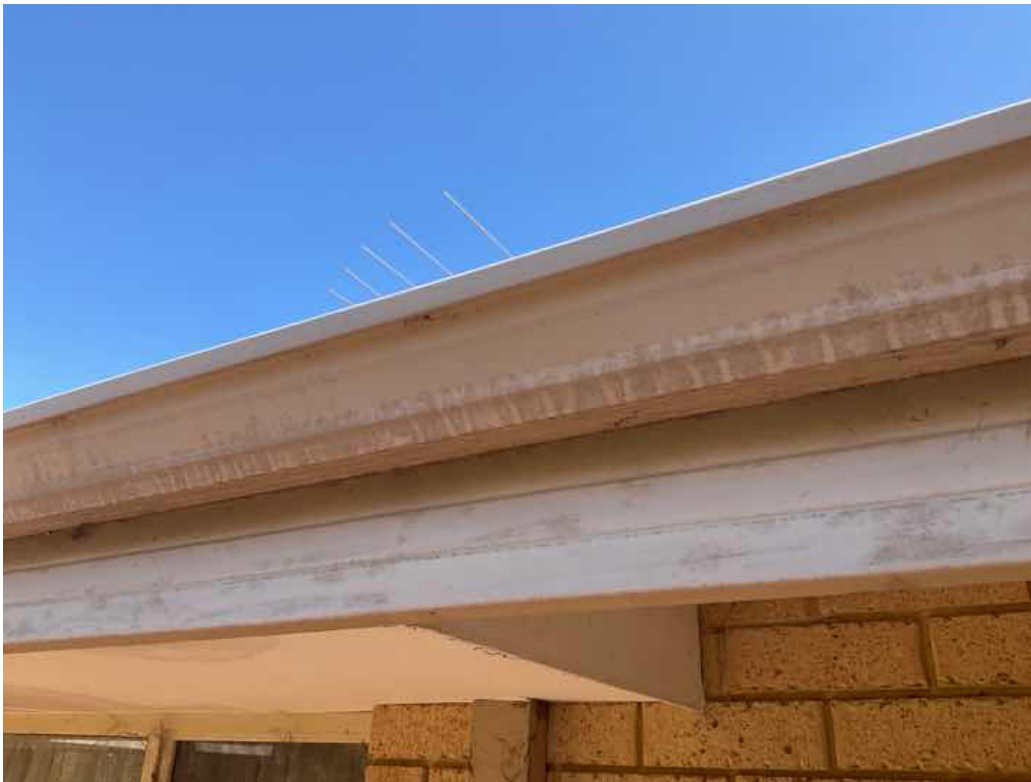
All visible guttering appears fair serviceable condition with no apparent defects at the time of inspection. Note: Periodic maintenance checks should be carried out for rust penetrations and leaks.

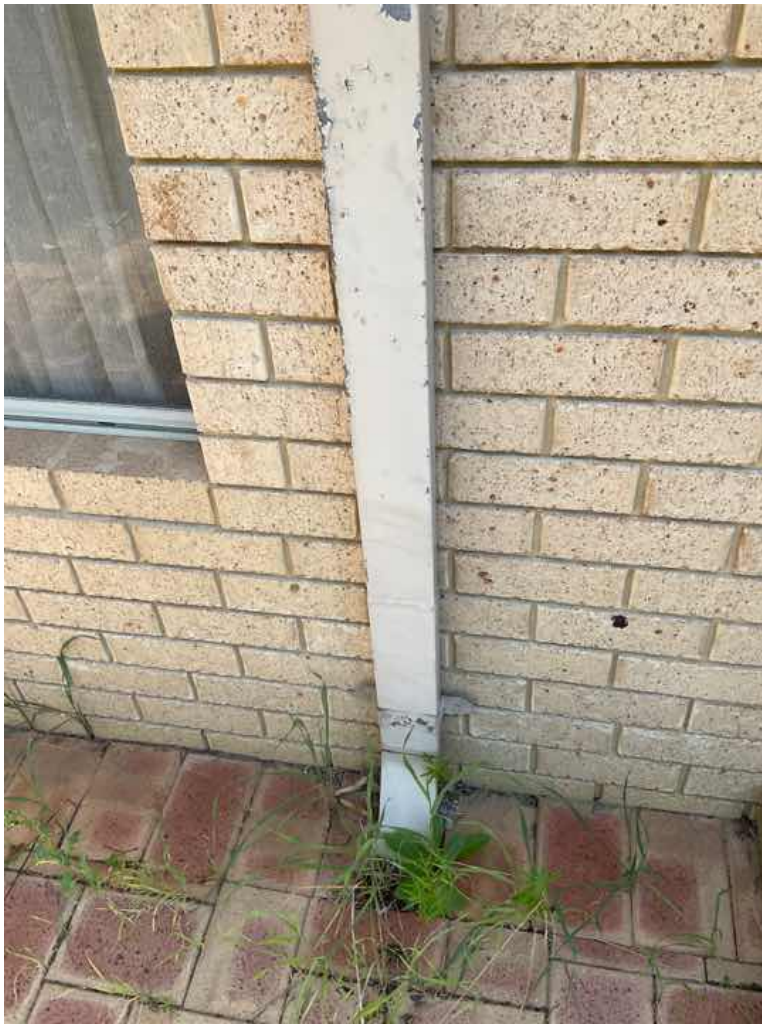
On visual inspection no apparent defects were noted to the down pipes and are considered serviceable, however no comment can be made with regard to blockages, connections to stormwater or functionality in the absence of rain. Note: Periodic maintenance checks should be carried out for rust penetrations and leaks.

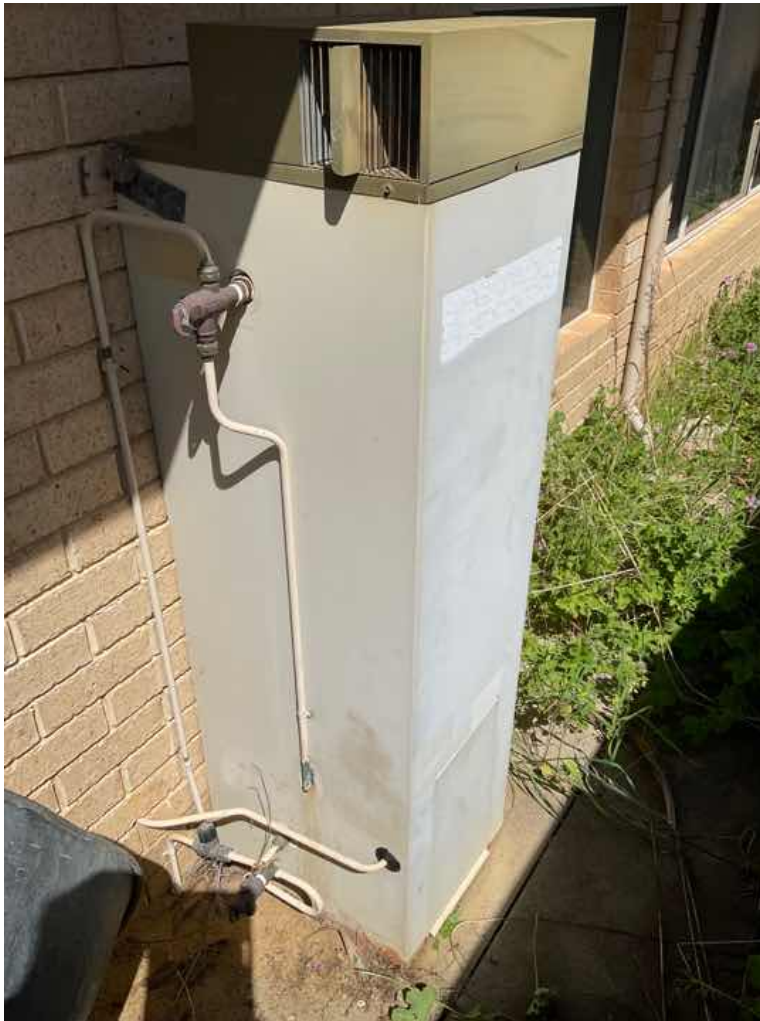
The hot water system appears to be in a serviceable condition for its age.

Please note, the gas was turned off at the meter at time of inspection.

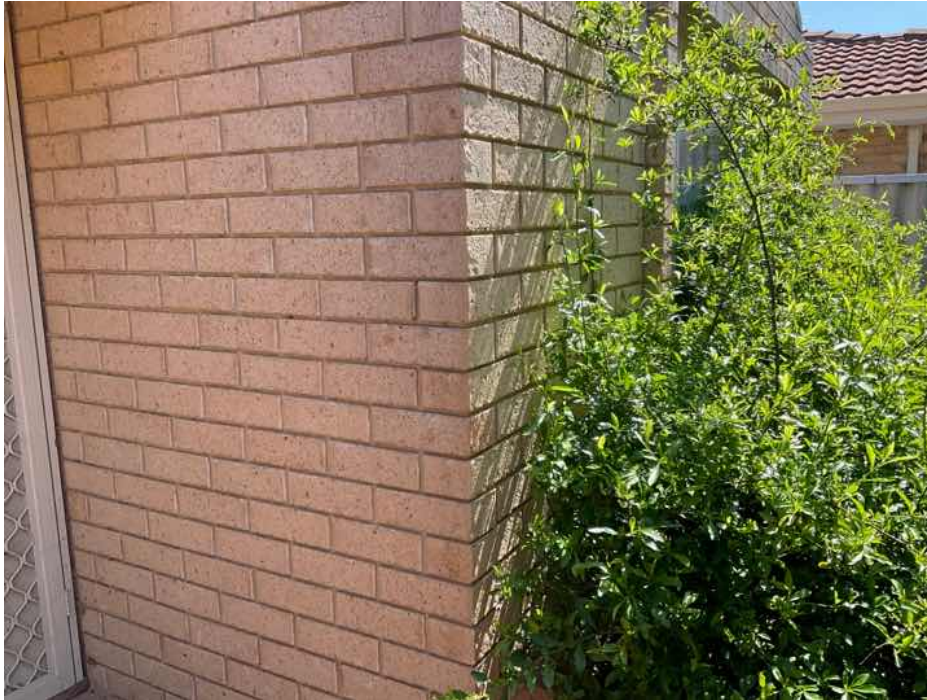
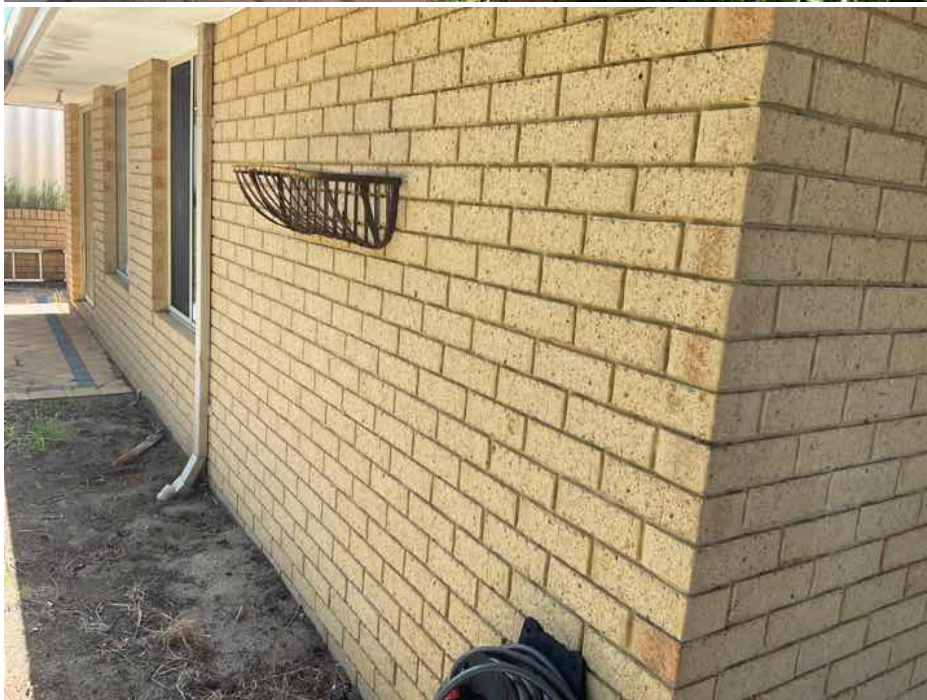
On visual inspection, the general condition of the exterior walls are in a good serviceable condition for their age.

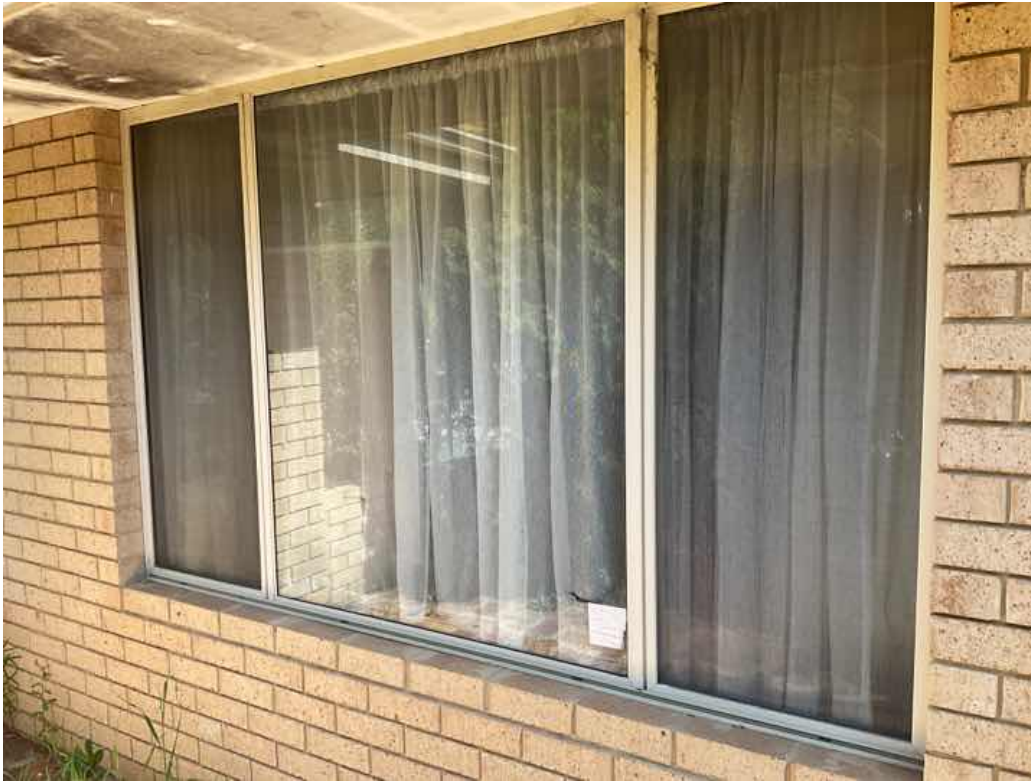
On visual inspection, the general condition of the windows are in a fair serviceable condition for their age.

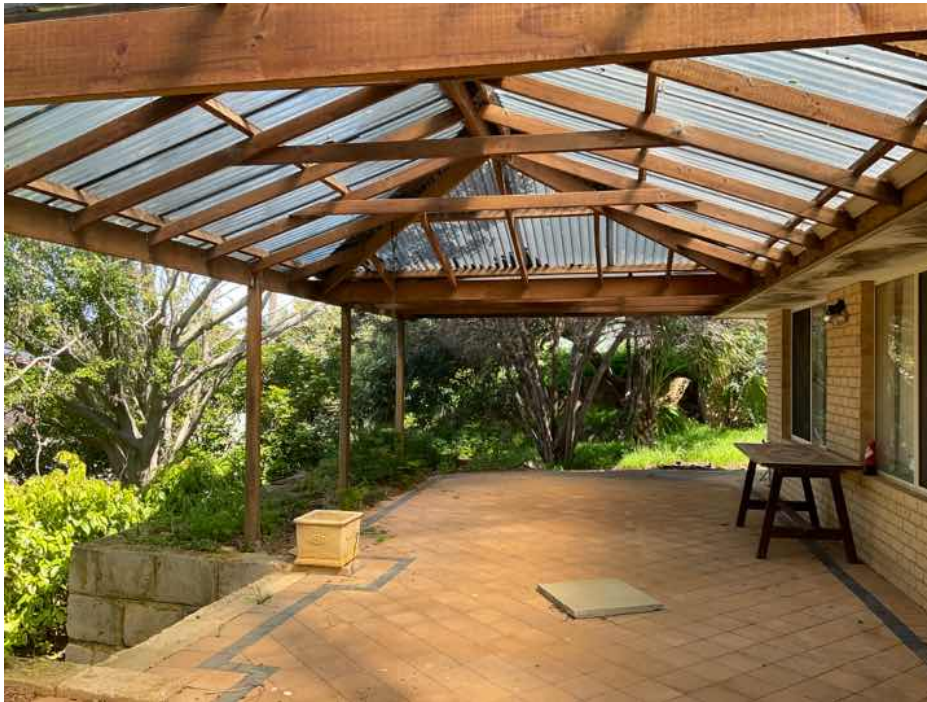
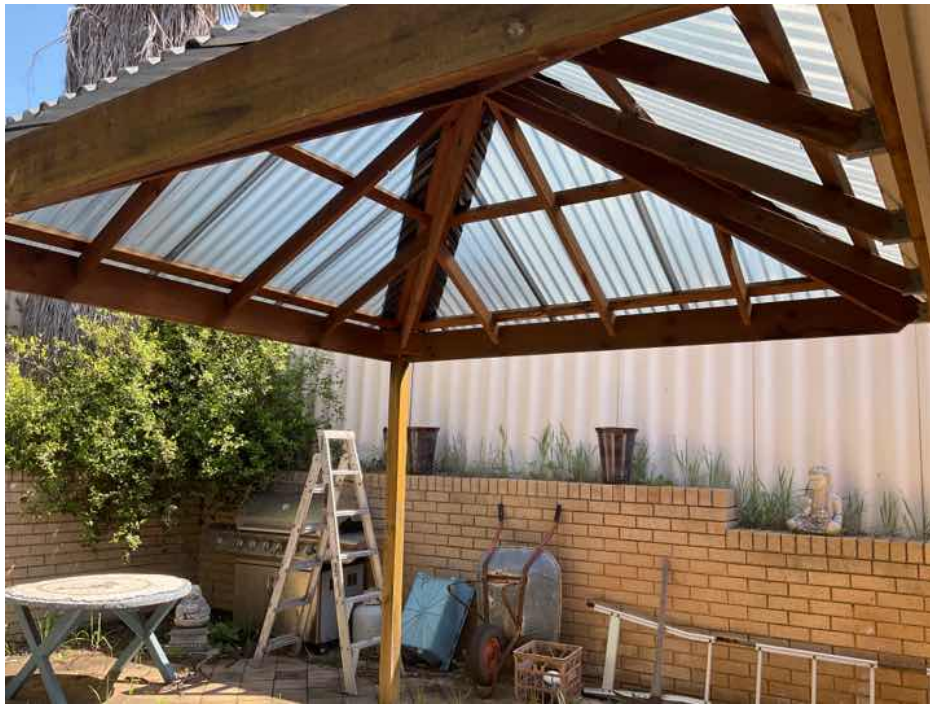
The visible sections of the Alfresco areas are serviceable and/or in reasonable condition for their age showing no apparent problems when inspected.

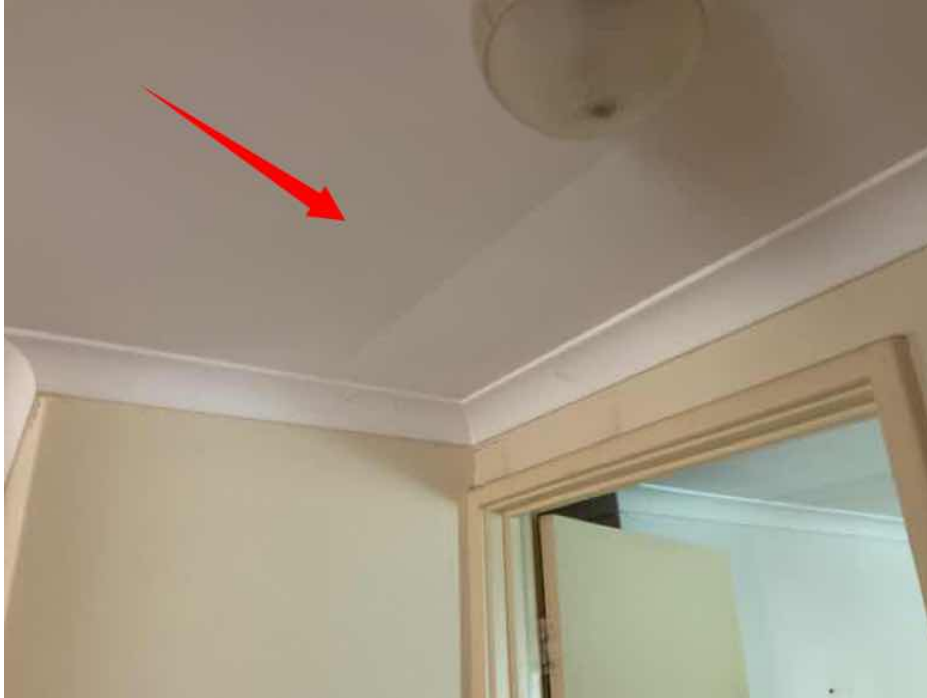
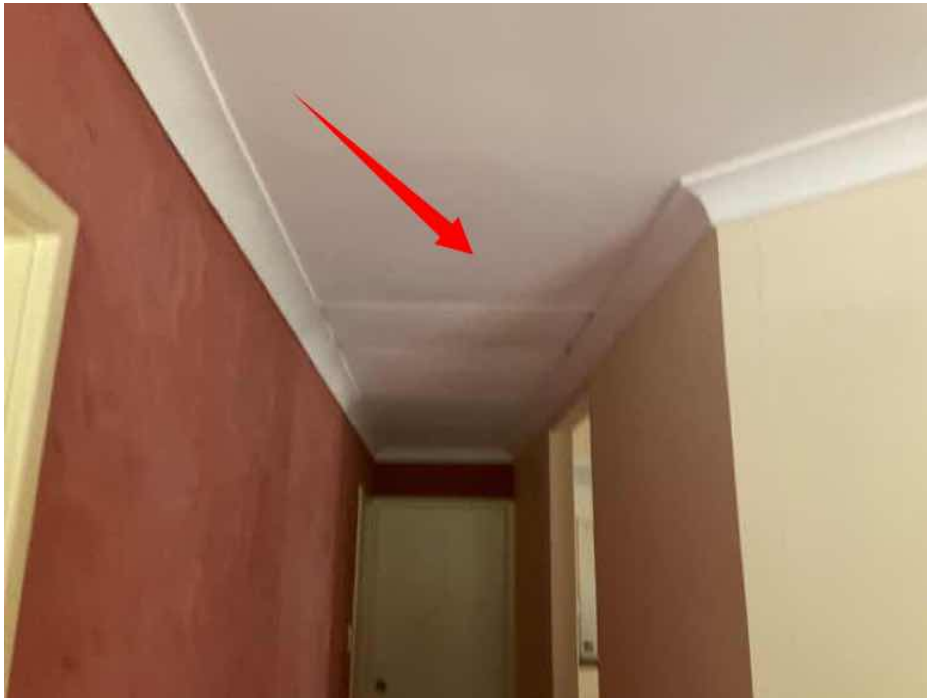
Section	Location	Name	Comment
INTERIORS	Smoke Alarm	Was a Smoke Alarm Fitted	No, smoke alarms were not sighted within the property. Legislation requires Smoke Alarms to be installed and to compliance prior to a property selling. Check with your local council regarding type, locations and other related requirements.
INTERIORS	Family Room	Overall Condition	<p>From the visible and accessible areas, the family room appears to be in a serviceable condition for the age of the property.</p> <p>The ceilings within the room are showing general movement/ accentuation lines on the sheet joins suggesting the the glue is slowing breaking down between the sheet itself. Cornice cracking is also evident.</p> <p>The ceilings may be able to be re-screwed and glued but ultimately replaced.</p> <p>General movement movement cracking to the entrance walk through wall area into the bedroom hallway is apparent, currently not a major structural concern and easily repaired as necessary.</p> <p>The structural support column within the room is showing general movement cracking as a consequence of movement from the support steel/lintel running across the column.</p> <p>We would suggest this is a structural defect where recommendation for repair from a structural engineer is required.</p>

Legislation requires Smoke Alarms to be installed and to compliance prior to a property selling.

Check with your local council regarding type, locations and other related requirements.

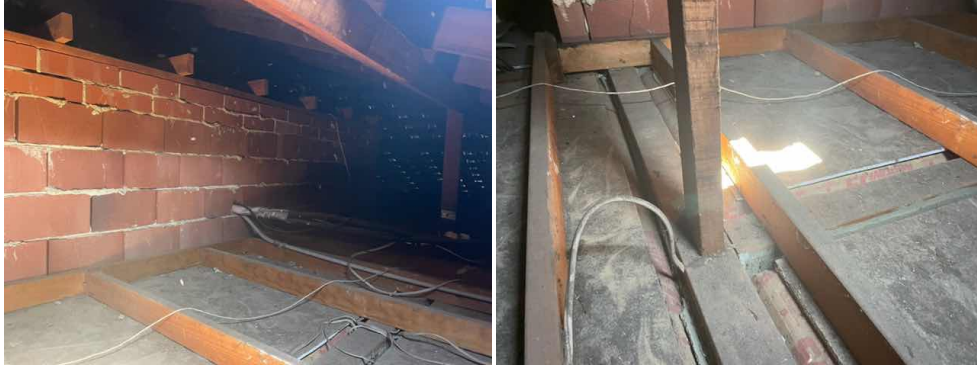
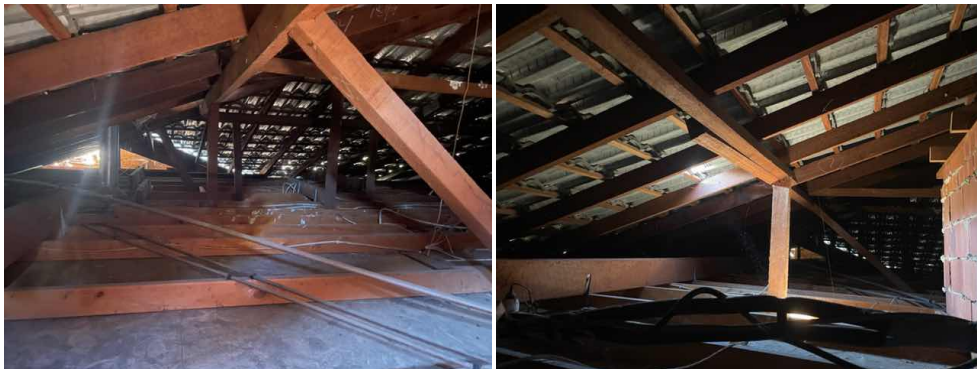
From the accessible and visible areas of the roof structure, showed to be built to a fair standard overall, built for its intended purpose and age, showing no apparent problems or issues at time of inspection.

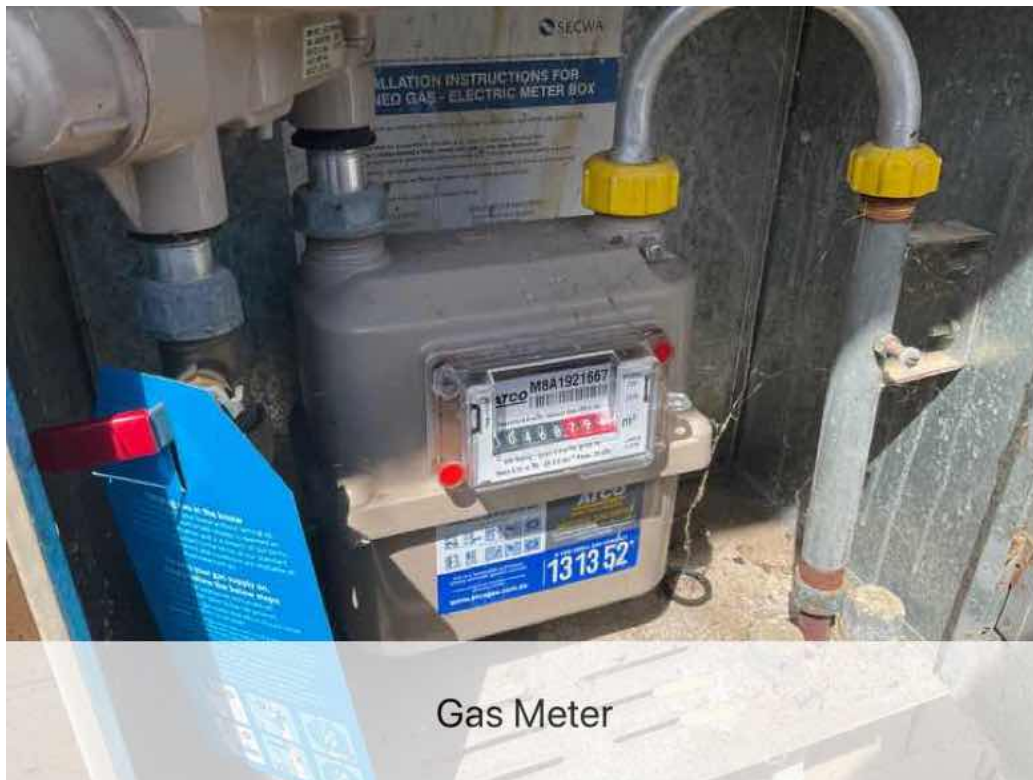
Gas Meter

The water was connected however no hot water as the gas was turned off.

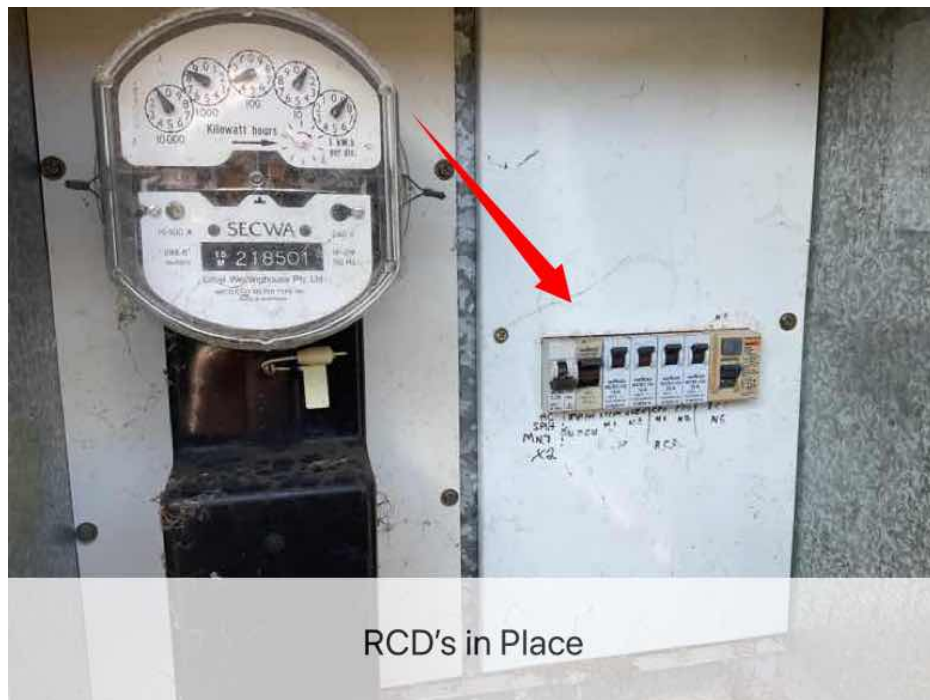
RCD's in Place

Electricity to the dwelling was connected. RCD's were noted within the meter box. The earth stake was viewed.
