# BRENT HENNESS PPI

**PRE-PURCHASE INSPECTIONS**

*7/1 PETER CLOSE HORNSBY HEIGHTS NSW 2077*

## Visual Pre Purchase Building Inspection Report

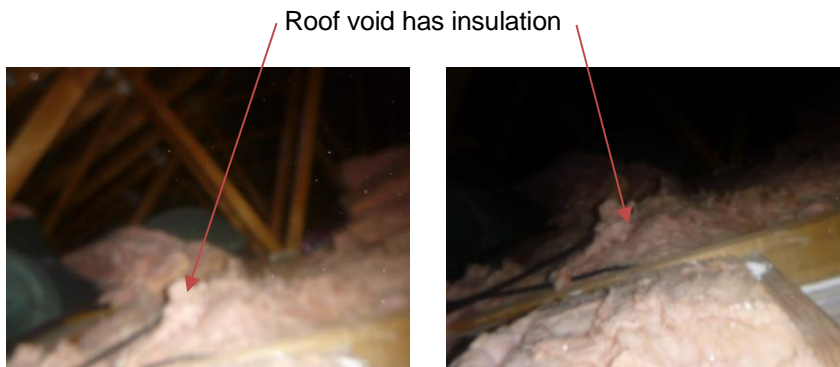
Access was hindered into this roof loft area by the:

- a. valley series timber truss sections
- b. the low pitch in areas,
- c. the low pitch is eave areas,
