## BUILDING & PEST INSPECTION REPORT

21 Parklands St  
Calamvale, QLD 4116

BYB  
25/09/2025

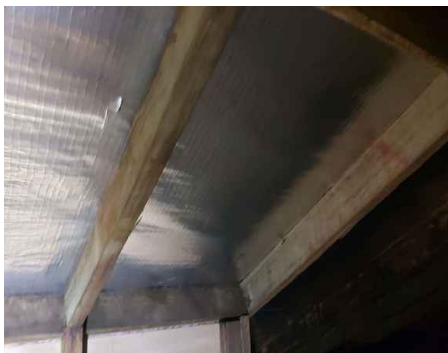
**Access, Restrictions and Limitations: Sarking**

Sarking is present in the roof space. This restricted inspection of some roofing timbers.

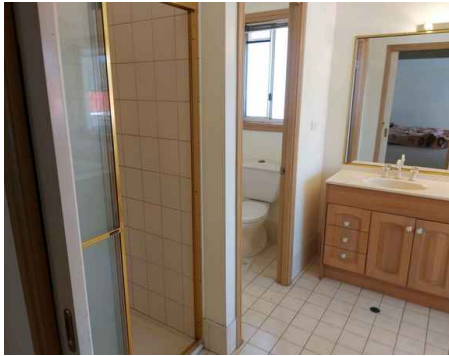
1st Floor Ensuite

No Major Defects Were Observed. Normal ongoing maintenance is required.

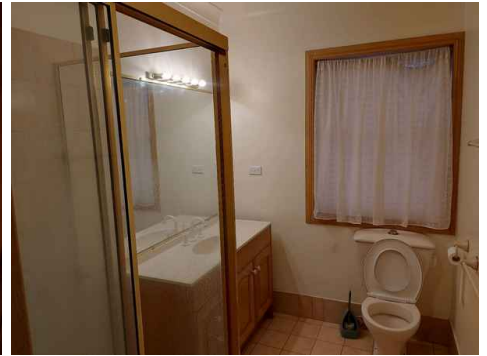
1st Floor Ensuite

Spa baths and the associated fixtures and fittings are not tested and excluded from the scope of this inspection and report. If testing is required consult a qualified plumber
